# The need for complementary hydraulic analysis in post-restoration monitoring of river restoration projects

**T. A. Endreny and M. M. Soulman**

## Post-restoration monitoring of river restoration projects

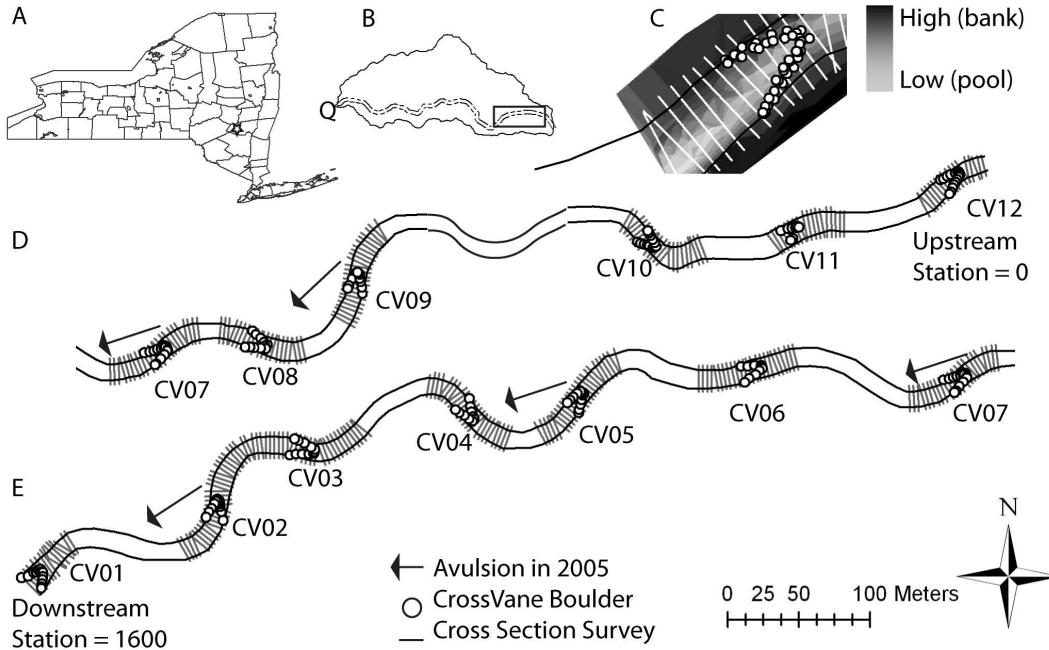
The Big Hollow project used 12 cross-vane structures and 48 j-hooks to redirect bank scour forces and keep the bankfull erosion forces in the channel center. The restored project experienced areas of failure during an April 2005 rain-on-snow flood event that caused four avulsions in the restoration project (see arrows in Fig. 1d and e). The avulsions were located near cross vanes 2, 5, 7, and 9, where cross-vane number increases in the upstream direction. Prior to the avulsions, aggradation and degradation in pools along the reach had been reported. The post-restoration monitoring of this project was completed by the authors and the GCSWCD project team. These monitoring efforts recorded trends in Batavia Kill pool depths for the first three years after construction. Analysis of these data explores how aggradation influenced the flood-triggered avulsions. The paper also examines whether variation in cross-vane geometry or cross-vane location explained the variation in channel aggradation.

**Fig. 1.** (A) Location in New York of (B) Batavia Kill watershed. (C) Diagram of a cross-vane and its scour pool. (D) Upstream reach of restoration project with 6 cross-vanes and (E) downstream reach of project, where arrows show the avulsion sites.

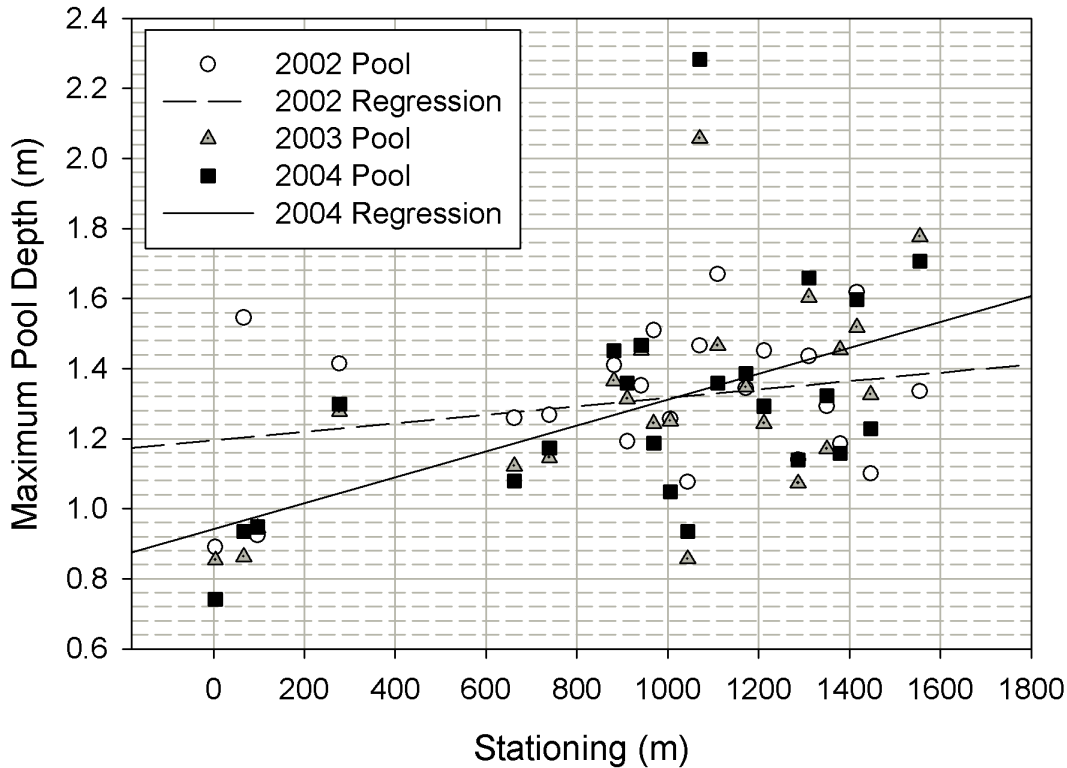
For each survey year, pool depth generally increased in the downstream direction in the Batavia Kill restoration project at Big Hollow (Fig. 2). In 2002 the upstream 800 m of the project had average pool depths of 1.2 m, only 0.1 m shallower than the downstream 800 m of project average pool depths. In 2002 the upstream section had the only 3 pools shallower than 1 m. In 2004 the upstream pools had aggraded to an average depth of 1 m, while the downstream pools had increased to an average depth of 1.4 m, with one pool scouring from 1.5 to 2.3 m. By 2004 6 of the 7 upstream pools had partially aggraded. In the downstream section, the trend for pools was mixed, with 9 of 17 pools aggrading, including those downstream of the later avulsions. A survey of the cross-sections after the 2005 flood showed additional aggradation in the pools downstream of the avulsions (Buck-Engineering PC, 2006).

**Fig. 2.** Maximum pool depth for 24 monitored pool cross-sections for 2002, 2003, and 2004 with trend lines for 2002 and 2004.

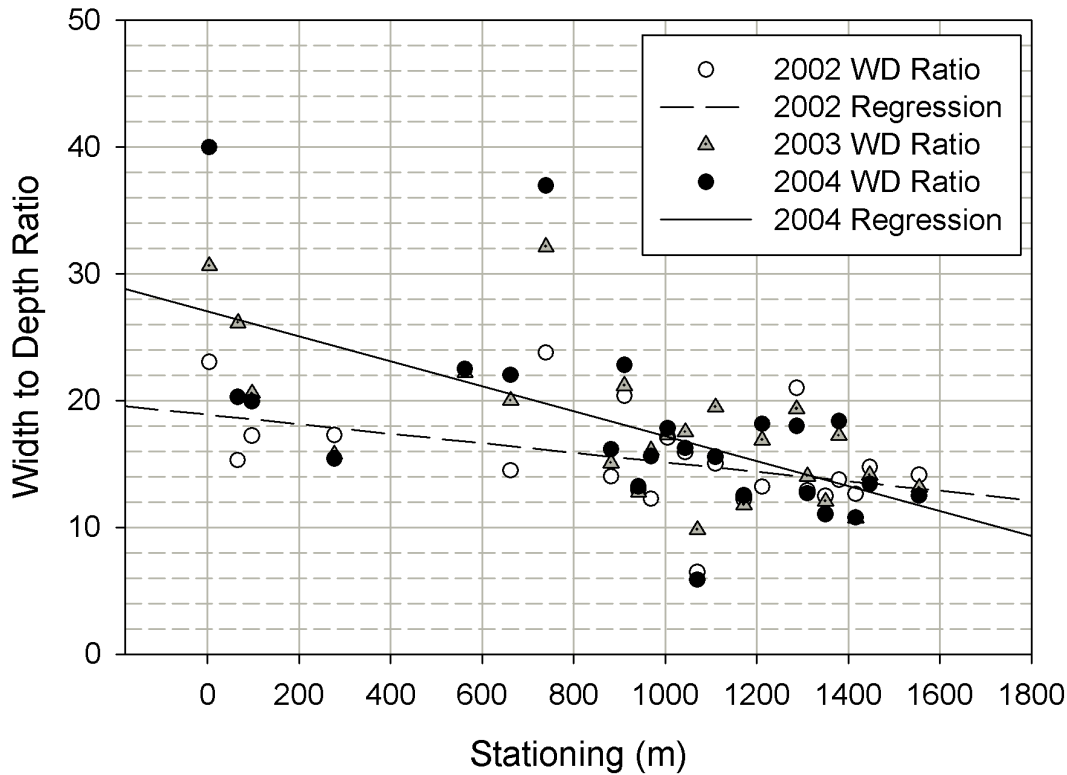
Width-to-depth ratio decreased in the downstream direction (Fig. 3). Reach average width-to-depth ratios were 15 in 2002 and 18 in 2004. In the 800 m upstream section, the average ratio increased from 18 in 2002 to 24 in 2004, while the 800 m downstream section had an average ratio of 14 across the 3 years. The upstream to downstream trend in decreasing ratios steepened between 2002 and 2004. Despite variation in width-to-depth ratios, all of the measured values were within the normal range reported for stable cross-vane restored rivers (Radspinner et al., 2010).

**Fig. 3.** Width-to-depth ratios for 24 monitored pool cross-sections for 2002, 2003, and 2004 with trend lines for 2002 and 2004.

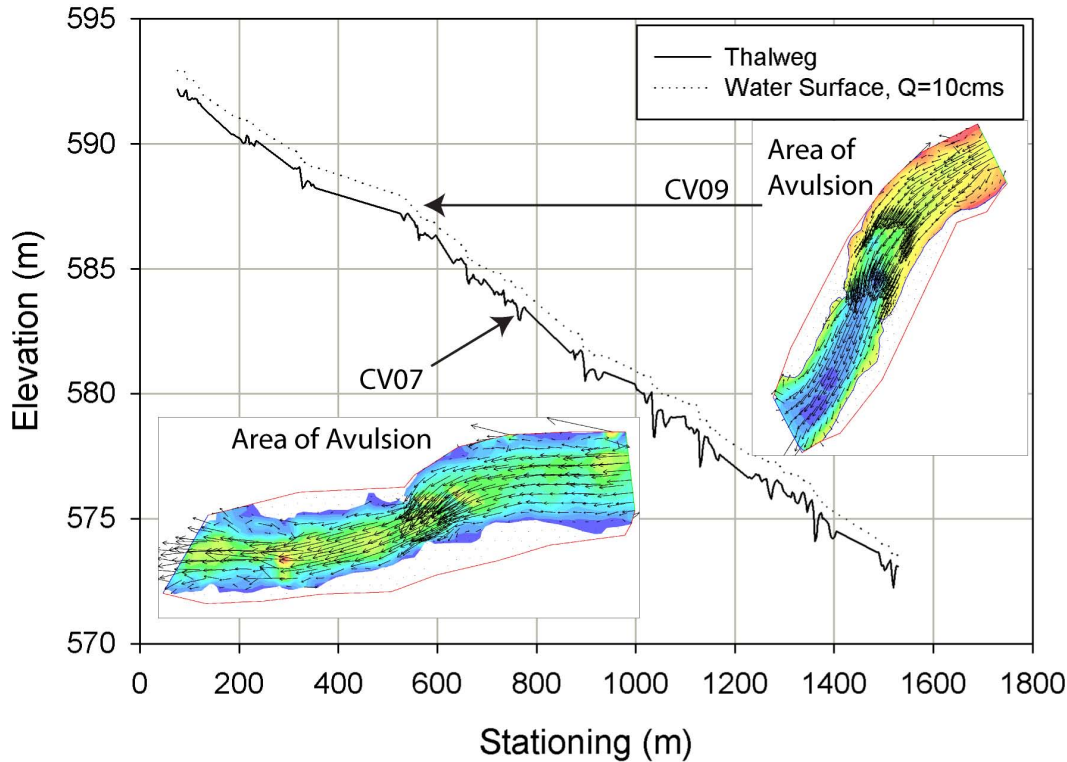
The HEC-RAS simulations of water surface profiles at bankfull flow used the 2004 bed geometry. The simulated water surface profile had rapidly varied flow at all cross vanes, with hydraulic jumps predicted in the pools (Fig. 4). The HEC-RAS results suggested the channel conveyance was adequate to hold the bankfull flow at all cross-sections and aggradation was not causing overbank flow. HEC-RAS also predicted water surface and energy slopes between 10–20% at several of the pools where there was significant scour.

River2D simulations were run to examine the cross-section distribution of velocity forces near the banks. River2D simulations at cross vanes upstream of the avulsions predicted scour forces would concentrate along the banks where the avulsions occurred (see Fig. 4, inset). The vane arms not extending toward the middle of the channel could cause this penetration of upstream flow into the bank. The avulsion accentuated the aggradation in downstream pool by splitting the flow and reducing the downstream power and causing a settling of bedload.

**Fig. 4.** HEC-RAS predicted water surface slopes along the project reach with inset of River2D predicted flow velocity and vectors at cross-vane 7 and 9.
