Louisville-Jefferson County
Metropolitan Sewer District

CSO130

1400 STORY AVE

Project Name: Story Avenue and Spring Street Green Infrastructure

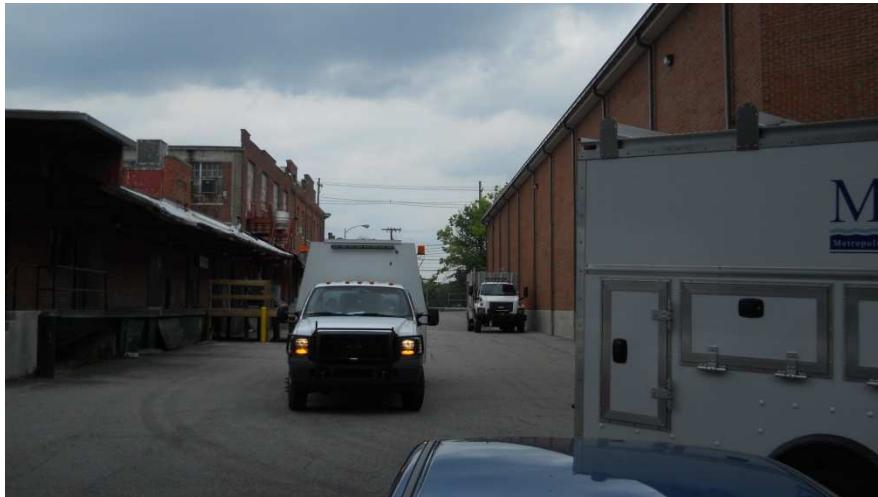
Fig 1: The vehicles are parked in the parking lot between J. Gumbo's and the Medical Center Laundry

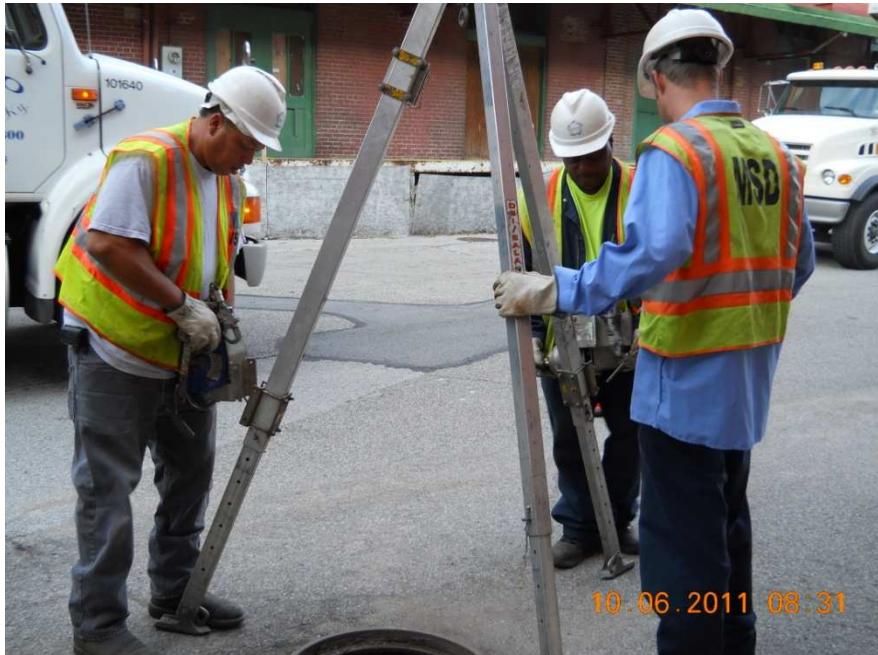
Fig 2: There are a lot of commercial vehicles around the job site.

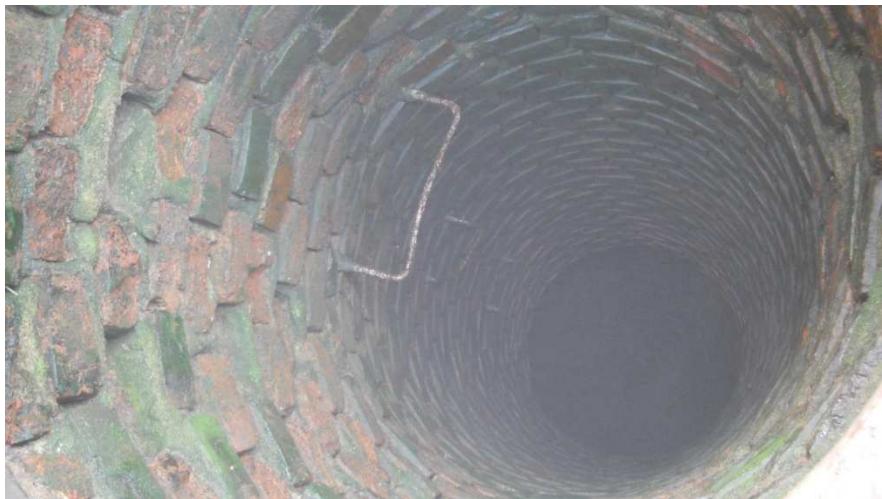
Fig 3: The rungs have been corroded away although some still are present and could be harmful to entrants

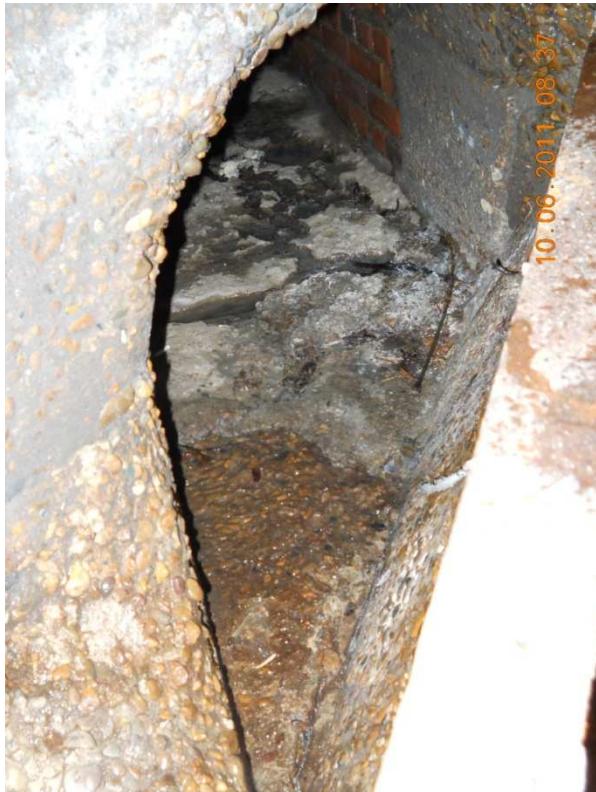
Fig 4: The over flow line is in good condition

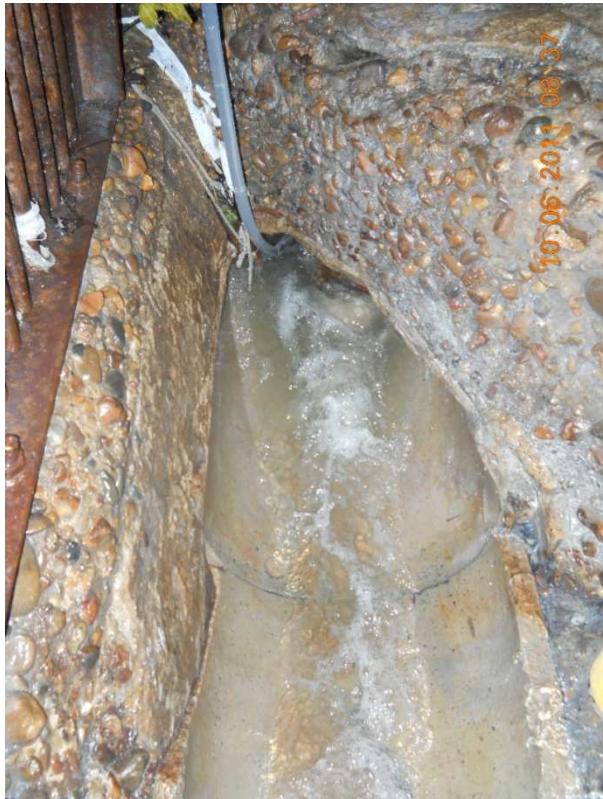
Fig 5: The downstream low flow line is in good condition

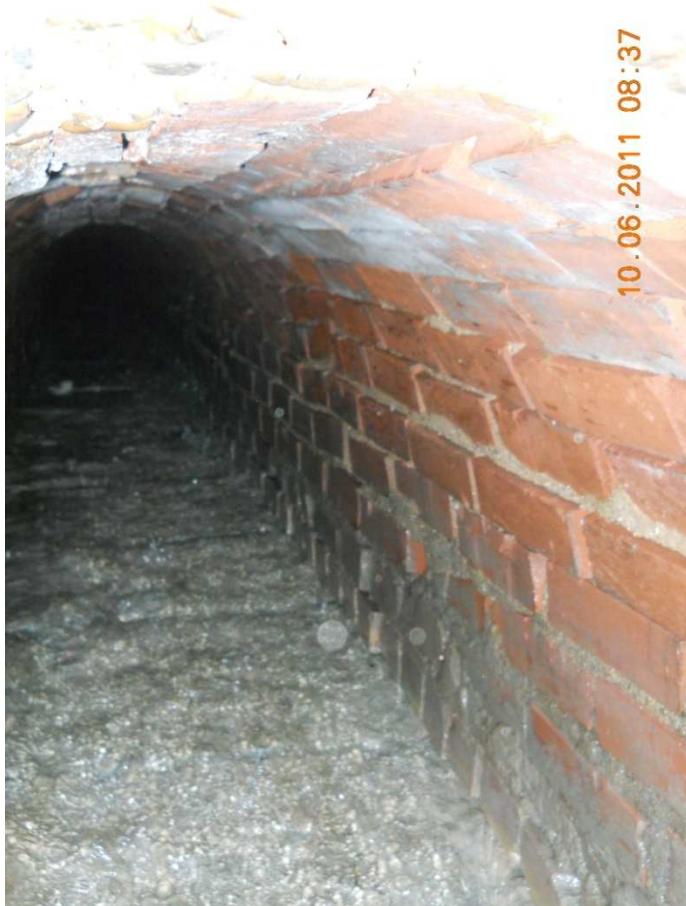
Fig 6: The upstream low flow line is in good condition. Most of the influent waste water is clear

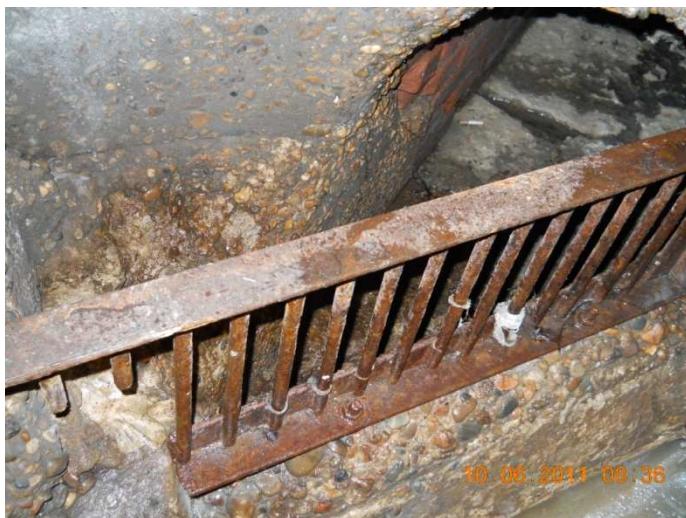
Fig 7: The bar screen is showing signs of rust but no major affects to its structural integrity.

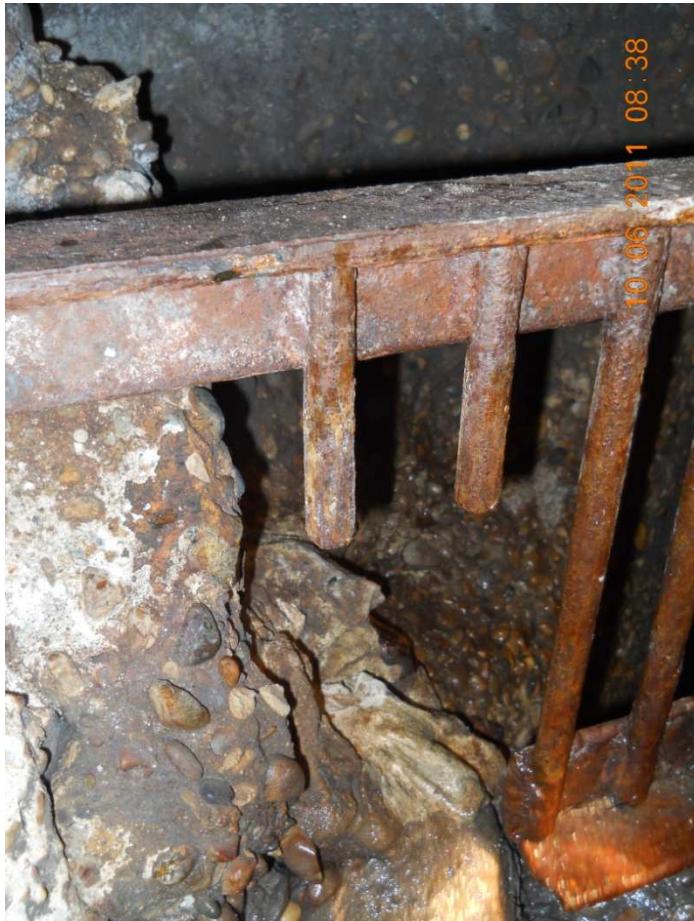
Fig 8: There is a space in the bar screen where debris could go through.

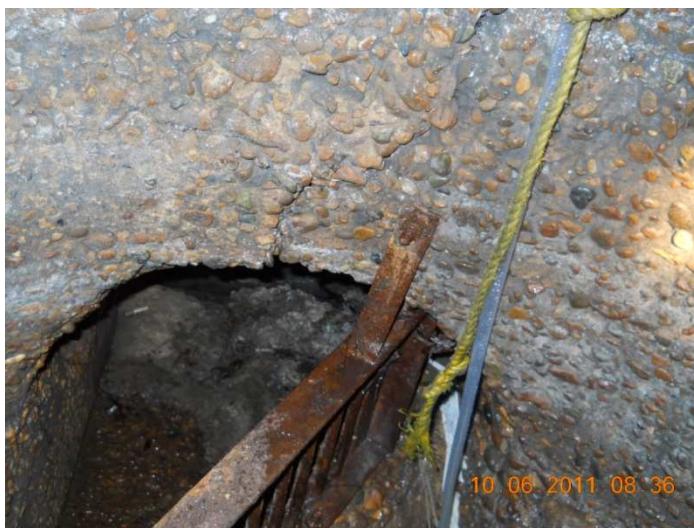
Fig 9: The bar screen is mounted securely over the dam.

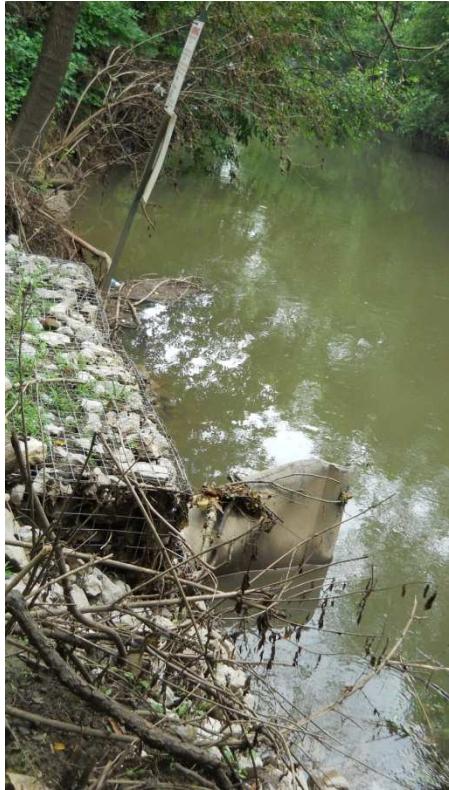
Fig 10: The tide flex valve is shut. There is no S & F near the site
