Supplement of

Identifying hydrological responses of micro-catchments under contrasting land use in the Brazilian Cerrado

R. L. B. Nobrega et al.

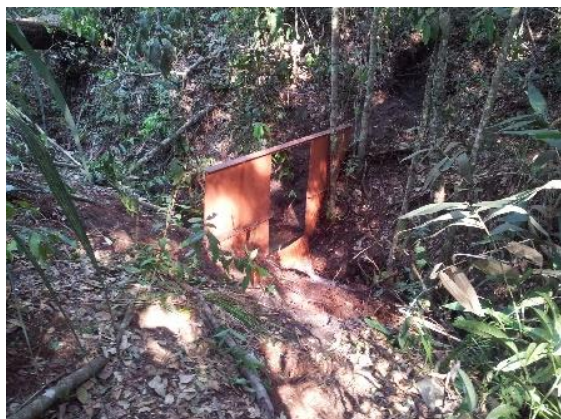
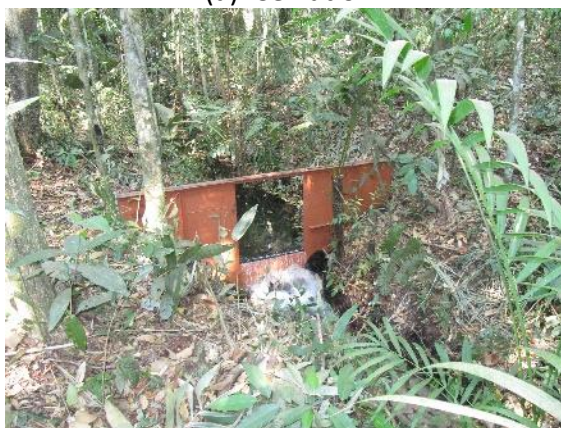
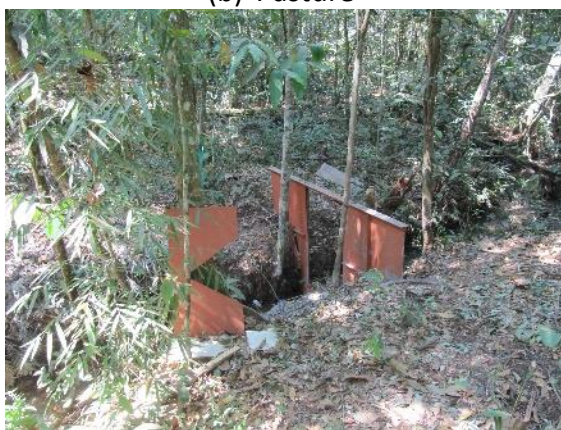
(a) Cerrado

(b) Pasture

(c) Cropland

Supplement Figure S1 Adjustable weirs at the outlet of each catchment (Photos: R. Nobrega).

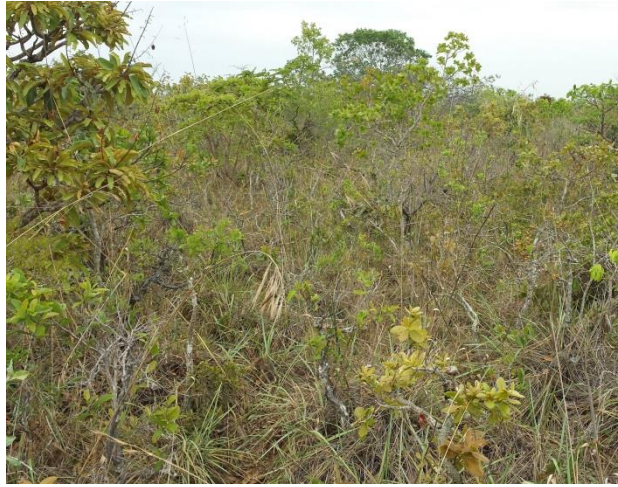
Supplement Figure S2 Cerrado sensu stricto vegetation in the cerrado catchment (Photo: R. Nobrega).

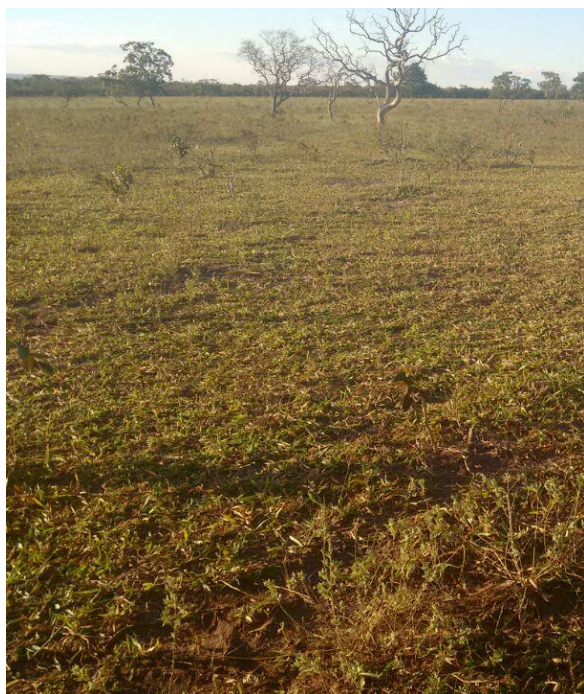
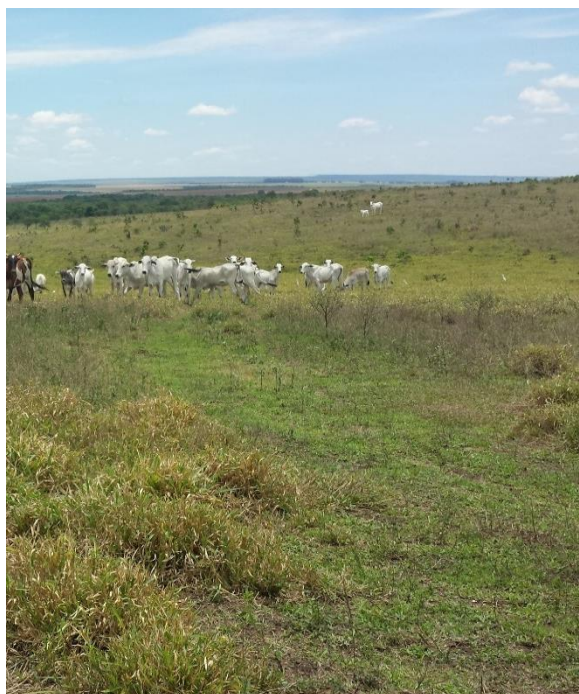
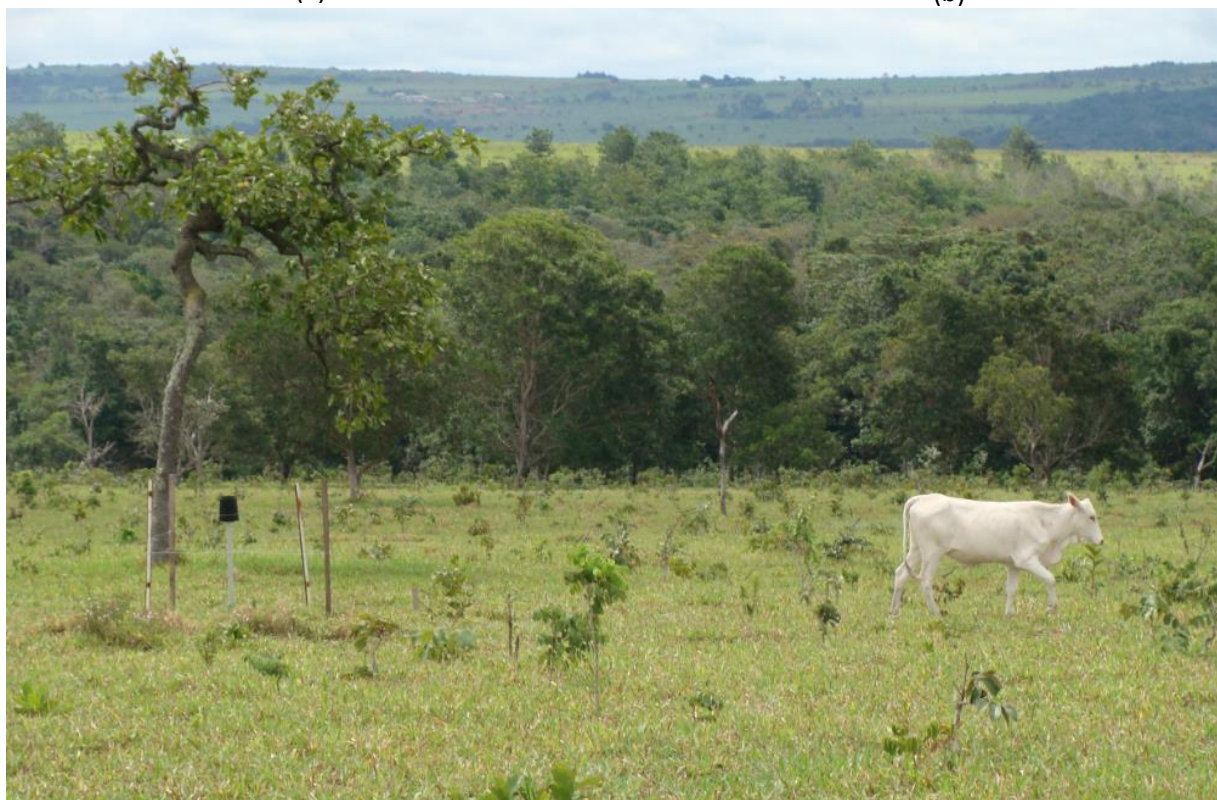
Supplement Figure S3 Pasture catchment during (a) dry and (b/c) wet seasons (Photo: R. Nobrega).

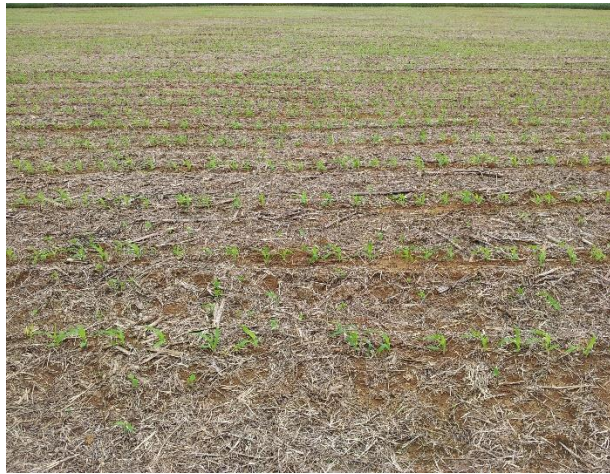
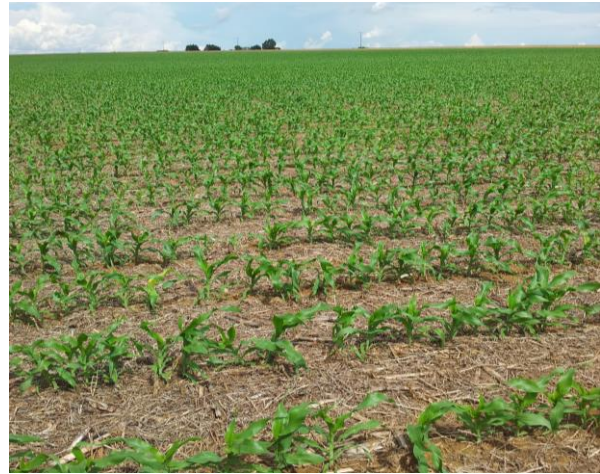
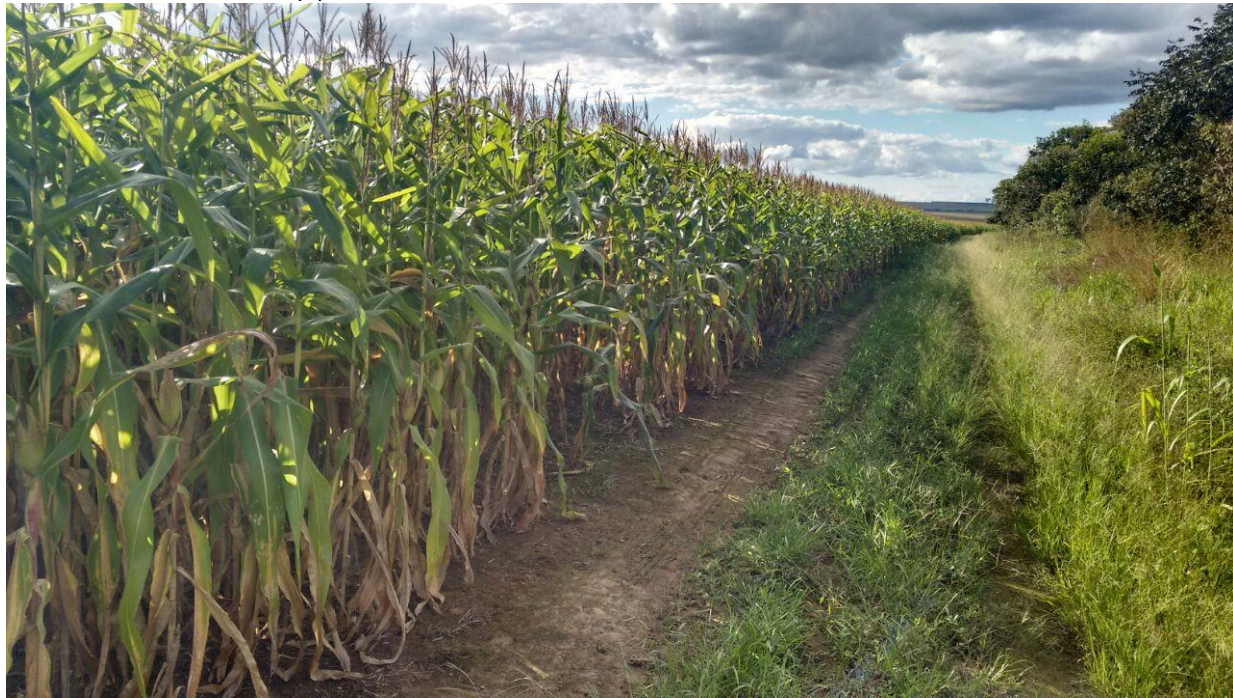
Supplement Figure S4 Maize growth development at (a/b) early stages and (c) a view of the boundary between the cropland and the riparian zone (Photos: R. Nobrega and T. Santos).

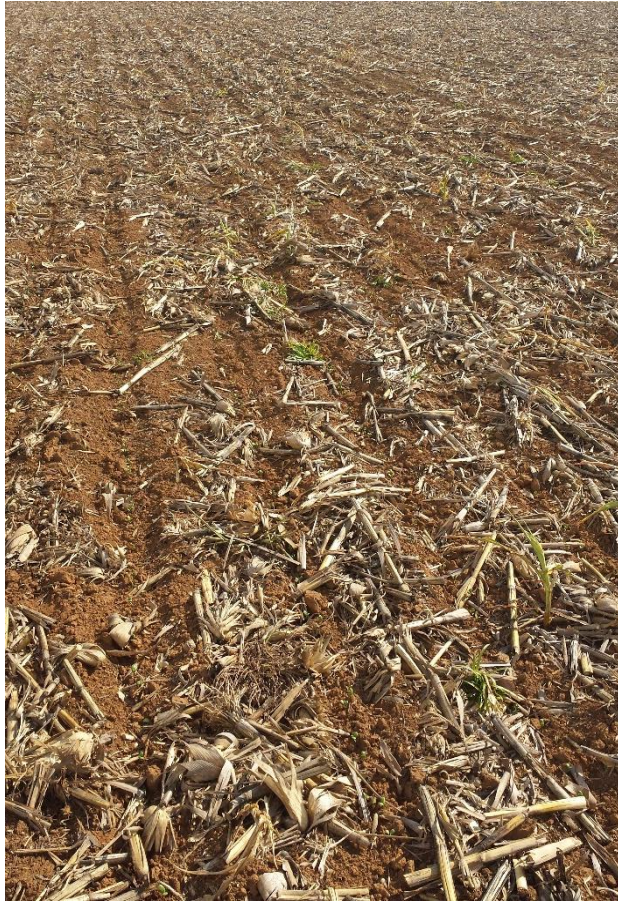
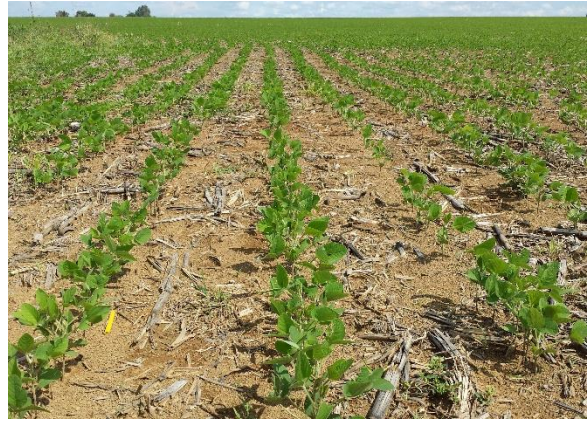
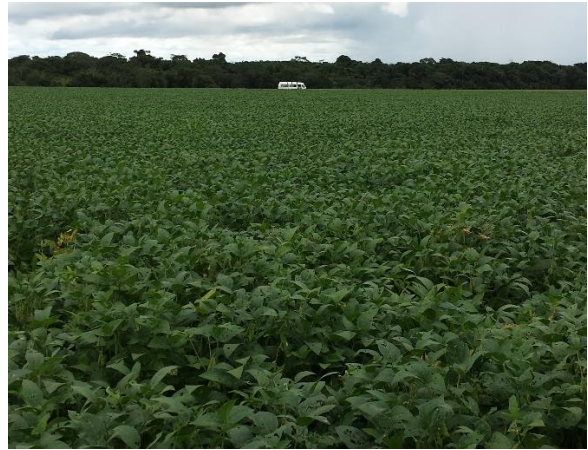
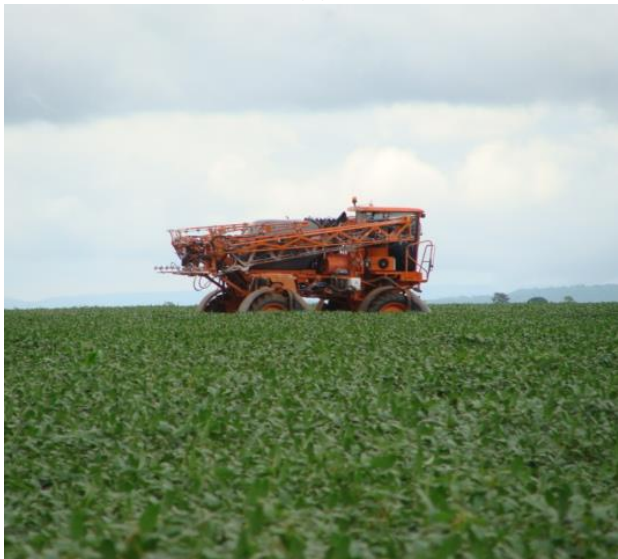
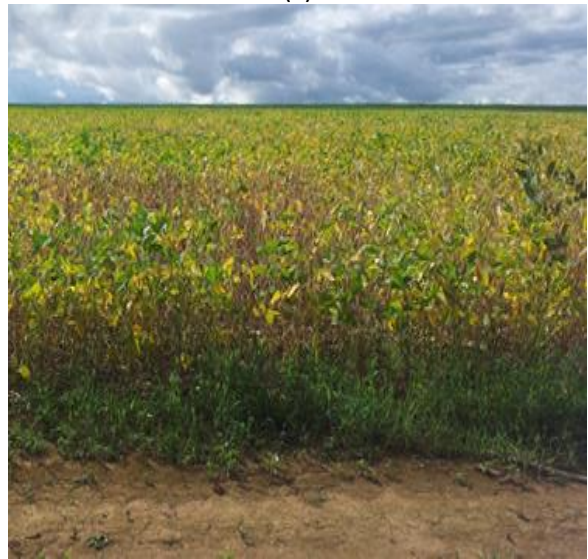
Supplement Figure S5 Soy bean crop development in the cropland catchment (Photos: R. Nobrega).

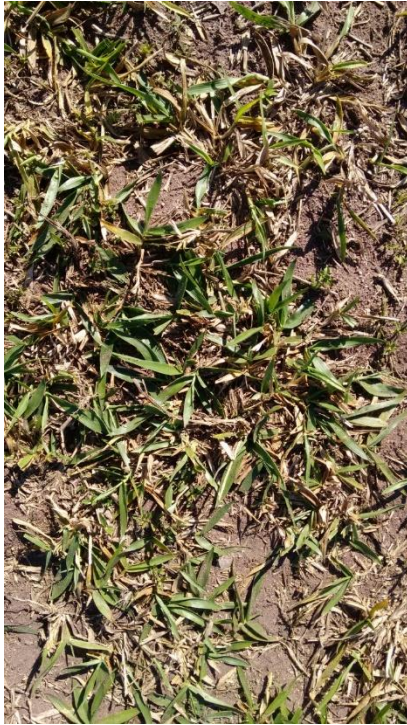
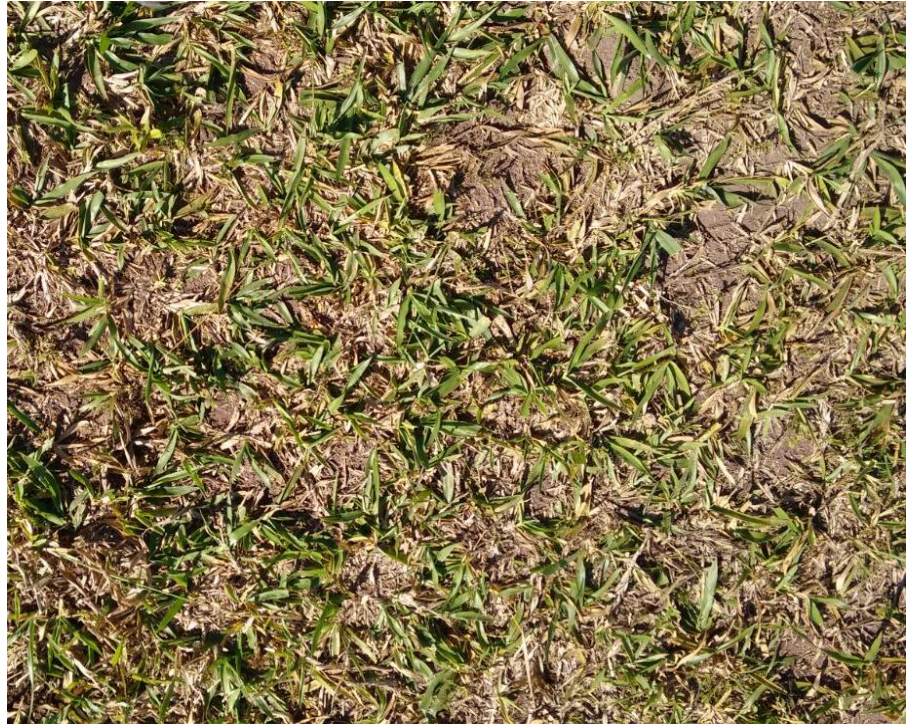
Supplement Figure S6 Grassland degradation aspect in some parts of the Pasture catchment (Photos:T. Santos).

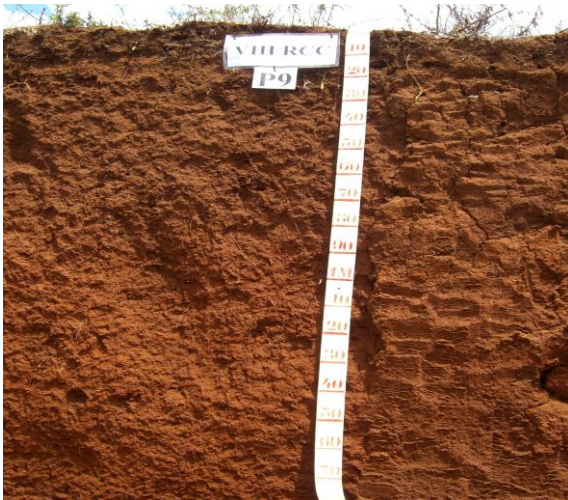
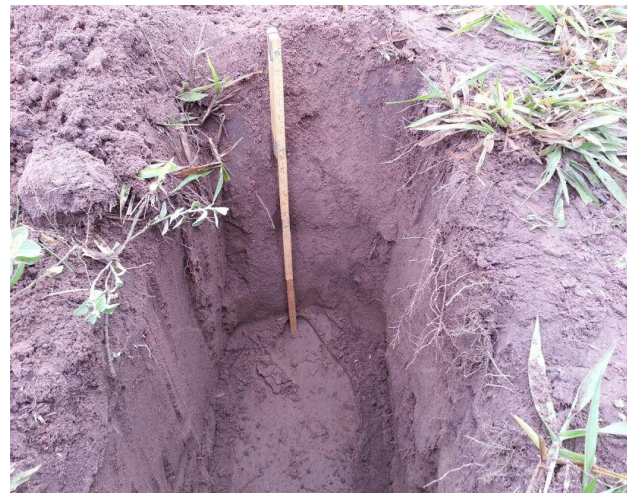
Supplement Figure S7 (a) Similar soil profile to the Ferralsols to the one found in the cropland catchment and (b) profile of the Arenosols in the pasture catchment, also found in the cerrado catchment.
