# Floodplain sediment from a 30-year-recurrence flood in 2005 of the Ping River in northern Thailand

S. H. Wood<sup>1</sup> and A. D. Ziegler<sup>2</sup>

4, 3839–3868, 2007

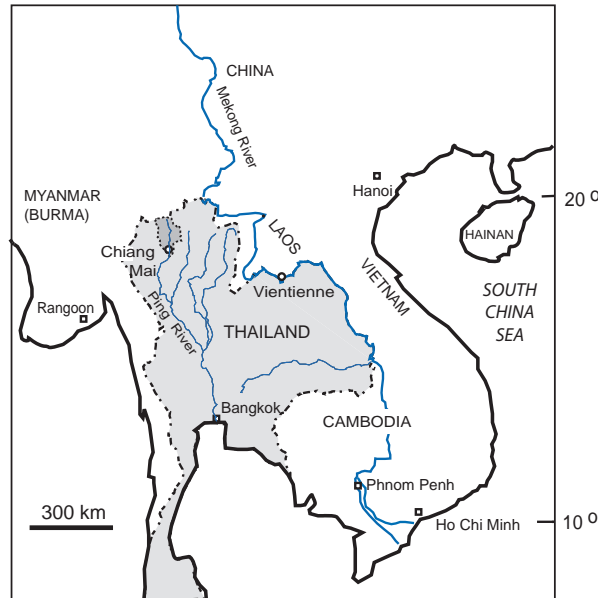
**Fig. 1.** Location of the Ping River. Dark shaded area is drainage area upstream of Chiang Mai and the study area.

Infrequent large floods usually occur in northern Thailand late in the May–October rainy season. Although the May–October rainfall is dominated by storms of moist air moving northeast from the Indian Ocean, large floods are typically associated with tropical depressions moving westward from the South China Sea (Fig. 1). Three flood events

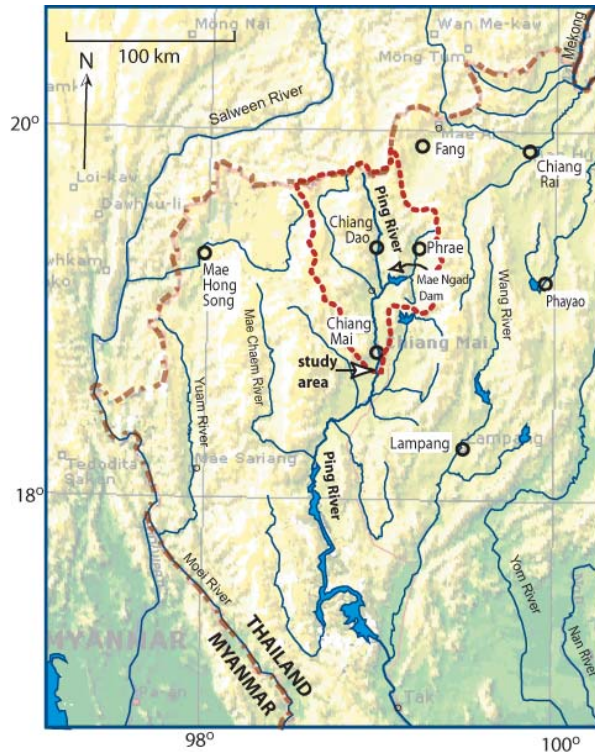
**Fig. 2.** Outline of the Ping River drainage (dotted line) upstream of the study area showing the location of the dam on the Nam Mae Ngad which regulates flow from 1/5 of the drainage. Labeled cities are those provincial capitols which reported major flooding 12 August–4 October 2005.

The Ban Ko village study area (Figs. 2–5) is located 12 km downstream from the P-1 stream gauge at the Nawarat Bridge in Chiang Mai. Mean annual discharge of the Ping River at P-1 is  $26 \text{ m}^3 \text{ s}^{-1}$ . The Ping River above gauge P-1 has a drainage area of  $6355 \text{ km}^2$  (Fig. 2). Of this drainage area, 1/5 is regulated by the Mae Ngad Dam (active volume of 90 million  $\text{m}^3$ , total volume of 302 million  $\text{m}^3$ ), which has controlled drainage from about  $1300 \text{ km}^2$  since 1977. No major tributaries or diversions exist between Ban Ko and P-1; therefore, this gauge is a good measure of flow to the study area

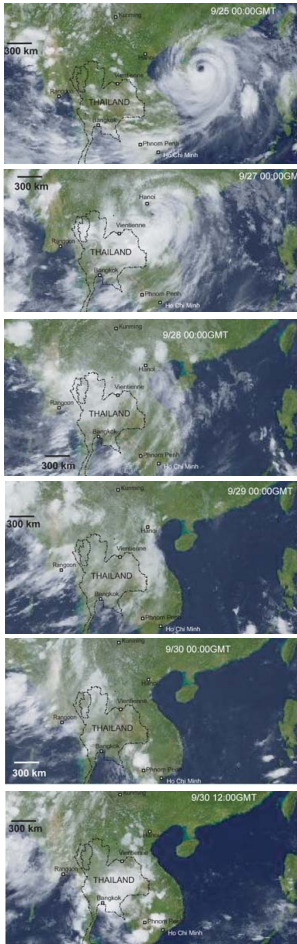
**Fig. 3.** Satellite images showing the westward traveling tropical storm from Typhoon Damrey, 25–30 September 2005. Ping River drainage basin above Chiang Mai P1 gage outlined with dotted line. From archive of EEI-lab, Kochi University, MTSAT IR IR1 JMA. Thailand local time is 7 h later than GMT.

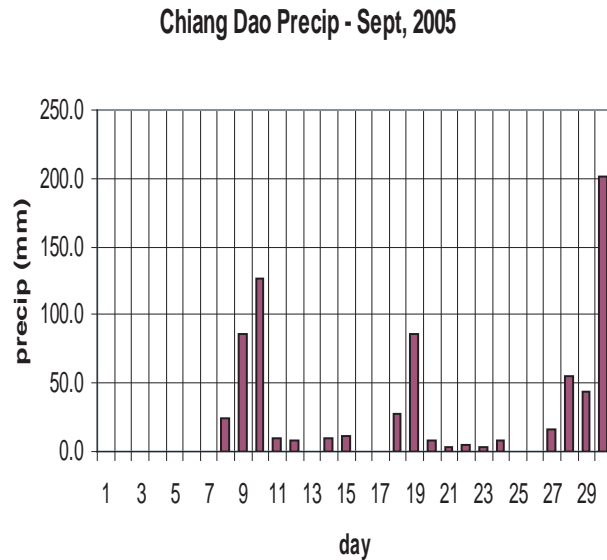
**Fig. 4.** September 2005 daily precipitation at the Ban Pahng Ma Oh Watershed Research Station, Mae Na Subdistrict, Chiang Dao District. No rain occurred for several weeks after the 30 September storm.

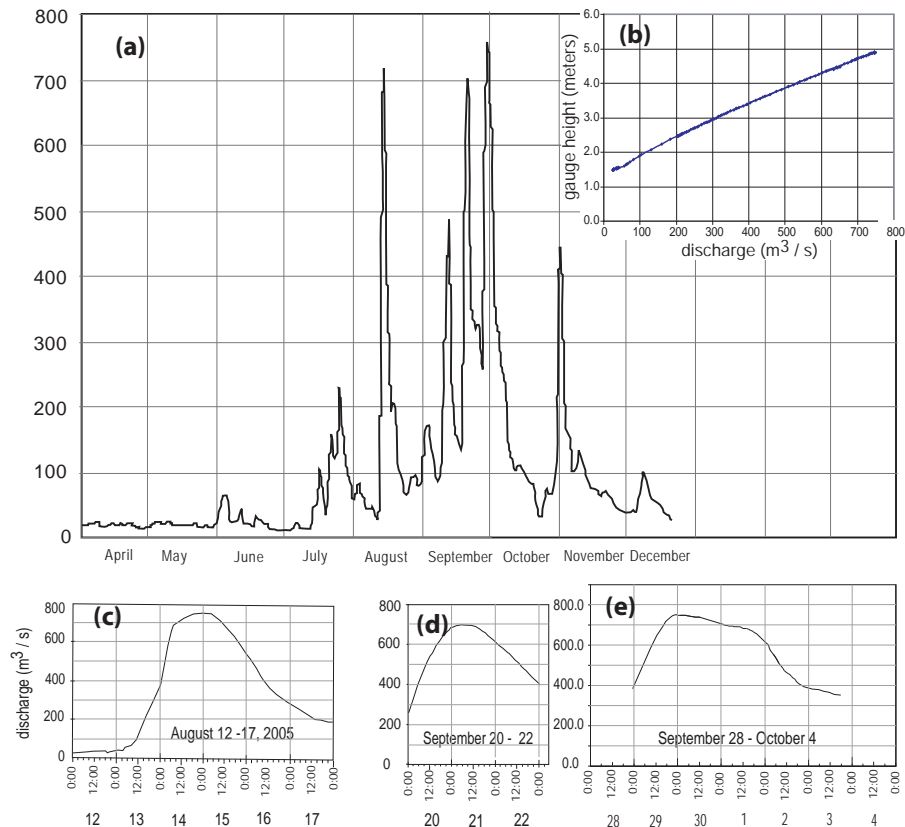
**Fig. 5.** Hydrographs of daily-mean flow readings at the P1 gage at Narawat Bridge in Chiang Mai. **(a)** the mean-daily flow 2005 hydrograph, **(b)** Stage-flow relationship, **(c)** hourly flow – 12–13 August, **(d)** hourly flow – 20–22 September, and **(e)** hourly flow – 29 September–2 October, (Data from Royal Irrigation Department, Hydrology and Water Management Office: internet site: <http://www.hydro-1.net>).

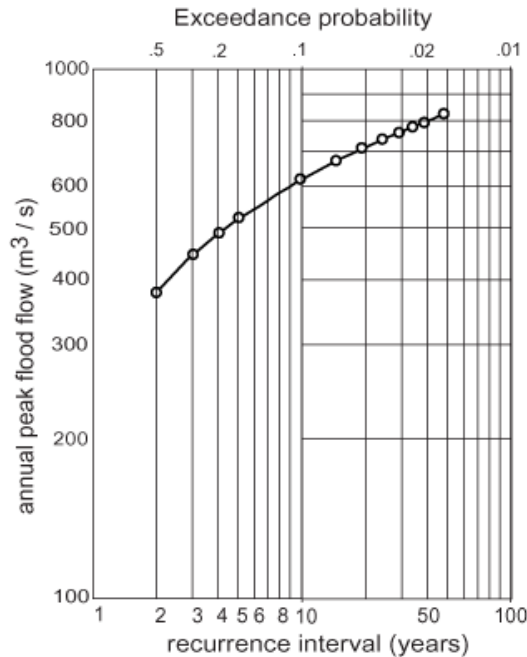
**Fig. 6.** Flood frequency graph constructed from the 1954 to 2005 record, and including the reported record peak flood flow of 830 m<sup>3</sup>/s of 1952. Graph from an unpublished report of the Hydrology and Water Management Center for the Upper Northern Region of the Royal Irrigation Department.

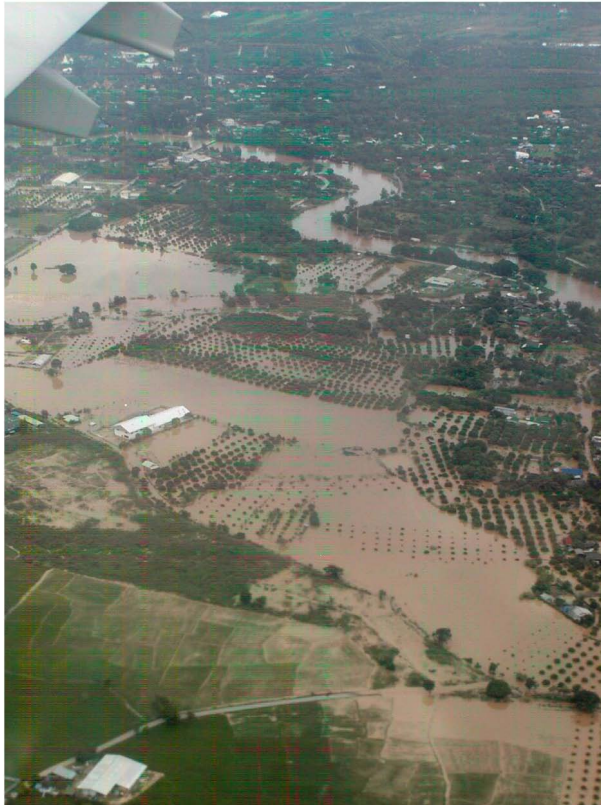
**Fig. 7.** Photo from airplane of the flooded area of the Ping River at peak flood flow 16:00, 29 September 2005. View is to the east toward the bridge at Ban Mae Kha. Tributary channel joins the river on the right (downriver) side of photo. Area of mapped sediment thickness (Fig. 5) extends from the white building (left center of photo) to the river.

We measured the thickness of mud sediment deposited on the floodplain at Ban Ko where the peak flooding was photographed at 16:00 on 29 September from the window

The flooded Ban Ko study area is shown in the 29 September photograph (Fig. 7). Water delivered to this area flowed over the levee on the main channel of the Ping River, as well as up a low-gradient tributary channel – and then most likely set up a weak current over the floodplain area that exited over the levees (Fig. 11). The estimated flooded area shown in the photograph is about  $1 \text{ km}^2$  (Fig. 10). Based on water level stains (Fig. 8a) and the level survey (Fig. 9), the average depth of floodwater in the back-levee area was 1.2 m which is equivalent to a water volume of 1.2 million cubic meters. Because the bed of the tributary channel grades to the low-water main-channel bed, the tributary channel at flood stage could accommodate flow through a cross section 5 m deep and 12 m wide. This particular tributary channel did not have a flood gate, as many channel/canals in the area do. Floodwater overtopping roads did not damage the levees; and no substantial breaches occurred, despite floodwater reaching 0.5 m at some places.

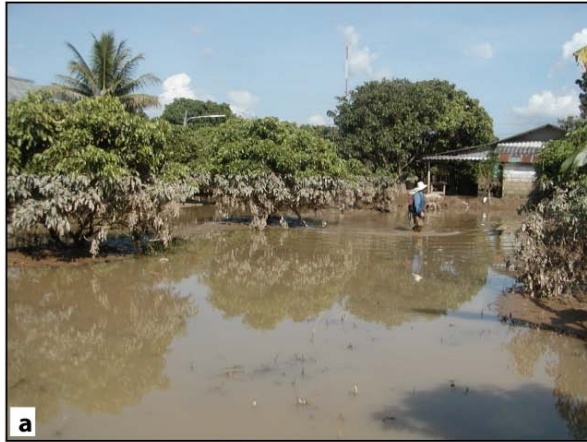
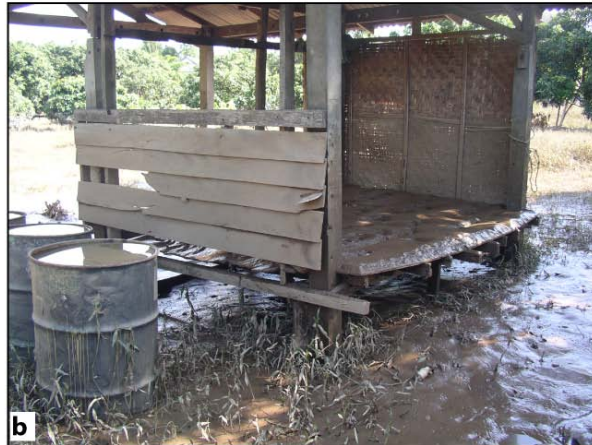
**Fig. 8. (a)** high water line on fruit trees. Floodwater depth was 1.3 m. Location is at point B of Fig. 11. View is to the southeast. **(b)** hut located at point H2 on Fig. 11. Five cm of sediment deposited on platform elevated 0.55 m above ground (see Fig. 12). Photos taken on 2 October.

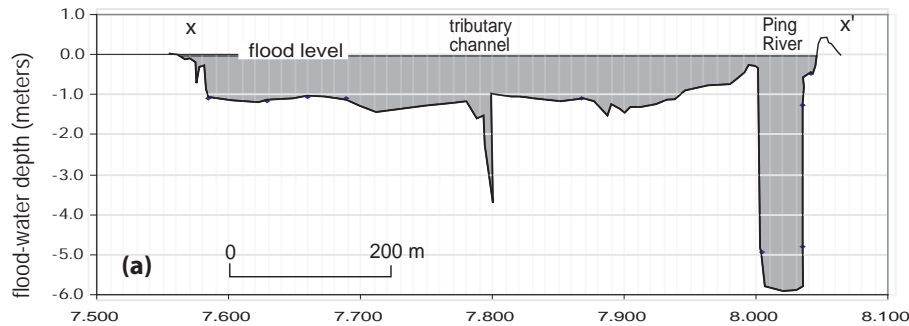
**Fig. 9. (a)** Map of surveyed ground elevations below maximum flood level. **(b)** elevation profile along line x-x' showing maximum flood level in area of sediment thickness survey.

Sediment-thickness measurements were made on 2 October, and also on 7 October to cover those areas that were underwater on 2 October. Our method was to slog through the wet mud-mantled fruit orchards and rice fields and measure soft mud thickness with a millimeter ruler at more than 200 locations over a 0.27-km<sup>2</sup> area (Fig. 8a). Locations were determined with hand-held GPS units to a ±7 m precision. Where thickness was questionable, the light-brown mud was scraped away to the darker, firmer, gray mud of the August depositional surface. Sediment thickness was also measured on floors of four elevated bamboo shade huts, where farmers rest in the heat of the day (Fig. 8b). Sediment from the upper part of the water column had settled on these elevated platforms; and therefore, provided information to compare with the sediment thickness on the surrounding ground that received sedimentation from the full water column. In March 2006 an elevation profile was surveyed using a laser level in order to better understand the pattern of flooding (Fig. 9).

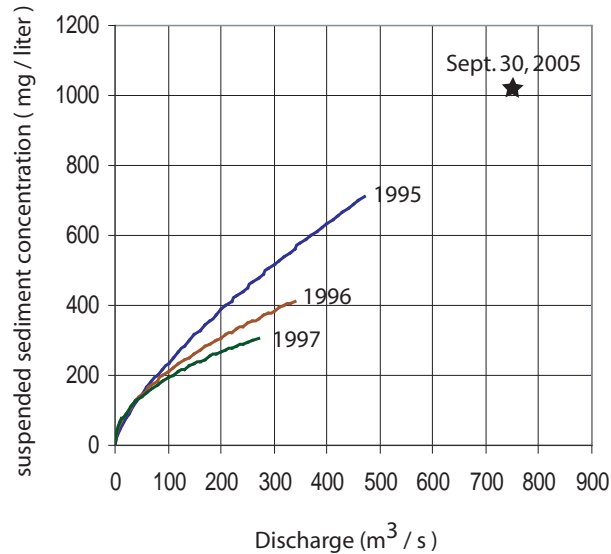
**Fig. 10.** Suspended sediment concentration (single surface grab sample) measured during flood flow of 750 m<sup>3</sup>/s on 30 September 2005 at Narawat Bridge, compared to suspended-sediment rating curves for the Ping River P1 based on sampling by the Royal Irrigation Department in 1994, 1995, 1996, and 1997. In those years peak flows reached 525, 467, 342, and 270 m<sup>3</sup>/s, respectively.

Total suspended sediment concentration of 1020 mg L<sup>-1</sup> was determined from one grab sample of the turbulent, muddy, brown floodwaters at Chiang Mai. Sample was taken from 0.2-m deep at the west abutment of Nawarat Bridge near the P-1 gaging station at 16:00 on 30 September. River was in full flood at 740 m<sup>3</sup> s<sup>-1</sup> (4.9 m stage). This value is much higher than any values shown on sediment rating curves (1994–1997) (Fig. 10). Because our 1020 mg L<sup>-1</sup> concentration was taken just after peak flow, it might be low compared with the concentrations on the rising limb of the flood hydrograph. We have only this limited sediment concentration data for the Ping River; however, in monitoring a 75-km<sup>2</sup> tributary watershed, values sometimes exceed 8000 mg L<sup>-1</sup> during large runoff events (Ziegler, unpublished data). Thus, there is potential for relatively high

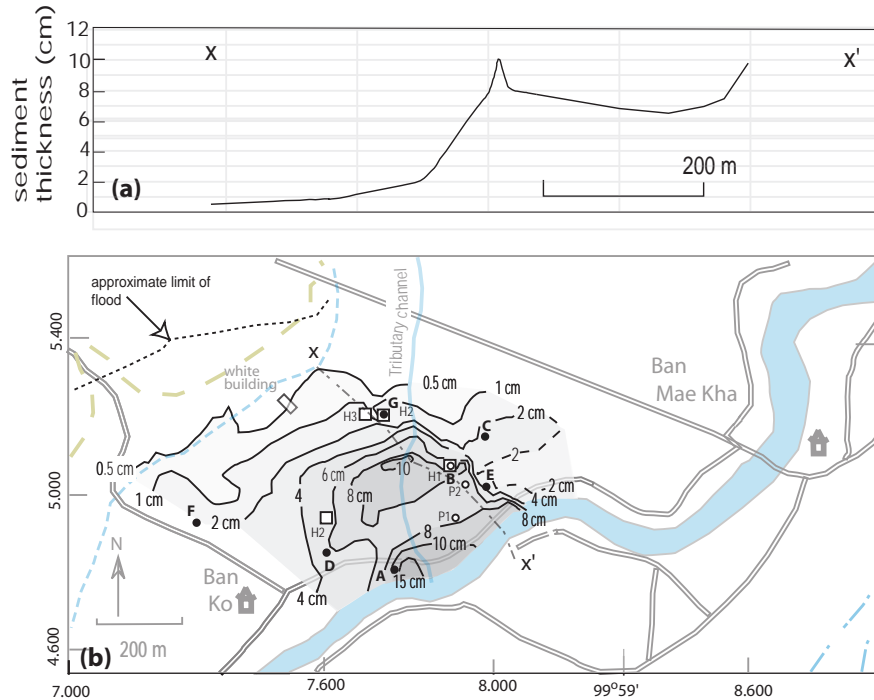
**Fig. 11.** (a) Profile of wet sediment thickness along line x-x'. (b) Isopach map of wet-sediment thickness deposited on floodplain and levee during the 29 September–2 October flood. Points A–G are locations of samples for which grain size analysis are shown in Fig. 14. Points H1–H4 are locations where thicknesses were measured on elevated platforms as well as on the surrounding ground (data shown in Fig. 9). Line x-x' is the line of profiled thickness in Fig. 11a and profiled elevation in Fig. 9b. Photos of sediment are shown in Fig. 13 at locations A, B, P1, and P2.

Greatest thickness in the Ban Ko study area was 15 cm of silty-fine-sand sediment along the levee on the north side of the Ping River (Site A, Fig. 11). A pocket of thick sediment was located near the tributary channel. Sediment thicker than 8 cm covered 16% of the study area, and extended no more than 250 m from the main channel. Sediment thicker than 4 cm covered 44% of the area and extended no more than 350 m from the main channel. At a distance of 450 m from main channel, sediment thickness diminished to 0.5 cm (Fig. 11). Thickness averaged over the 0.27-km<sup>2</sup> area is 3.3 cm; this equates to a wet sediment volume of roughly 9000 m<sup>3</sup>. Converting the volume of wet sediment ( $\rho_{\text{wet}}=1.6 \text{ g cm}^{-3}$ , water content = 0.60) to dry weight indicates that about 9000 Mg of material was deposited over the 0.27-km<sup>2</sup> area. The average dry sediment deposit is 33 kg m<sup>-2</sup>; however, 72% of this material is bounded by the 2-cm isopach contour, within 200–400 m of the river channel.

5 eas of the floodplain. Our data generally show the exponential decline in sediment thickness away from the main channel (Fig. 11a) that is reported in other studies of flood sediment, and long-term vertical accretion (Bridge, 2003). The overall scale of floodplain sedimentation is less than, but similar to, that of the April–June, 1973 flood on the Mississippi in Louisiana (USA). For that flood, Kesel et al. (1974) found that sediment thickness and texture decreases away from the river: e.g., 400 m from the river, sediment thickness was about 2 cm; however sediment depths of 0.5 to 1.0 cm extended 10 km away from the channel. Peak discharge of the 1973 Mississippi flood was  $42\,500\text{ m}^3\text{ s}^{-1}$ , and large areas were inundated with 4 m of water for 2 months. 10 Suspended sediment concentrations were not reported.

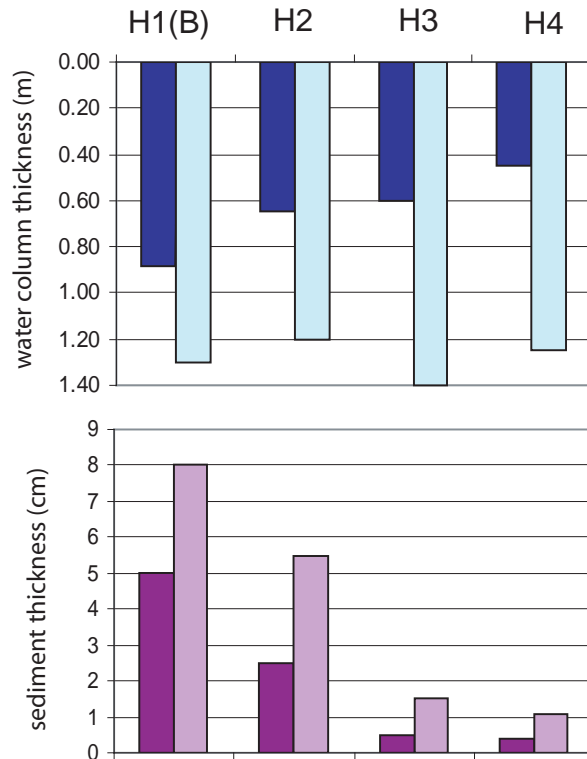
**Fig. 12.** Upper graph shows thickness of the column of water over elevated platforms (dark pattern) compared to the total depth of water at the site (pale pattern). Sediment thickness deposited on elevated platforms (dark pattern) compared to thickness on the surrounding ground (pale pattern). Locations of H1(B), H2, H3, H4 shown in Fig. 11.

Sediment thicknesses were measured on elevated platforms of 4 huts (Fig. 12). These data indicate that the amount of sediment intercepted by the platform, and that which settled to the bottom was roughly proportional to the thickness of the overlying water column. For example, at hut H2 (Fig. 8b) the flood depth was 1.2 m over the ground and 0.55 m over the hut floor (Fig. 12). From these observations we conclude that the suspended sediment concentrations were relatively uniform in the water column from which sediment settled. In other words, the water delivered to the point of sedimentation was well mixed from top to bottom.

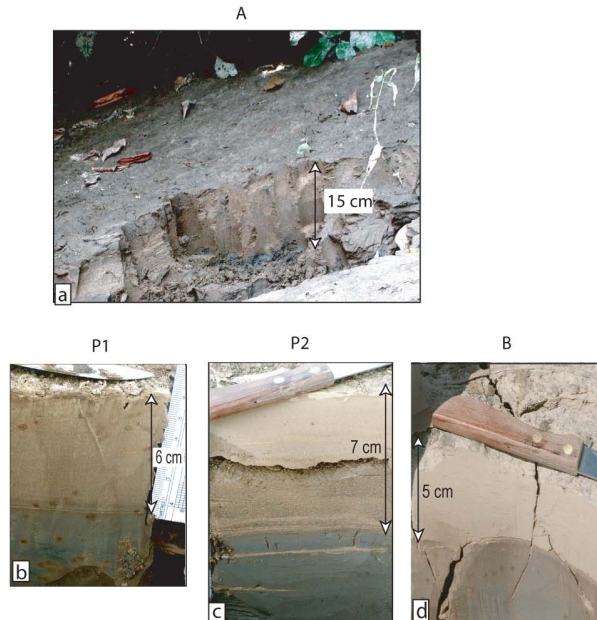
**Fig. 13.** Photographs of 29 September–2 October sediment at locations P1, P2, B, and A shown in Fig. 5. **(a)** Brown, massive, clayey coarse silt overlying grey clay of the August flood at point, P1, 100 m from river channel. The 6-cm-thick layer shows slight upward fining, and has developed several rust-stained insect burrows when photographed 2 months after deposition. 4 November photo. **(b)** Sediment shows a basal 3.5-cm layer of brown clayey coarse silt overlain by 3.5 cm of pale brown clayey silt that has dried and parted from the layer below. The underlying gray August sediment has light-brown silty streaks. 4 November photo at point P2, 160 m from river channel. **(c)** Massive 5-cm layer of brown clayey silt at site B, 200 m from the river channel. Grain-size analysis shown in Fig. 10. 4 November photo. **(d)** River-channel-facing levee deposit on a 20-degree slope at site A. Deposit is 15 cm of brown silty fine sand (grain-size analysis shown in Fig. 10). 7 October photo.

Fine sand occurred only on the levee area, within 50 m of the main channel of the Ping River (Fig. 13a). Within 150 m of the main channel is a 3-to-6-cm layer of coarse silt (0.03–0.06 mm) showing indistinct upward fining (Fig. 13b). This coarse silt was overlain by a distinct layer of massive clayey silt in some locations (Fig. 13c). We believe this two-layer stratigraphy occurred in low areas that were fed floodwater at a lesser velocity than the initial surge that bore the coarse silt. At more distant sites the sediment was entirely massive clayey silt (Fig. 13c).

When photographed on 4 November, beneath the light-brown sediment of the September flood was gray clayey silt (Figs. 13b, c, d), which at sites P2 and B is 9-cm thick over a thin leaf layer that was assumed to be the pre-August flood surface. This sediment changed to a gray color within only 2.5 months. The August sediment was submerged by water for at least 1.5 months, whereas the water from the September flood drained within 2–3 weeks. The gray layer shown in Fig. 13c contained mm-scale light-brown streaks of coarser silt. Bioturbation of the flood sediment had already begun at some sites, as was indicated by rust-colored outlines of insect burrows, abundant in the gray sediment layer shown in Fig. 13b. In areas where sediment was less than 1.5 cm thick, the September sediment could not be discerned as a separate layer.

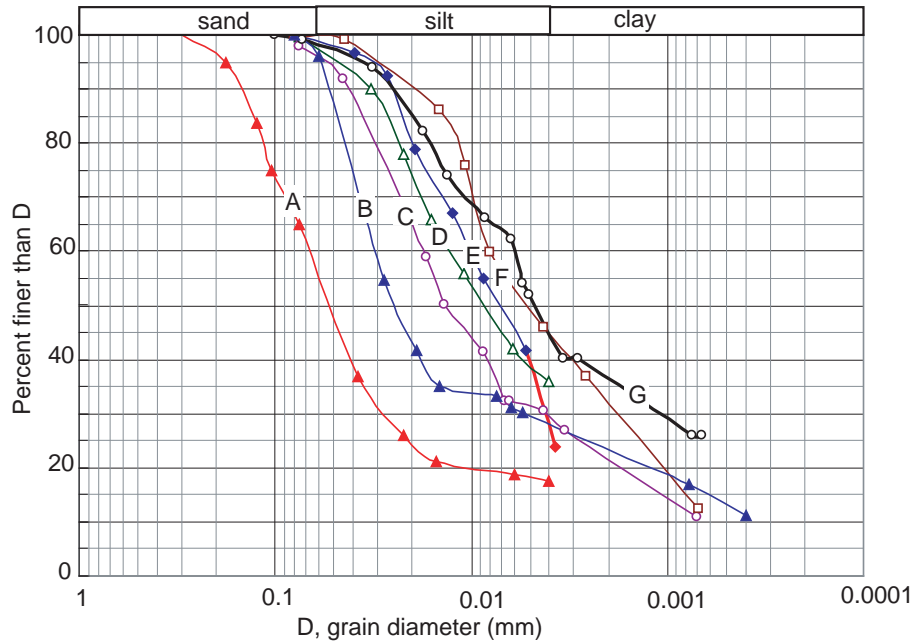
**Fig. 14.** Sediment grain size analysis for sample locations shown by points A, B, C, D, G, and F in Fig. 11. Analysis by standard hydrometer and wet-sieving methods.

Wet density of the mud and grain-sizes were determined for seven samples in the study area (Fig. 14). Density of most wet mud samples varied from 1.6 to 1.7 g cm<sup>-3</sup>; and the water content (water mass/mass of dry solids) ranged from 0.67 to 0.83. Grain size analyses indicate these sediments to be a silt with 20 to 45 per cent clay (Fig. 14). One sediment sample located at point A (Fig. 11) had a density and moisture content of 1.86 g cm<sup>-3</sup> and 0.3, respectively. This was a silty fine sand with 45 per cent fine sand and 17 per cent clay that was deposited on the levee about 15 m from the channel. Collectively the analyses show that grain size diminishes with distance from the
