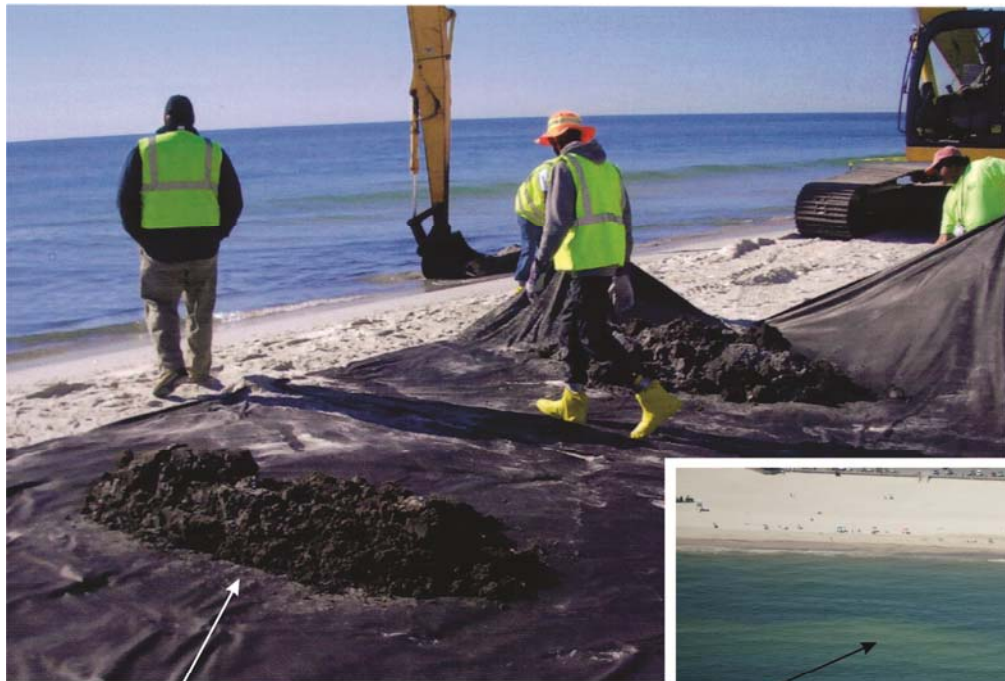
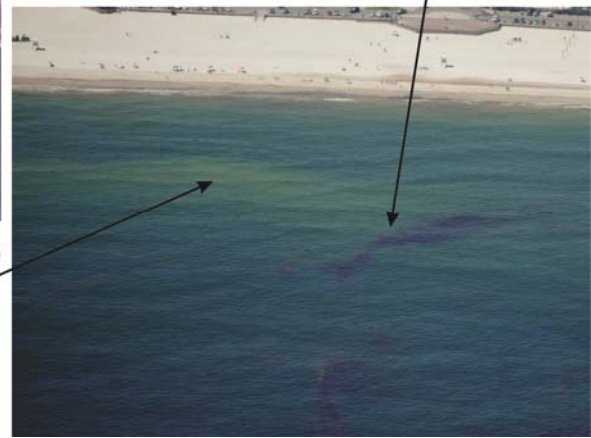
Floating oil mat nearing beach

Submerged mat materials following removal from nearshore trough

Longshore sandbar

Figure 7. Floating oil mat approaching Alabama beach and submerged mat materials recovered from trough between longshore sandbar and shoreline.
