(1) comments from the Editor

(2) author's response

Exposure of tourism development to salt karst hazards along the Jordanian Dead Sea shore

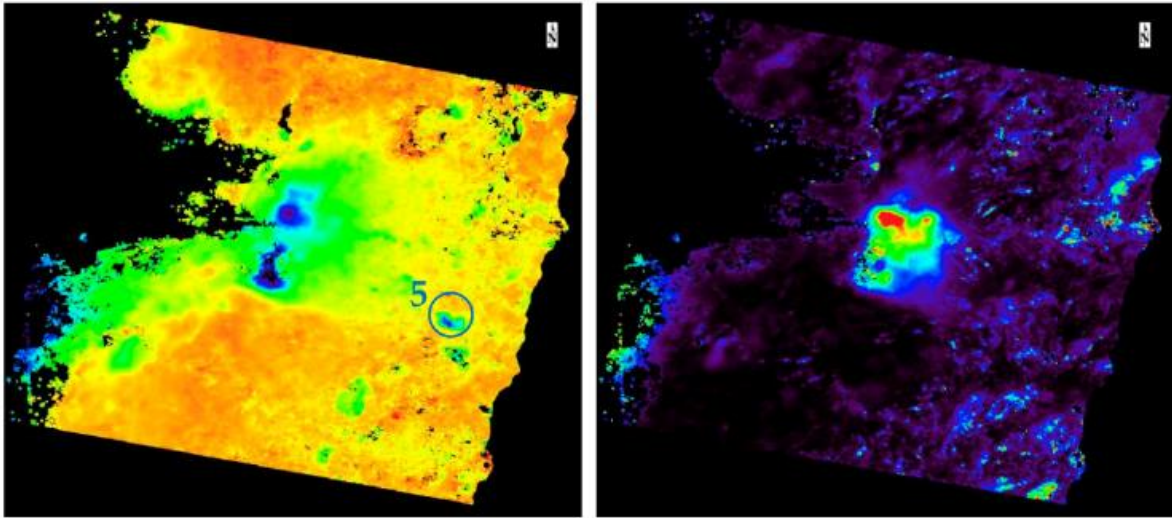
Figure 18. ENVISAT ASAR SBAS results over the Madaba region (Jordan). Average displacement rate from linear model (on the left) and corresponding χ^2 (on the right).

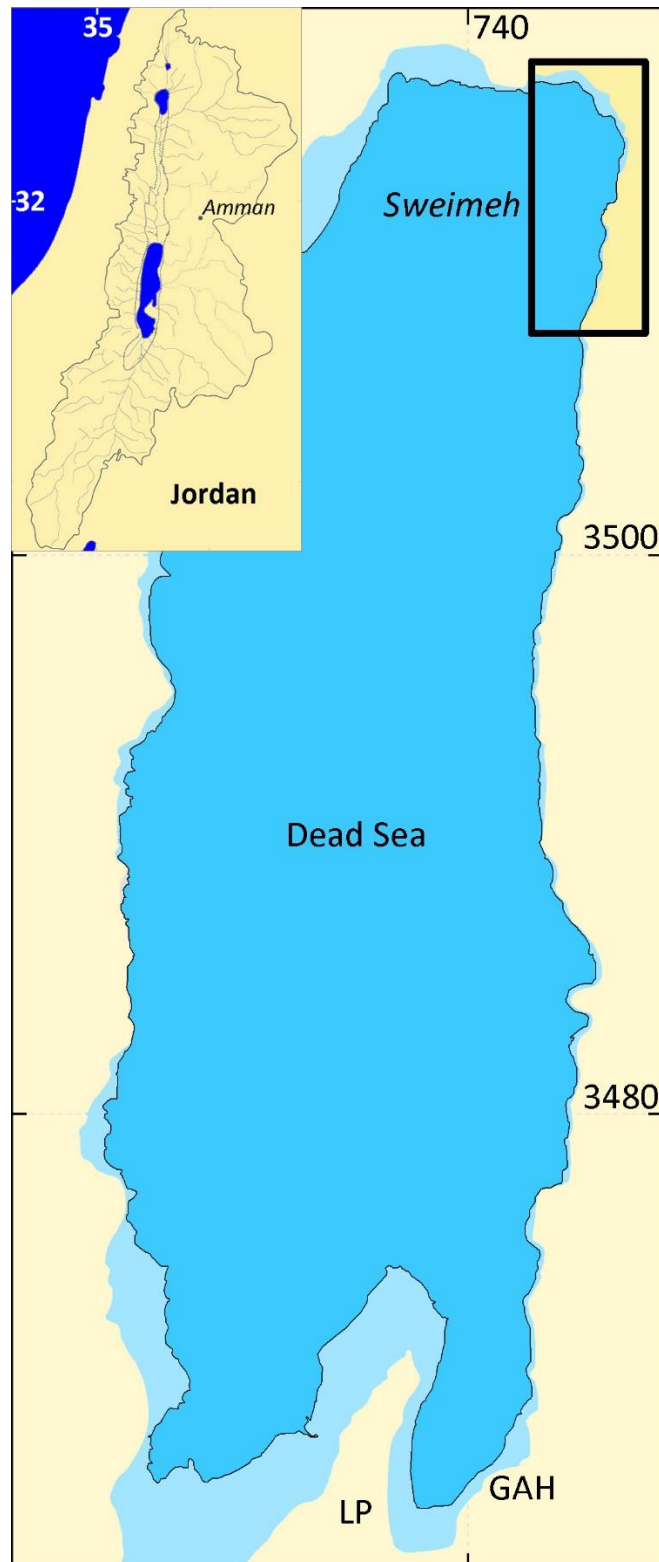
Figure 1. Inset: the Dead Sea (DS) watershed (coordinates in degrees). Main map: location and extent of the Dead Sea. The study area (Sweimeh) is located in the north-eastern part and marked with the east (black box). The extension extent of the lake in the 1960s appears in light blue colour. The black line indicates the present day shoreline (in 2018). In the figure south are also showed the located two main sinkhole sites: the Lisan Peninsula (LP) and Ghor Al Haditha (GAH) (coordinates in UTM 36 (km), WGS 84).

Studies concerning the DS sinkholes started in mid-1990s, concomitantly to with an always increasing occurrences of decametre-size collapses. The southern part of the lake was first affected (Fig. 1: Lisan Peninsula (LP), Ghor Al-Haditha (GAH)). In the 2000s, the western coast was progressively covered by dozens of sinkhole clusters (Abelson et al., 2006; 2017; Ezersky et al., 2017). At the opposite, the eastern side was not affected because it is essentially made comprised of rocky cliffs plunging directly into the DS. Noticeably, the northern part of the terminal lake was less exposed during most of that period (Abou Karaki and Closson, 2012). It is only during the last 10 years that the number of hazardous events has increased. The pace remains low, but the type of incidents is different has changed. The Landslides, with or without the occurrence of sinkholes, are now predominant. ¶

2. along the western coast, ~~one~~a salt layer (~11000 yr in age) ~~had~~has been identified as the main source of the underground cavities leading to ground collapses (e.g. ~~Yiechieli~~Yechieli et al., 1993; Abelson et al., 2003; Ezersky et al., 2017). Below the LP wave-cut platform, (Fig. 1), a thick salt layer ~~had~~has been identified by ~~the~~Arab Potash Company (APC) security engineers dealing with grouting operations for ~~earthen dikes'~~the stability of earthen dikes (Mansour, oral communication 2015, 2017). In the eastern part of the DS, the existence of this salt layer is still in debate, essentially due to the lack of boreholes with unquestionable dated rock samples. An alternative model developed by Al-Halbouni et al. (2017) suggests a mechanism based on numerous salt lens/layers dispersed into the alluvial fan sediments;

The Sweimeh area corresponds to a stretch of coast, about 2 km wide and 10 km long, situated along the north-eastern part of the DS (Figs. 1 and 2). The landscape is shaped by Pleistocene to Holocene sediments overlying a thick Mesozoic sequence of Triassic and Cretaceous rocks. The Triassic is represented by the Zarqa Ma'in Group (dolomitic limestone and marls, massive limestones, sandstones and shales). The Cretaceous sequence composed of sandstones, limestones and dolomitic limestones, overlies the Triassic Zarqa Ma'in group.

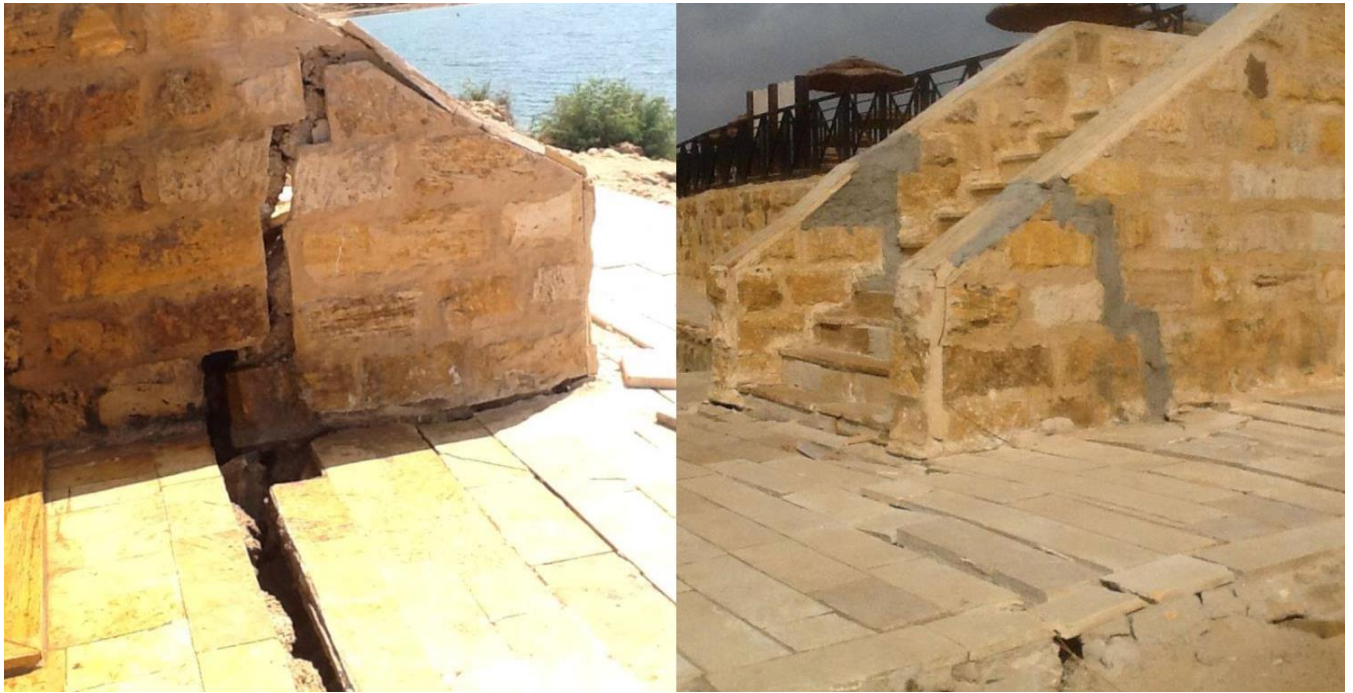
Figure 8. Examples of damage (left) and of quick repair (right) that are common in the [front beachesbeachfront](#) of the hotels along the DS coastline.

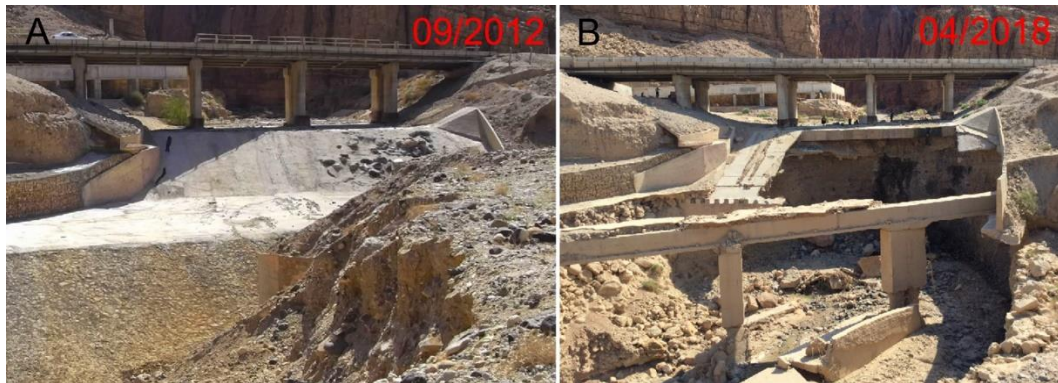
Figure 10. Example of a bridge along the Dead Sea motorway damaged by progressive erosion of the sediments. All bridges along the [DS Dead Sea](#) coast are affected by the rapid incision of the river bed. Each year, the available energy released during erosion process is more important (square function).

During the last decade, regular, almost biannually field inspections were carried out approximately biannually to follow and monitor the deteriorations of the DS shore in Sweimeh. All areas show surface deformations reflecting the ongoing subsurface dissolution processes. Cracks are occur very frequent/frequently on land, on walls, in swimming pools and in other man-made structures (Fig. 8). In general, no efforts were No effort was generally made by investors to investigate the causes of the damage or define a reasonable strategy to deal with the quite visible deteriorations. Instead, these were being "repaired" hastily, inefficiently, and mostly superficially on a nearly daily basis for inefficient makeup purposes. Land cracks are still being systematically filled with sand, while cracks affecting structures are being filled with concrete. Most of these cracks could are likely to be associated to with the subsidence occurring in the area, as measured by SBAS. Some of the monitored infrastructures are affected on two fronts (e.g. Fig. 9): a river incision that causes lateral slopes/slope displacement, and the emergence of springs in the beach areas are connected to the development of ground collapses. Heavy engineering work is, in this case, needed to stabilize the river profile and to avoid the undermining of slopes during flash flood events. The strong effects of river incision on the stability of infrastructure are obvious, especially on the bridges located hundreds of meters away from the DS shore (Fig. 10).

There are several major bridges on the DS highway, all suffering the effects of the DS water level ~~lowering~~ decline, especially ~~the~~ vertical erosion processes. In October 2017, one of these bridges located three kilometres south of parcel E, was heavily damaged and lost one of ~~the~~ its supporting pillars. Another bridge that suffered significant damage as a consequence of vertical soil erosion is the Zara-Ma'in Bridge, situated just a few kilometres south of the study area. Figure 10 shows the extent of the evolution of the damage affecting the western side of the Zara-Ma'in Bridge on the highway between 2012 (renovated bridge), and 2018. Most of the other bridges on the eastern DS highway show advanced signs of deteriorations.

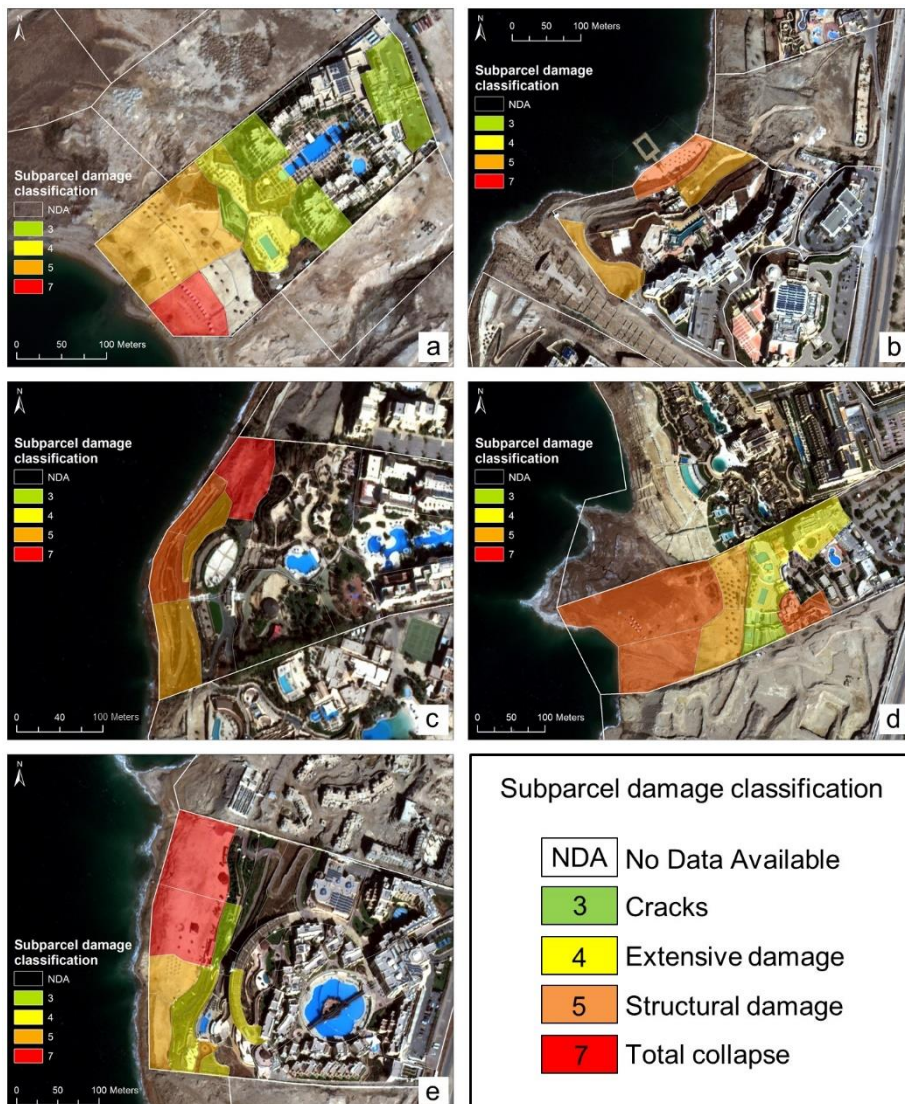
Figure 11. Damage exposure map of five main hotels in the study area. a: Holiday Inn; b: Hilton; c: Marriott; d: Dead Sea Spa; e: Crowne plaza.

Exposure maps were produced for the five main touristic infrastructures located along the DS coastline in Sweimeh (Fig. 11: (a) Holiday Inn; (b) Hilton; (c) Marriott; (d) Dead Sea Spa; and (e) Crown Plaza). The colour chart ranges from green to red. ~~It refers to,~~ indicating increasing structural ~~damages~~ damage observed in each plot. In the Holiday Inn plot, during the 1960s, the shoreline was in the area now occupied by the main swimming pools. Therefore, most of the infrastructures developed ~~in recently~~ over areas exposed ~~areas.~~ They in the last years, which are susceptible to ~~be~~ exposed to geohazards. geohazard exposure. The beach area (Fig. 4a) ~~is~~ has been affected by landslides and sinkholes since 1999. Because the beach is constantly worked and repaired to offer ~~the~~ tourists a pristine sandy beach. ~~As a result, the,~~ cracks are not clearly visible there. The red polygon corresponds to a landslide, while the orange one has fewer observable features. ~~NW~~ Northwest of the orange zone, the beach is not affected by ~~the~~ cosmetic work and fissures are apparent. Close to the shoreline, ~~are found~~ several springs of brackish water and areas covered by reeds are found. In the upstream part of the orange zone, the presence of sinkholes suggests groundwater circulation towards the springs. The part of the hotel next to the beach is marked by a large number of cracks in the pavements (yellow and orange polygons). ~~Their~~ Here the size of the cracks is smaller and ~~frequency are~~ their number lower ~~than~~ in respect to the beach area. The main ~~part~~ section of the hotel has no visible cracks, but the main entrance of the building is subsiding with significant damage ~~through~~ to the walls (in green).

The Hilton plot (Fig. 11b) is affected by geohazards on two sides. The beach area (in red) is directly exposed to a landslide having which has its crown in the upstream part (in orange). Similarly, Similar to the Holiday Inn, the beach area is totally entirely covered with sand and regularly worked. During the field surveys, cracks related to strong subsidence were obvious evident. North of the plot, the cracks were much more visible and extended hundreds of meters northwards, parallel to the shore. In this area, it appears that the whole coastal zone is apparently sliding. The obtained InSAR results confirmed these observations. The access road to the beach is located next to the landscaped Wadi Mukheris. This road shows important fissures that indirectly delineate the lack of stability of Wadi Mukheris' northern slope.

South of Wadi Mukheris, the Marriott plot (Fig. 11c) is strongly affected by recurrent landslides. The whole entire beach area is in red- and/or orange, depending on the damage density and size. of the damage. The red colour corresponds to active landslides, while and the orange colour to indicates areas where engineers managed to stabilize the hazardous situation ground. The whole exposed zone corresponds to the steepest emerged part of Wadi Mukheris delta. The Dead Sea Spa (Fig. 11d) presents high number of fissures in its entire area. The beach area shows many cracks and is affected by sinkholes. The entire plot is sliding towards the DS at different paces. The presence of underwater circulation is attested by ground displacements (subsidence and lateral movements), vegetation (reeds), and sinkholes. The beach of that has emerged with the Crowne Plaza (Fig. 11e) presents many cracks and springs of brackish water. The walls separating hanging gardens are either fissured or partially collapsed. The SE part decline of the plot is also affected by underground water circulation related to Wadi ad Dardur delta. Repeated field investigations suggested that although the river bed has been diverted southwards, groundwater circulation follows the previous direction, prior to the diversion DS water level.

The area of the Dead Sea Spa in its entirety (Fig. 11d) presents a high number of fissures. The beach area shows numerous cracks and is affected by sinkholes. Different parts of the plot are sliding towards the DS at different rates. The presence of underwater circulation is demonstrated by ground displacements (subsidence and lateral movements), vegetation (reeds), and sinkholes.

The beach of the Crowne Plaza Hotel (Fig. 11e) presents many cracks and springs of brackish water. Walls separating terraced gardens outside the hotel are either fissured or partially collapsed. The southeast part of the plot is also affected by underground water circulation related to the Wadi ad Dardur delta. Repeated field investigations suggest that although the river bed has been diverted southwards, groundwater circulation follows the direction prior to its diversion.
