AC2 to RC2

Our work is focussing on the Jordanian side of the Dead Sea (DS), and in particular in exposed areas showing increasing geomorphological and geological instabilities caused by the lowering of the DS water level started half a century ago. In these areas field studies were very few compared to the well supported western side of the DS. The title of the paper will be modified in the final version as we fully agree with the necessity of putting less emphasis on the vulnerability: the word “Vulnerability“ is replace by “Exposition“ in the title and the entire text will be fully adapted accordingly.

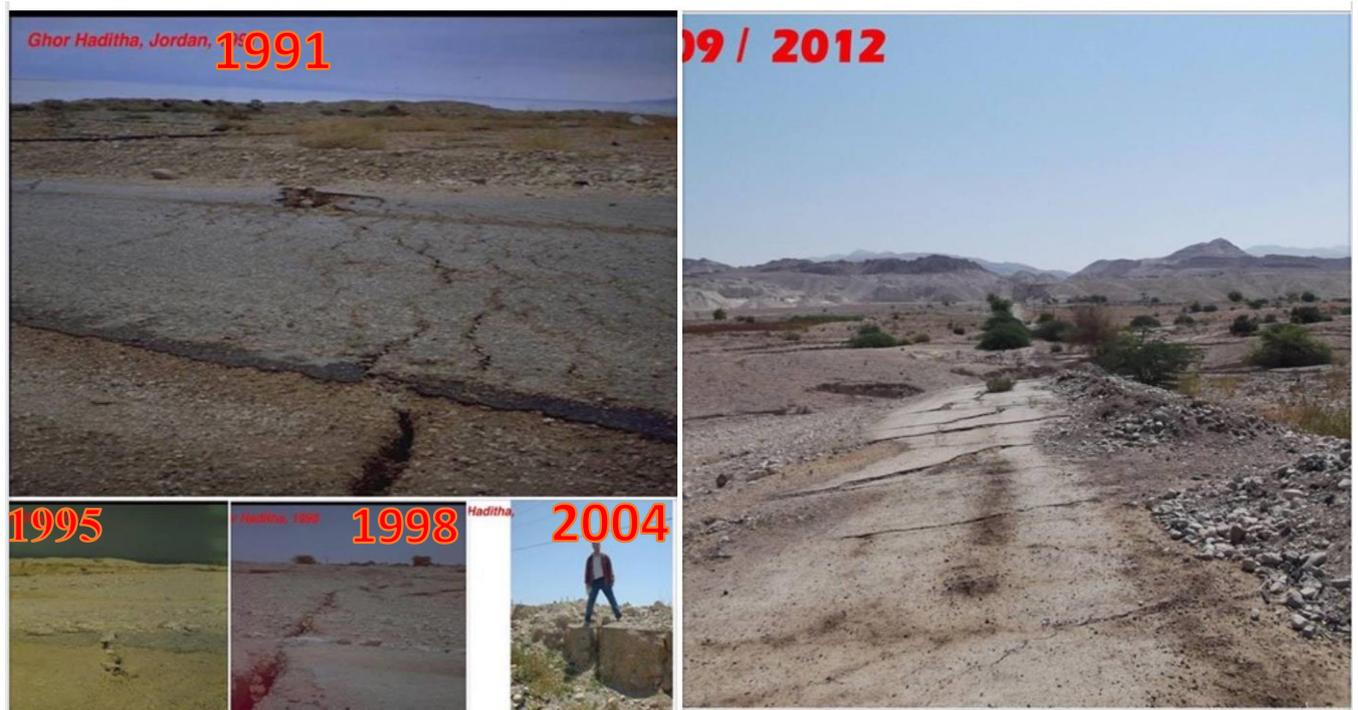
Evolution in a road in Ghor Haditha 1991-2012

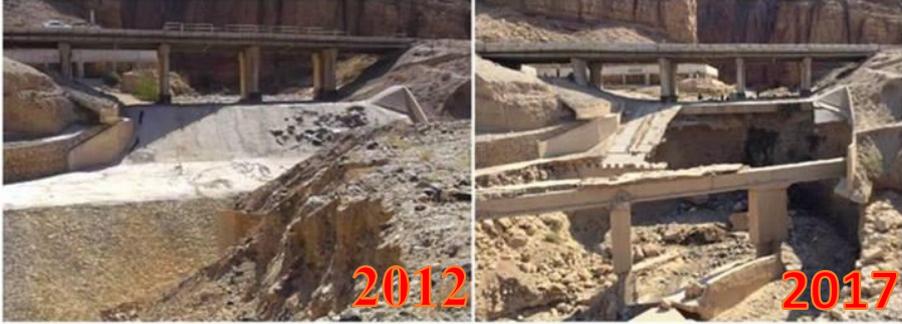
[FIGURE 9]

Figure 9: Example of a bridge along the Dead Sea motorway damaged by progressive erosion of the sediments. Similarly to Figure 8 A-B, all bridges along the coast are affected by the rapid incision of the river bed. Each year, the available energy released during erosion process is more important (square function)

We believe that this work in this particular time is an important factor to boost the interest of the planners and the decision makers in charge of the touristic infrastructures development of the zone up to the point of taking their responsibilities in a more effective way. Since The 10th of October 2018, the start of this discussion version of the paper appearing on this site, major accidents took place in the area shown on (figure 9 of the paper), 22 people most of them children lost their lives

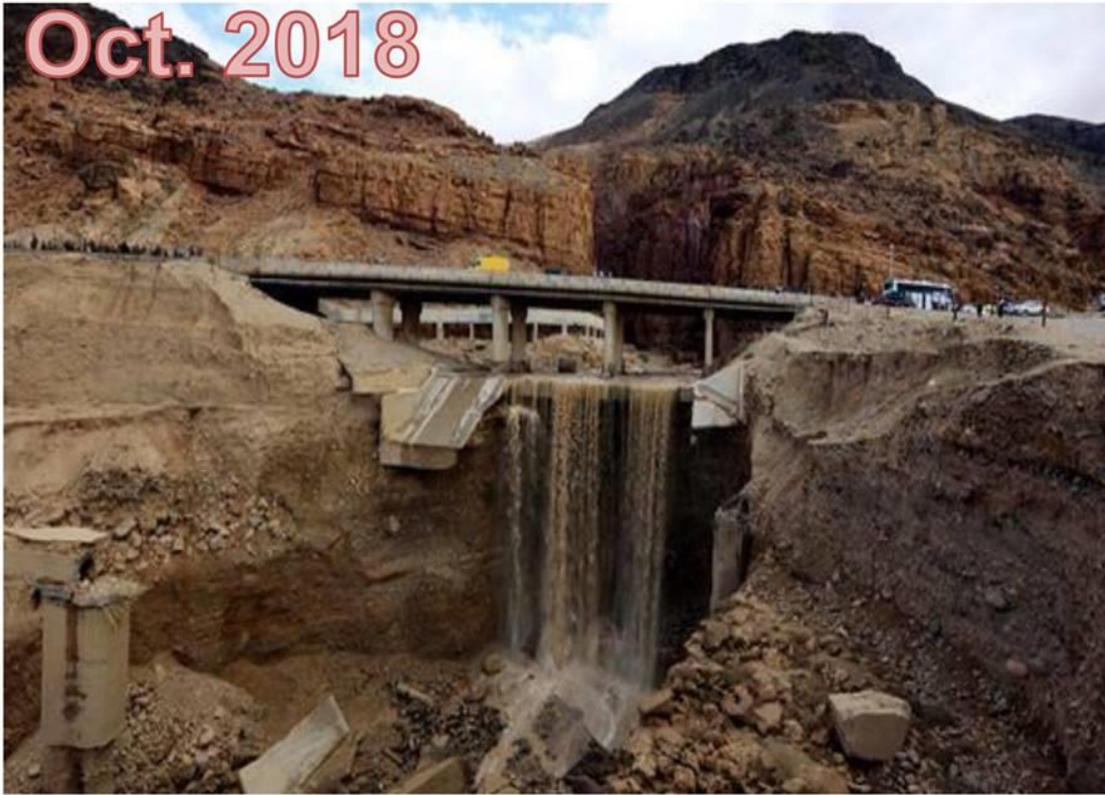
04/2018

A partially damaged bridge which lost one of its pillars in Oct. 2017 leading to its partial closer. It totally collapsed on the 25th of Oct. 2018.

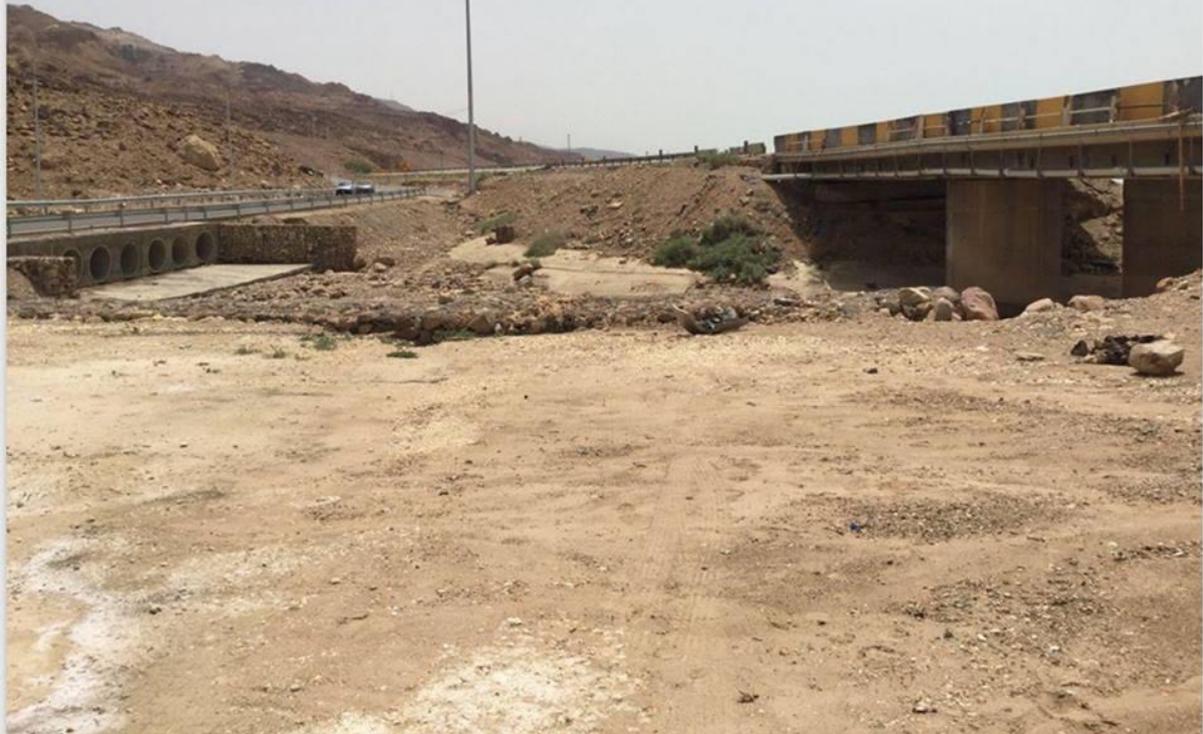
Total Collapse 25-10-2018

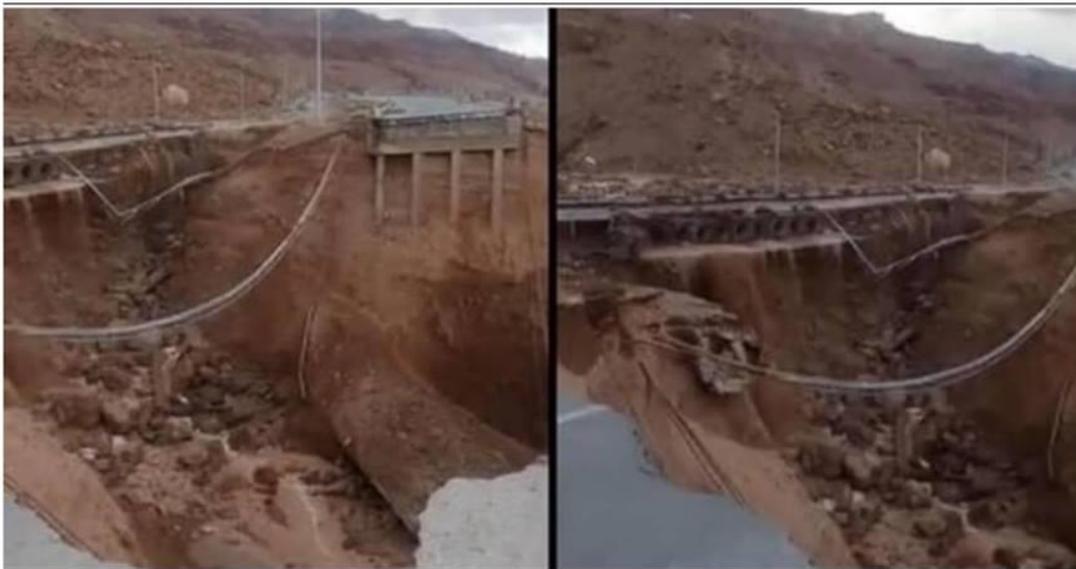
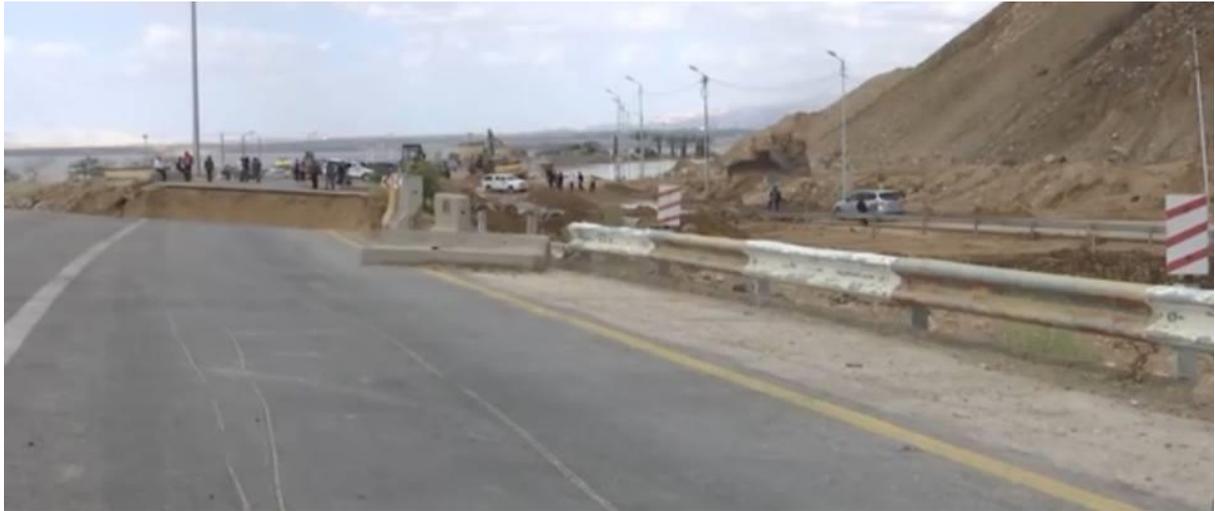
Almost a month later on Nov. 18th a landslide swept part of an ongoing Dead Sea Beach 32 M\$ project with an estimated damage of about 350,000 \$.
