Response from the authors (in blue) to the comments by referee Ivan Vergara (in black), updated 9. April 2021.

The manuscript "Groundwater fluctuations during a debris flow event in Western Norway – triggered by rain and snowmelt" analyses the behaviour of the groundwater level during the occurrence of a debris flow and compares it with the behaviour during other extreme events and with the typical groundwater situation. It is considered that the research is novel because the analysis of these data is not common and the results are very important for the study of shallow landslides by allowing to know the situation of the ground before, during and after the failure. Moreover, the manuscript is well written and has fine and clear figures. Then are some comments that could improve understanding of the work.

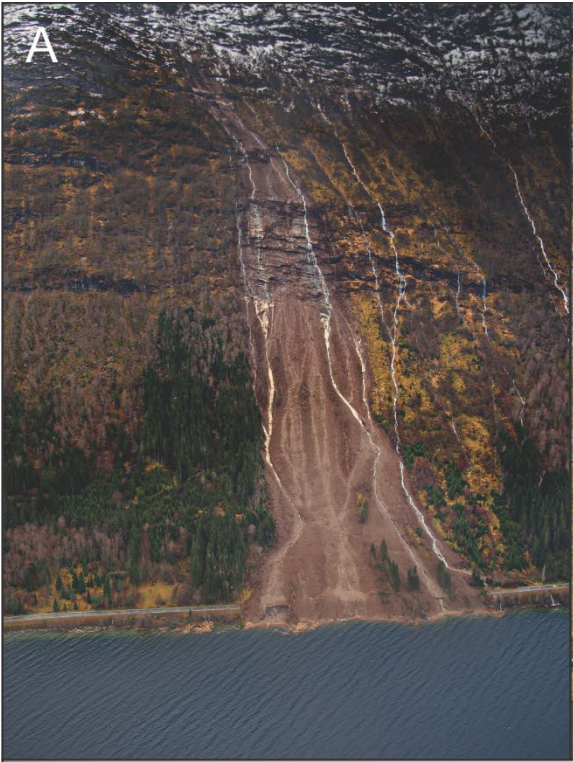
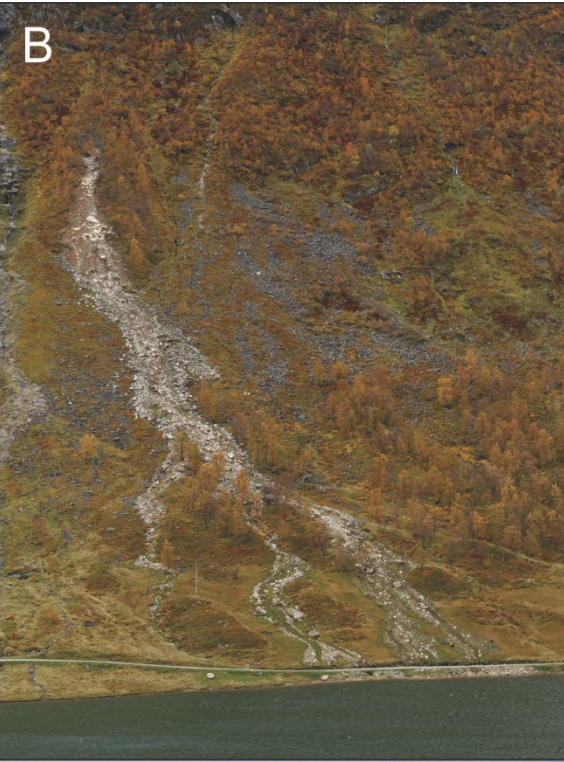
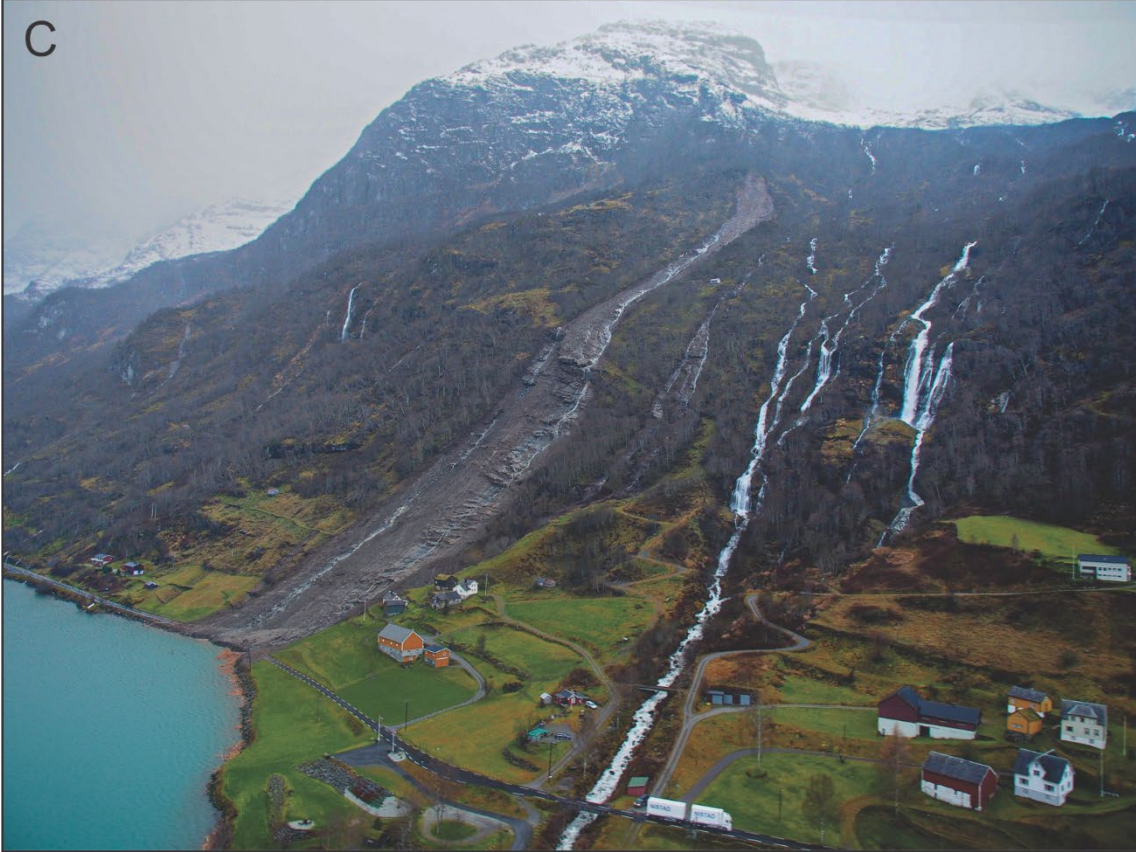
Figure 2: Photos of **landslides** that occurred during storm Hilde in 2013, see table 1 for details.

A. Skredestranda. ~~The slide occurred at around 21–22 on 15 November, was triggered at an altitude of 620 m, covered about 250 m of the road and continued into lake Hornindalsvatnet (altitude 53 m).~~ ~~Photo: Jan Helge Aalbu, 16 November 2013.~~

Table 1. Information ~~of the~~ the landslides shown in Fig. 2A, 2B and 2C.

Figure	Location	Date	Hour	Top altitude	End altitude	Length slide	Mean slope	Comment
2A	Skredestranda, south of the lake Hornindalsvatnet, Nordfjord.	15 Nov	21–22	620 m	53 m	830 m	34°	The landslide continued into the lake Hornindalsvatnet (53 m altitude), covered 250 m of the road. Road was closed for several days. Triggered small tsunami < 1 m (NVE; Søgnesand, 2018).
2B	Anestølen, Sogndal – this study.	15 Nov	19–23?	700 m	439 m	550 m	25°	See details in this paper.
2C	Oldedalen, Yri, Nordfjord.	15 Nov	~ 23	480 m	33 m	780 m	30°	The largest of three slides that occurred around the lake Oldevatnet (33 m altitude). Damaged road and took out electricity. Triggered tsunami in the lake (NVE).

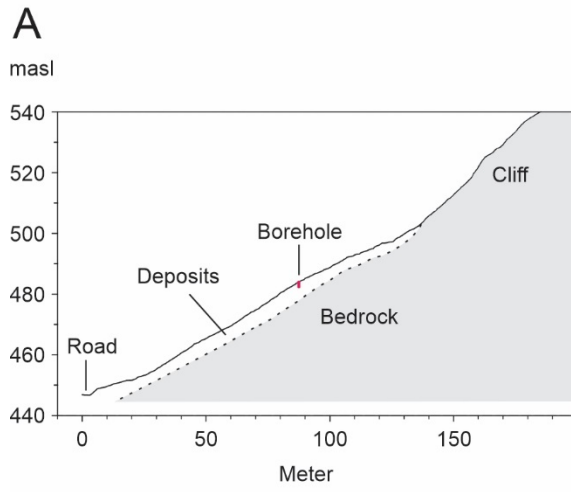
Figure 5: Profile of the hillside just south of the southern slide scar of the 2007 landslide (Fig. 4B) showing the borehole with the instrumented piezometer. A. Average steepness of the sediment-covered slope is 25–26°. The stippled line indicates where we believe the boundary between till and bedrock is located, based on observations from the 2007 slide scar (Fig. 4B). B. The mini-diver (sensor) is suspended from a wire in the piezometer and anchored 1.64 m below the surface. The top 60 cm of deposits consists of organic soil and weathered till, with firm till below that. We drilled through boulders at depths of ca. 1 m and 1.5 m.

“The lower part of the slope is covered by slide deposits and till and the average slope angle is 25 °– 26 °. The sediment-covered slope tapers off upwards into steeper and exposed bedrock and cliffs (Fig. 5A). From the outcrops of the slide scar of the 2007 slide event (Fig. 4B), we found that the thickness of the deposits on the slope varies, probably between 2 and 5 m.”

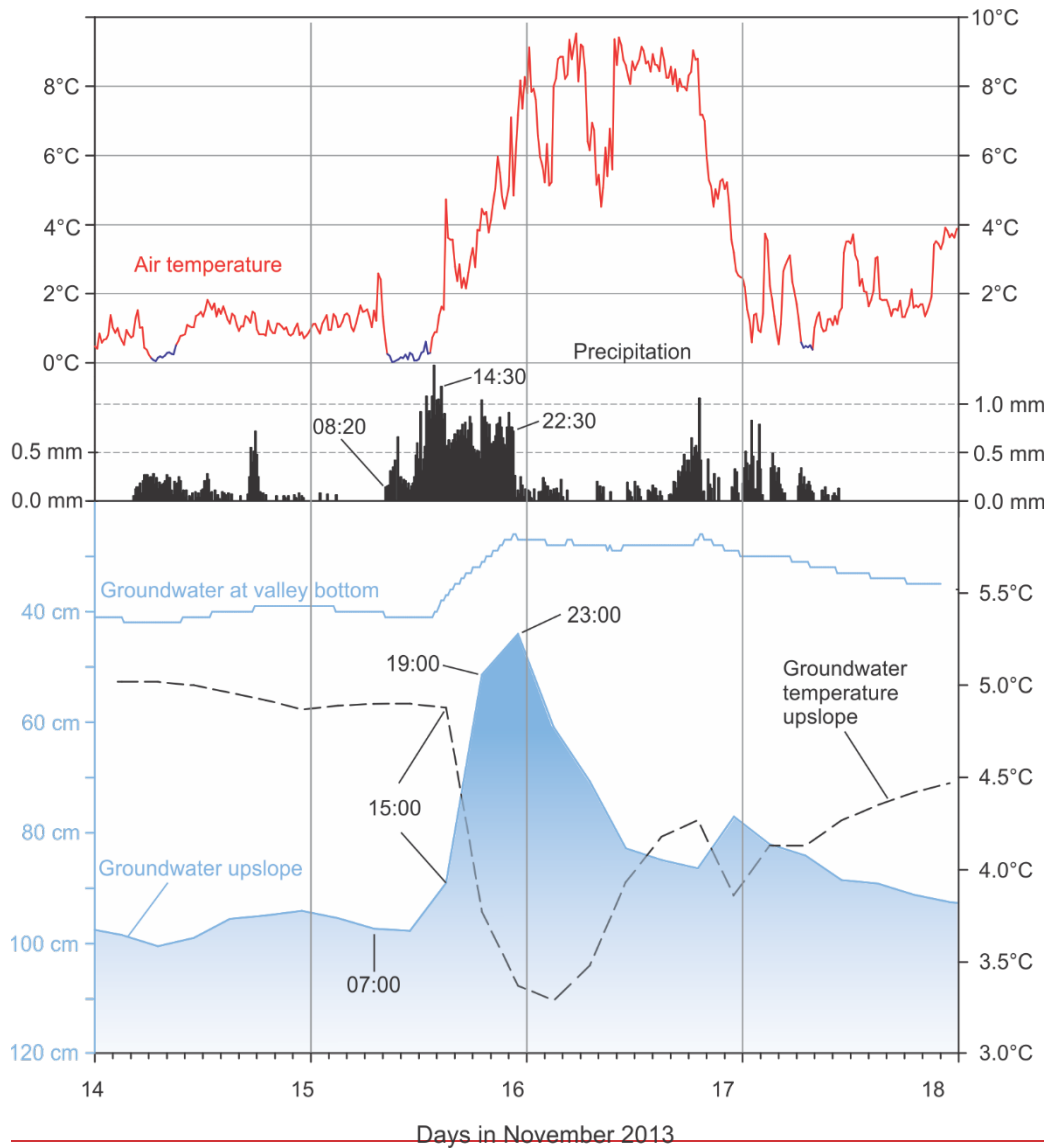
235 **Figure 8: Air temperatures, precipitation and groundwater between 14 and 18 November 2013. The upper diagram shows air temperature (red curve) and precipitation in mm per 10 min. The lower diagram shows the groundwater level and groundwater temperature. Blue segments of the air temperature-curve show periods when the temperature is close to 0°C. Groundwater probably reached its highest level between 19:00 and 23:00, shown as a dotted line and a question mark.**

L234-237. I don't understand the relationship between this sentence and Fig. 6. On the other hand, I do not understand the arguments to infer that the peak occurred before 23 o'clock... If the intensity of the rain and the air temperature did not change, it would not be explained either because the groundwater reached the peak between 8:30 p.m. and 9:30 p.m. and then it started to decrease.

Sorry, there is a type error here in our text, it should not say “see Fig. 6” in our text, but it should be “see Fig. 8.” This has now been changed (line 263).

Yes, we agree, good idea. We have now plotted the extrapolation in Fig. 8 as a stippled line.
