Supplement

Groundwater fluctuations during a debris flow event in Western Norway – triggered by rain and snowmelt

Bondevik and Sorteberg

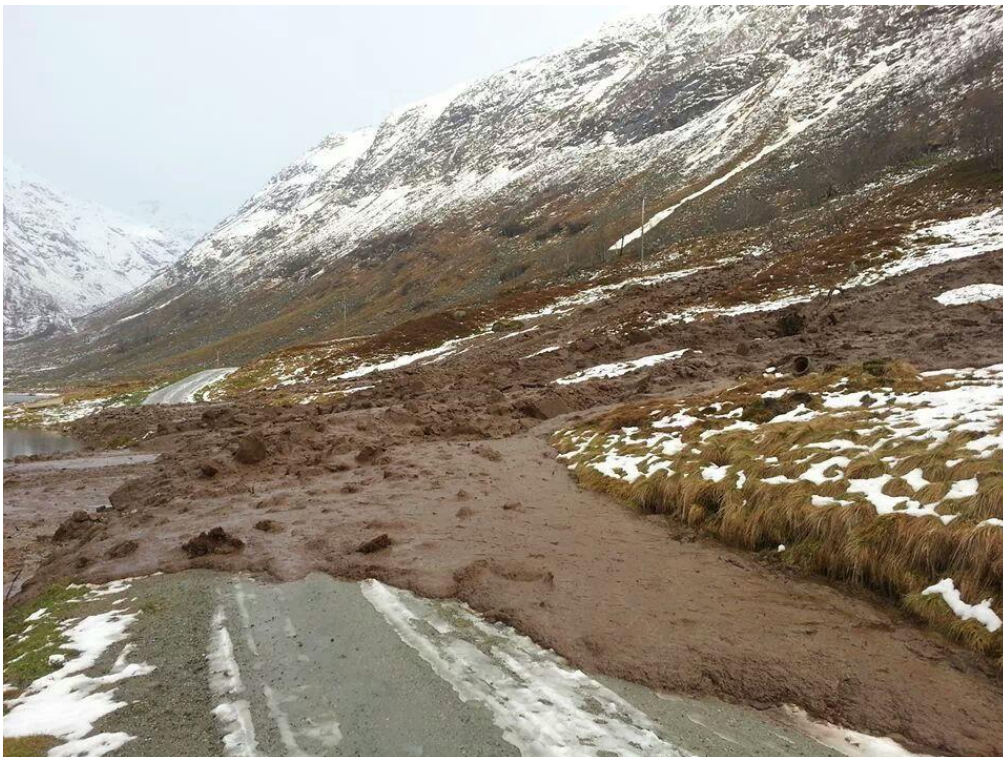
Figure S2: The debris flow deposits covered the road and continued into the lake. Photographed in the morning of 16 November 2013 by Vidar Leirdal.

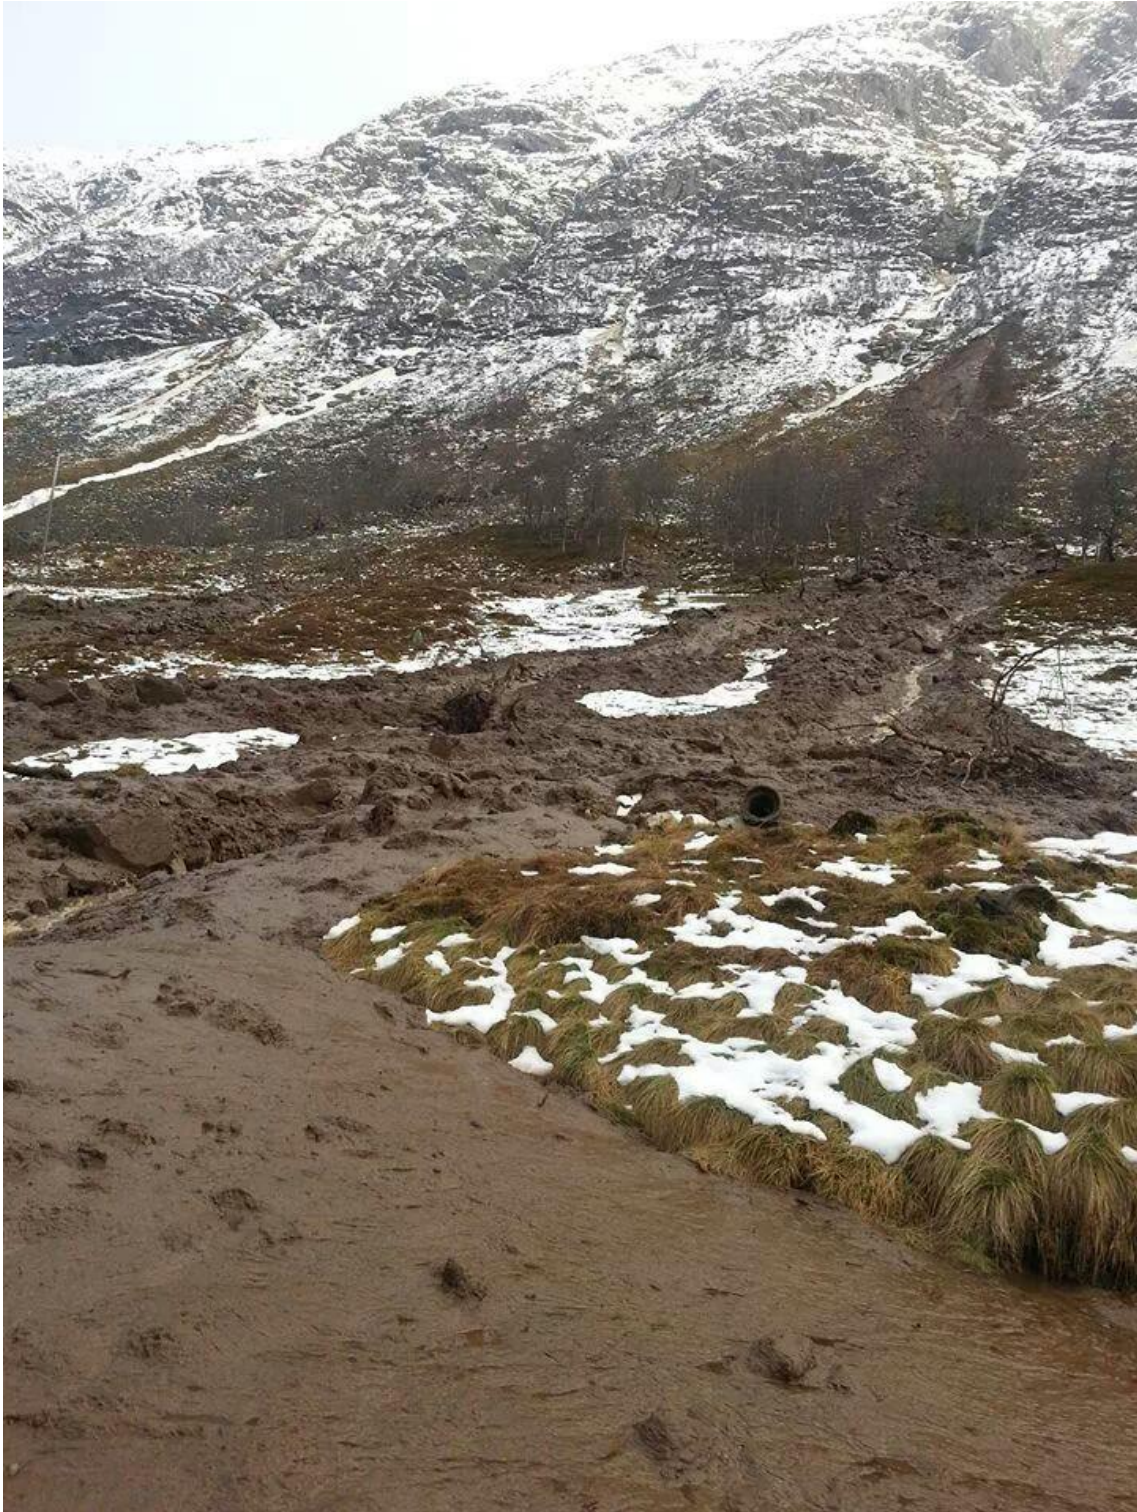
Figure S3: The debris flow photographed in the morning of 16 November 2013 by Vidar Leirdal.

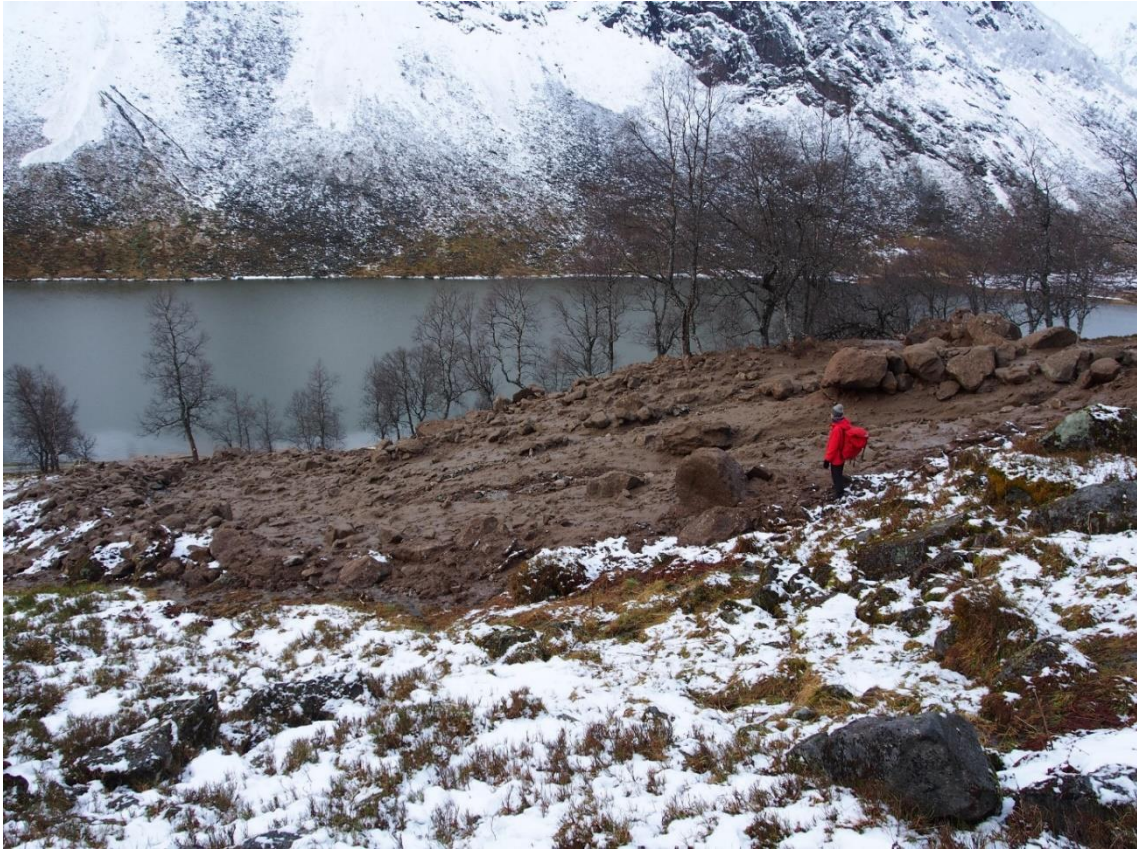
Figure S4: The debris flow photographed in the morning of 17 November 2013 by Stein Bondevik.

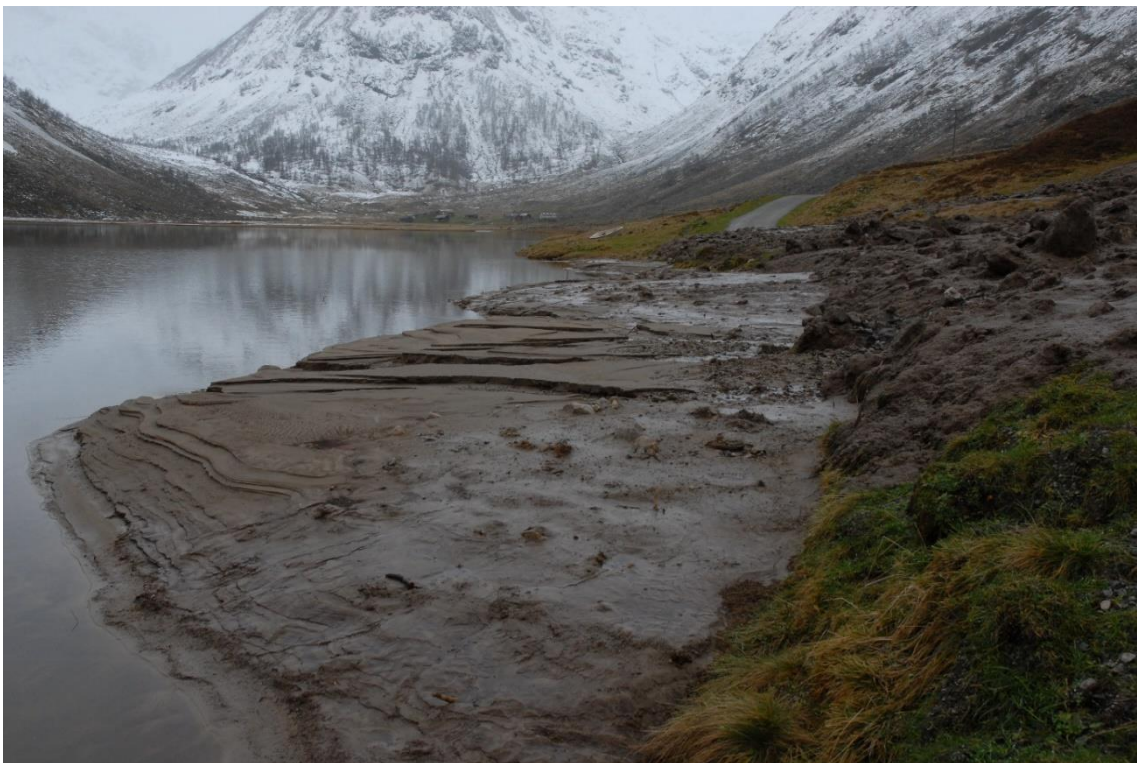
Figure S5: The debris flow ended in the lake and built out a delta. Photographed in the morning of 17 November 2013 by Stein Bondevik.

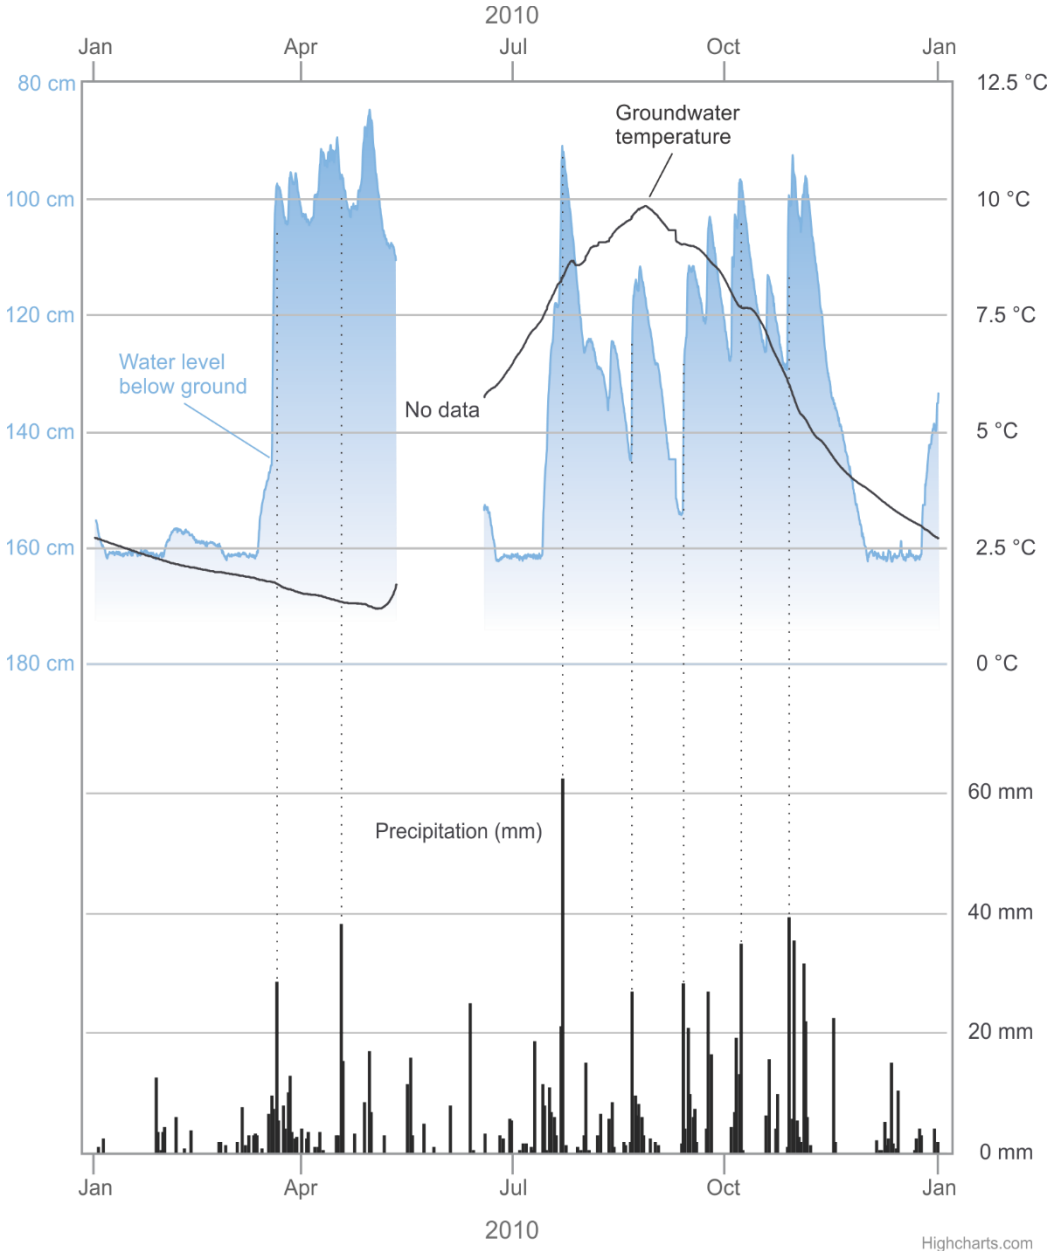
Groundwater fluctuations, groundwater temperatures and precipitation in 2010 (Fig. S8)

Figure S8: The upper diagram shows groundwater level (blue curve) and groundwater temperature (black curve) from the borehole on the slope in 2010. The lower diagram shows 24h precipitation at the weather station at Selseng, station no. 55700, <http://eklima.met.no>. No data between 11 May and 17 June.

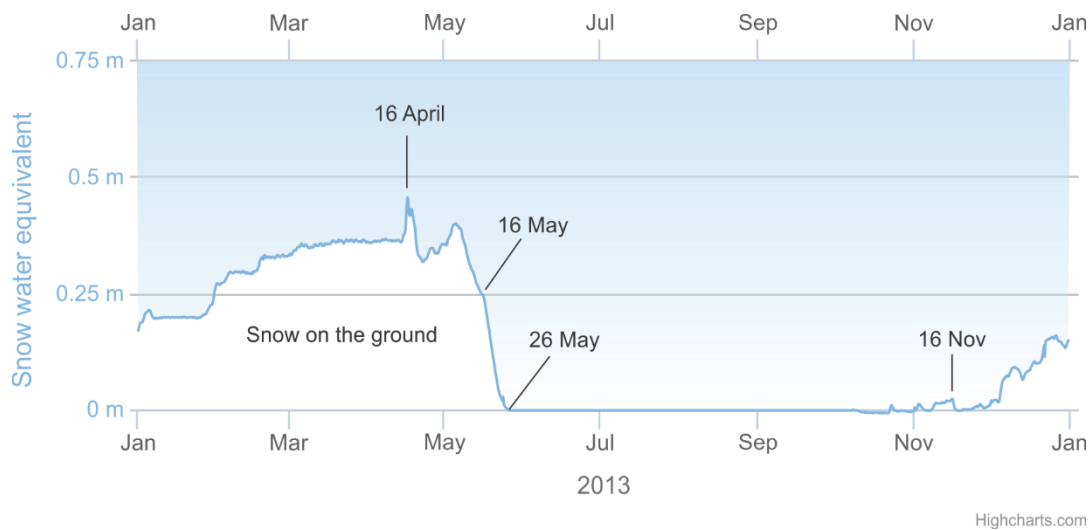
Snow at the weather station at Anestølen in 2013 (Fig. S9)

Figure S9: Snow water equivalent measured at the weather station 77.24.0 using a snow pillow. Snow water equivalent is the amount of water stored in the snow pack. There was a little snow on the ground on 16 November (24 mm of water).
