Groundwater fluctuations during a debris flow event in Western Norway – triggered by rain and snowmelt

Stein Bondevik¹, Asgeir Sorteberg²

¹Department of Environmental Sciences, Western Norway University of Applied Sciences, P.O. Box 133, NO-6851 Sogndal, Norway

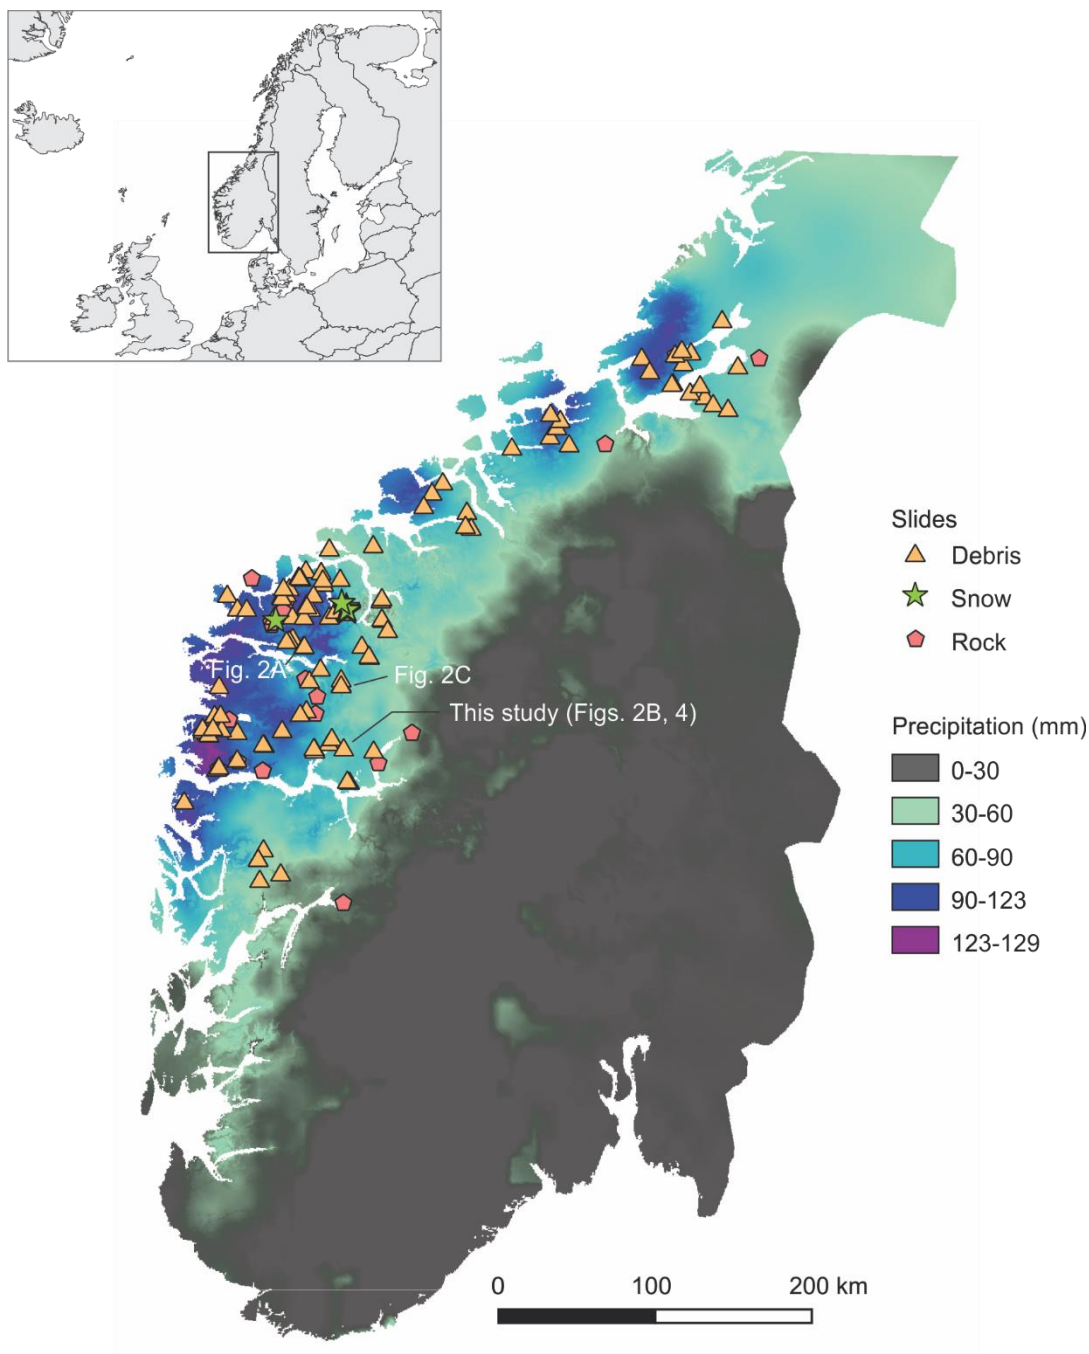
Figure 1: Landslides that occurred on 15 and 16 November 2013 during storm Hilde in Western Norway – 114 debris flows, slides, 7 snow avalanches and 28 rockfalls. Data retrieved from the Norwegian landslide database: <https://gis3.nve.no/link/?link=SkredHendelser>. Precipitation is interpolated from observations and shows the amount in mm per 24 hours, collected at 06:00 UTC 16 November (08:00 local time), data retrieved from <http://www.xgeo.no/>.

During this storm, the intense rainfall and snowmelt triggered more than 100 landslides in Western Norway. The
maximum rainfall intensity was 80–100 mm in 24 hours, locally up to 129 mm. Most of the slides were debris slides and flows
40 (114), but rockfalls (28) and snow avalanches (7) also occurred (Fig. 1). Many roads were damaged, a bus got stuck, people
were evacuated, and houses and cars were damaged by slide material, but fortunately no one was killed (Fig. 2). The number
of slides makes this one of the largest landslide events in Norway during the last two decades (Krøgli et al., 2018).

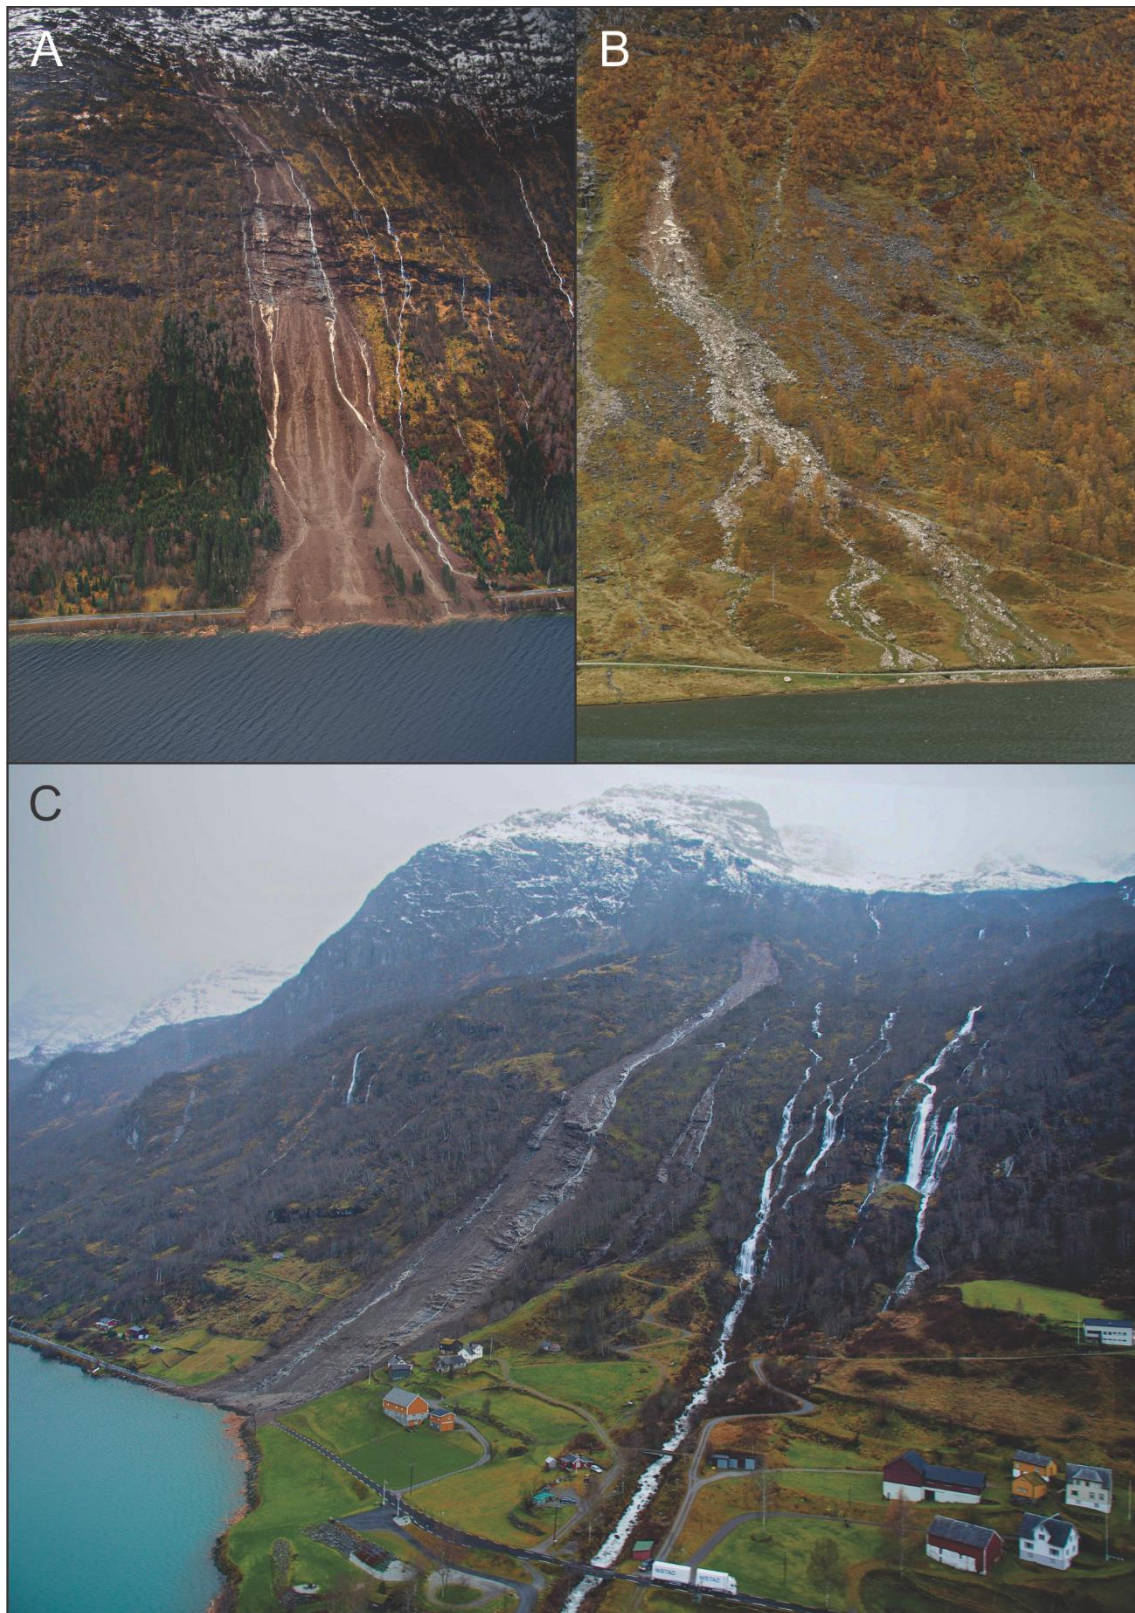
Figure 2: Photos of slides that occurred during storm Hilde in 2013.

A: Skredestranda. The slide occurred at around 21-22 on 15 November, was triggered at an altitude of 620 m, covered about 250 m of the road and continued into lake Hornindalsvatnet (altitude 53 m). Photo: Jan Helge Aalbu, 16 November 2013.

60 **B: Anestølen, this study.** Photo: Kevin Saurin, 6 October 2014.

C: Oldedalen at Yri. The slide occurred around 23 on 15 November, started at about 350 m above sea level, and continued into lake Oldevatnet (altitude 34 m). Photo, Jan Helge Aalbu on 16 November 2013. The slides in A and C both generated small tsunamis.

The slide happened in the evening of 15 November or during the following night. It was first observed by a person
driving an all-terrain vehicle to the mountain farm at Anestølen in the morning of 16 November; he found that the road was
120 covered by wet debris, and was unable to proceed (Fig. S2). The driver thinks the flow happened sometime during the night,
but cannot exclude the possibility that it was the evening before, on 15 November (Olsen et al., 2015). The nearest slides to
Anestølen (see three triangles in Fig. 1 immediately west of this site), happened on the evening of 15 November, and during
the night and early morning of 16 November at 02:00 and 07:30.

125 The slide is a typical debris flow with levees and lobes. The flow had a point source at an altitude of 720 m, widened
downslope, and continued in a channel with levees on both sides (Figs. 2B, S3). The channel was eroded about 2 to 3 m into
the deposits, and exposed the bedrock in certain places. A spillover lobe is evident on the southern side of the slide. Towards
the lake, the flow split into three different paths (Fig. 2B) (Olsen et al., 2015), and ended in the lake (441 m altitude). Here, a
fan and a delta of fine-grained material, mostly sand and organic material, were deposited (Fig. S4). We inspected the slide on
130 17 November (Fig. S5) and found snow inside the very wet slide debris. The entire lake was colored brown by suspended
sediment from the slide that had entered the lake.

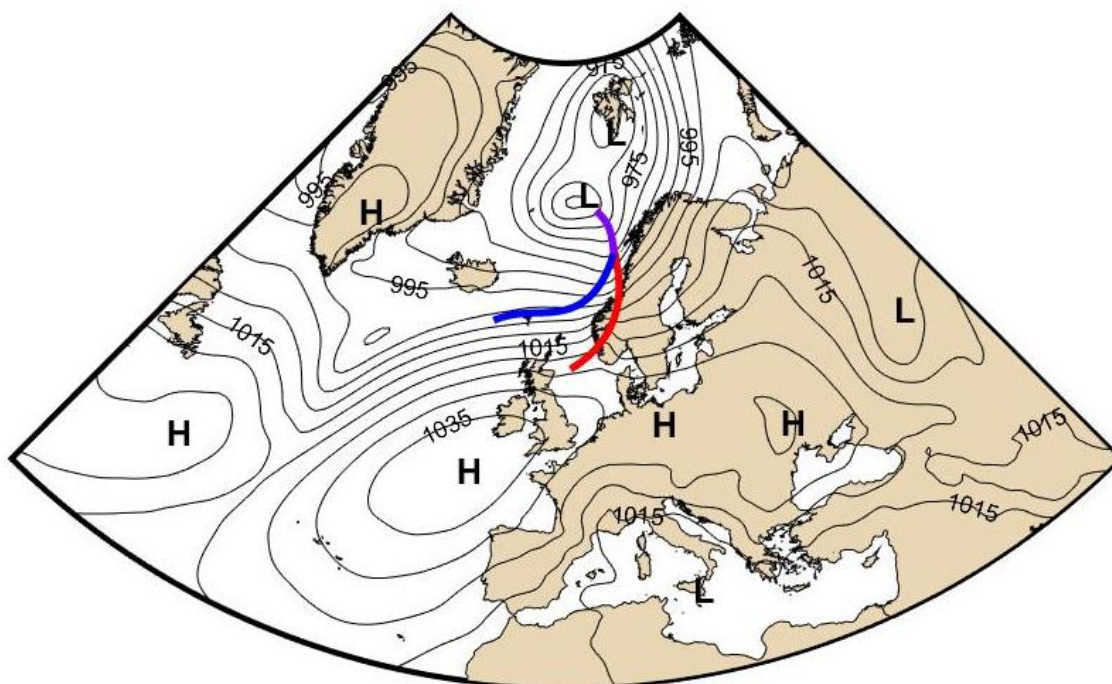
Figure 3: Mean sea level pressure (hPa) on 15 November at 12:00 UTC (14:00 local time). Large amounts of warm and moist air blew towards the Norwegian coast because of low pressure northeast of Jan Mayen and high pressure southwest of England. The air was close to 100 % saturated with water vapor, which precipitated as the air cooled when it rose over the mountains in western Norway. The red line indicates the position of the warm front and the blue line is the cold front. The warm air sector lies between the red and blue lines. The purple line indicates an occluded front, which means that the cold front has caught up with the warm front.

The storm was a classic extreme precipitation event on the west coast of Norway. A warm mature front, partly
occluded, passed southern Norway on 15 November. The pressure configuration, with a very low-pressure system northeast
45 of Jan Mayen and a high-pressure center southwest of the UK, generated a strong north-south pressure gradient and induced a
southwesterly flow of moist warm air towards western Norway (Fig. 3). It rained heavily as the moist air was lifted by the
warm front. The precipitation further intensified as the flow ascended over the mountains of western Norway. This weather
situation leads to the formation of narrow plumes of intense high-level moisture, often referred to as atmospheric rivers. These
cause most of the extreme precipitation events on the west coast of Norway (Azad and Sorteberg, 2017).

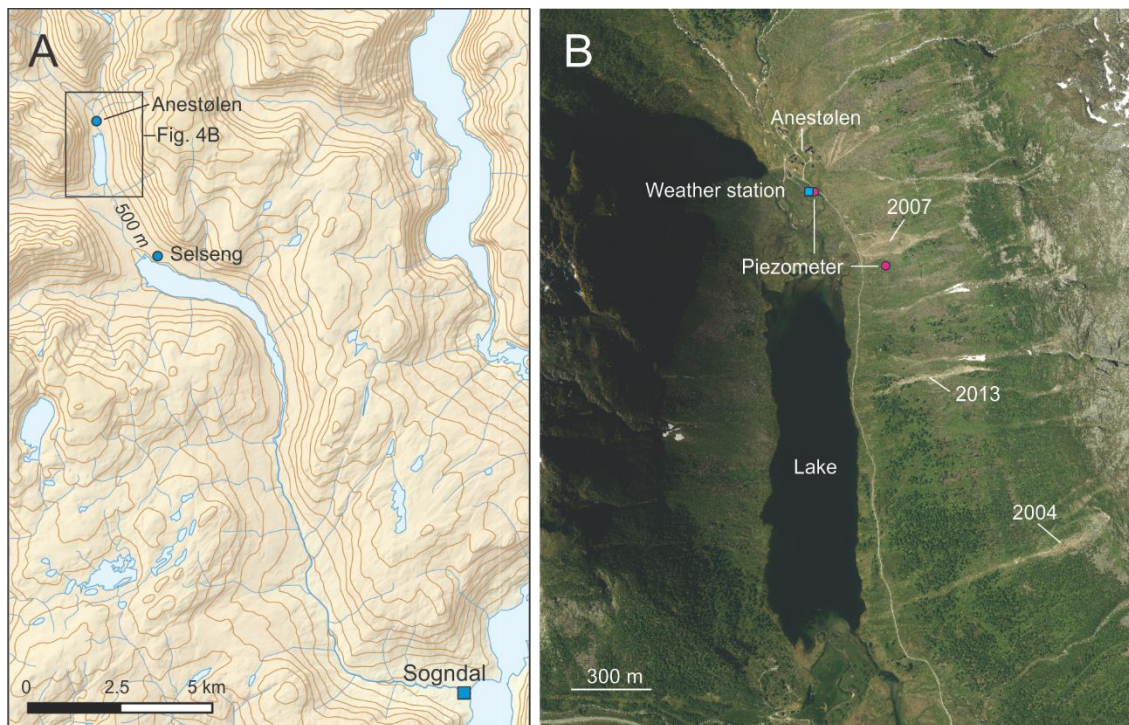
Figure 4: Map and aerial photo of the site near Anestølen. A. The contour interval is 100 m. B. Aerial photo from 2018. The eastern slope is prone to debris slides and flows, and the most recent slides are indicated with the year they occurred. There is a weather station including a piezometer located in the valley bottom. We installed a piezometer in a borehole on the hillslope close to the southern slide scar of the 2007 slide. © Kartverket/Geovekst (www.kartverket.no).

The hillside we instrumented is typical of Western Norway, and is prone to debris flows and shallow slides. The hillside is near Sogndal, east of the lake at Anestølen (Fig. 4). Recent slide events on this slope occurred on 18 May 2004, 22 September 2007 (Tyssebotn and Velle, 2010) and 15 November 2013 (Olsen et al., 2015) (Fig. 4B). The lower part of the slope is covered by slide deposits and till and the average slope angle is 25° – 26° . The sediment-covered slope tapers off upwards into steeper and exposed bedrock and cliffs (Fig. 5A). From the outcrops of the slide scar of the 2007 slide event (Fig. 4B), we found that the thickness of the deposits on the slope varies, probably between 2 and 5 m.

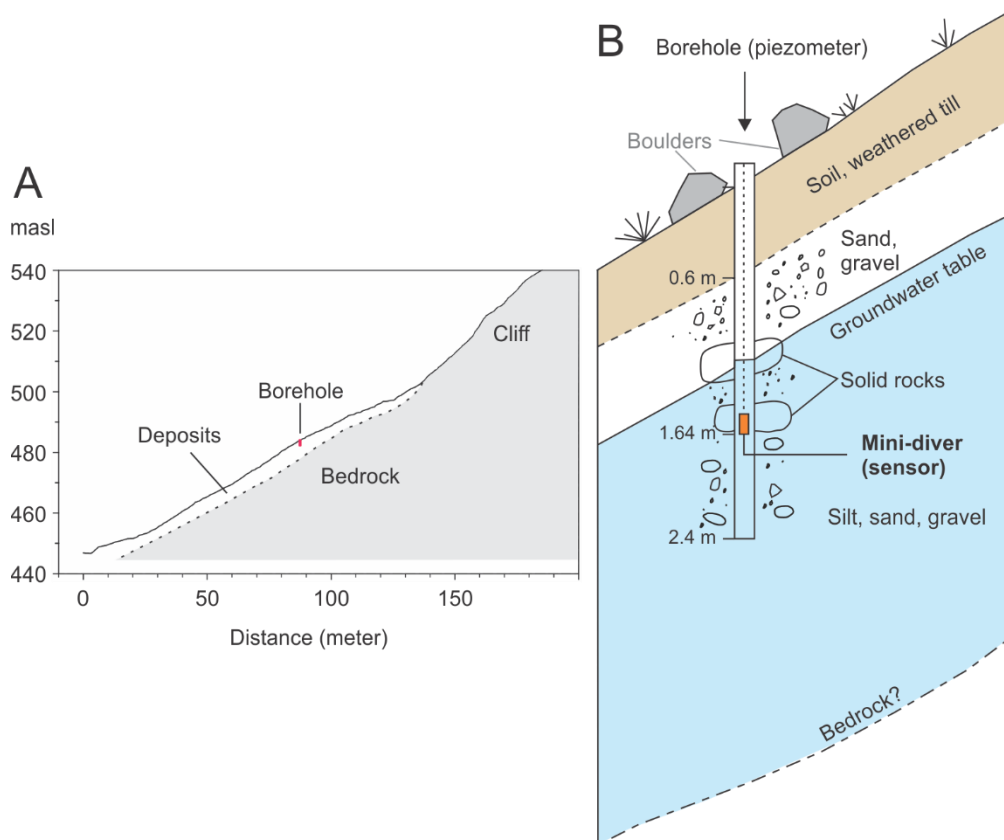
Figure 5: Profile of the hillside showing the borehole with the instrumented piezometer. A. Average steepness of the sediment-covered slope is 25–26°. The stippled line indicates where we believe the boundary between till and bedrock is located, based on observations from the 2007 slide scar (Fig. 4B). B. The mini-diver (sensor) is suspended from a wire in the piezometer and anchored 1.64 m below the surface. The top 60 cm of deposits consists of organic soil and weathered till, with firm till below that. We drilled through boulders at depths of ca. 1 m and 1.5 m.

We drilled through boulders and relatively firm deposits down to 2.4 m below the surface using a hammer drill powered by compressed air (Fig. 5B). We pushed and hammered threaded pipes, 1 m long and 32 mm in diameter, down into the borehole. The pipes were subsequently screwed together. The lower pipe (piezometer) has twelve slits, 10 cm long and 2 mm in width, to allow water seepage. The data logger, a mini-diver (DI 501) manufactured by Van Essen instruments, was attached to a wire and inserted into the pipe. The lower end of the mini-diver is at 1.64 m below the ground surface (Fig. 5B). The drilling and instrumentation are described in Tyssebotn and Velle (2010).

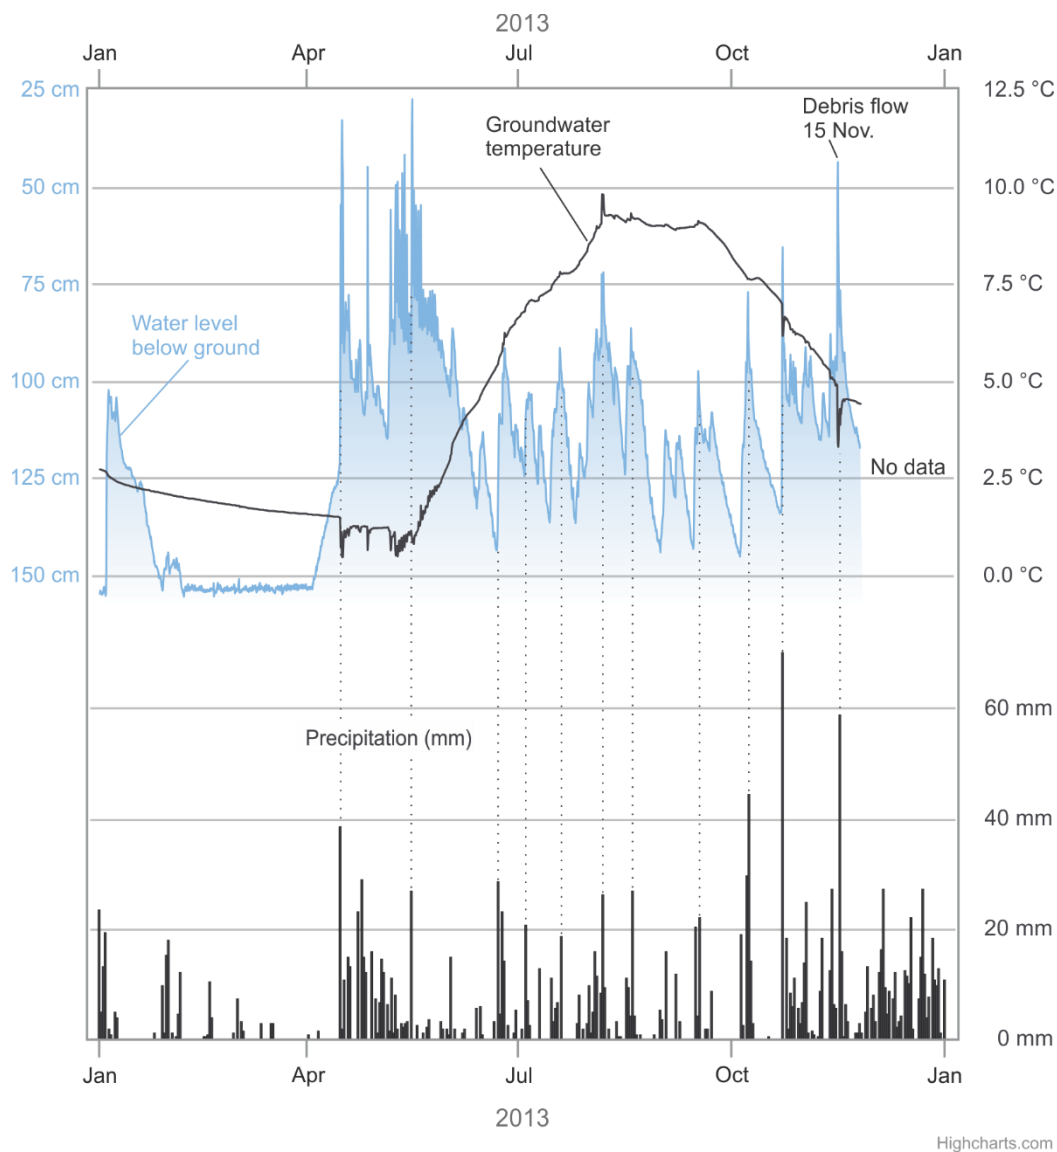
Figure 6: The upper diagram shows groundwater level (blue curve) and groundwater temperature (black curve) from the borehole on the slope in 2013. The lower diagram shows 24h precipitation at the weather station at Selseng (Fig. 4A), station no. 55700, <http://eklima.met.no>. One of the most pronounced oscillations is on 15–16 November, when a debris flow occurred on this hillslope.

The groundwater level on the slope varies according to season and precipitation. In winter the groundwater table is low, and in 2013 the water level was below the sensor in February and March, apparently because the ground was frozen (e.g. Ireson et al., 2013) (Fig. 6). During spring, from April to June, the groundwater is recharged by snowmelt, rain and thawing of the frozen ground (Du et al., 2019), which cause high peaks and rapid changes. In summer and fall, the groundwater level is controlled by precipitation events, and normally oscillates between 150 cm and 75 cm below the ground (Figs. 6, S6–S8). A few times in the summer, the groundwater level is lower than the sensor. Most of the oscillations show a rapid, almost instantaneous rise, and a longer, slower, decline – the oscillations are clearly asymmetric (Fig. 7).

Groundwater temperatures follow the season, but show small, irregular oscillations that reflect infiltration episodes
(Figs. 6, S6-S8). The big picture is a steady, slow temperature decline through the winter to about $1.5^{\circ} - 2^{\circ}\text{C}$, an abrupt drop
in the spring when temperature reaches its minimum ($0.5^{\circ} - 1.2^{\circ}\text{C}$) with wiggles in the temperature curve reflecting meltwater
170 reaching the sensor, followed by a large rise from May to August, up to $9.5^{\circ} - 10^{\circ}\text{C}$. In September the groundwater
temperatures start a steady decline towards the winter minimum. However, the temperature curves show a number of small
anomalies that coincide with peaks in groundwater level. These anomalies are caused by infiltration of surface water that is
either colder or warmer than the groundwater. Infiltration episodes between October and May cause the temperature to drop;

the largest observed were drops of 1.5°C and 1.8°C related to snowmelt (Figs. 6, S7). Between May and October, surface
175 water is warmer than the groundwater; infiltration episodes cause temperature rises, the largest recorded being about 1°C and
associated with summer rain events in July (Fig. S7) and August (Fig. 6).

260 Melting of the snow cover on the slope leads to high groundwater levels. In 2013 we recorded the year's highest peaks in April and May (Fig. 6), when the ground was still covered by substantial amounts of snow (Fig. S9). The high peaks correspond to lows in the groundwater temperature curve, reflecting the infiltration of cold meltwater. The small wiggles in the temperature curve end on 26 May – the same day the snow pillow at the weather station was free of snow (Fig. S9). The highest peaks were on 15 April and 16 May, 33 cm and 28 cm below the ground respectively, and coincided with rain (Fig. 6)
265 and high air temperatures ($> 8^{\circ}\text{C}$) (Fig. S1). This high pore pressure did not cause any sliding, perhaps because there was still considerable snow cover, estimated at around 1 m (Fig. S9).

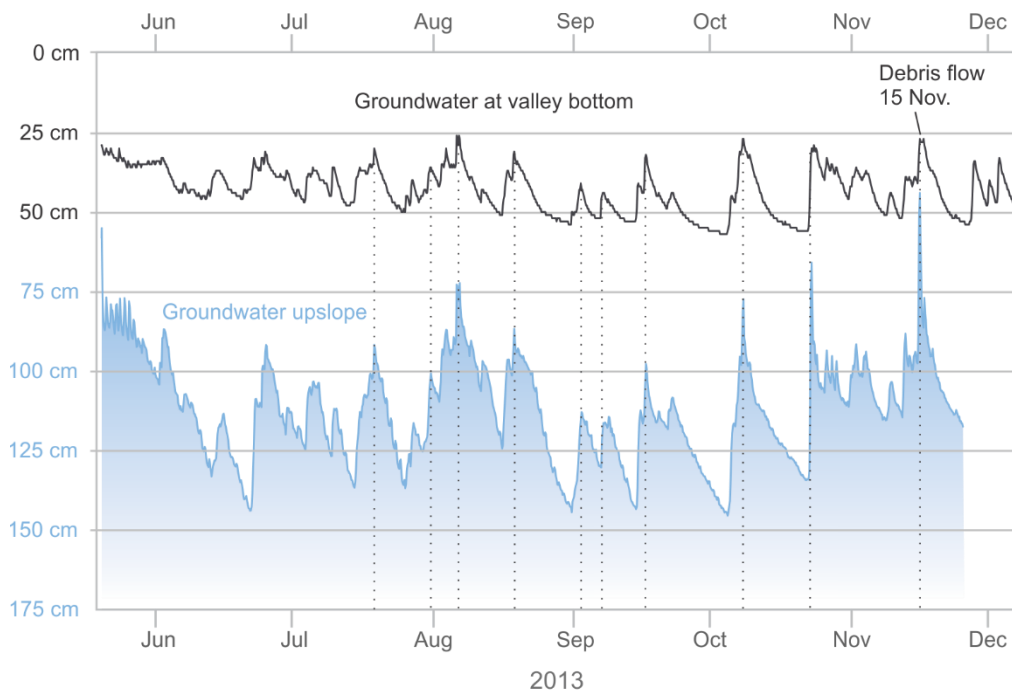
200 **Figure 7: Groundwater fluctuations in June-December 2013. The upper curve (black) shows fluctuations at the weather station in the valley bottom. The blue curve shows the fluctuations in the borehole upslope. The minima and maxima occur at the same time (dotted lines), but the peaks upslope are sharper, last less than 4 hours, have higher amplitudes, and the individual peaks reach different levels. The ground in the valley bottom is saturated at a registered depth of around 25 cm.**

160 The peaks and troughs of the oscillations occur simultaneously upslope and in the valley bottom (piezometer at the
weather station), but the peaks upslope are much sharper and vary in amplitude (Fig. 7). The valley bottom is saturated almost
every time there is a precipitation event. The upslope peaks reach different heights, depending on the amount of infiltration
(Fig. 7). Another difference is in the shape of the peaks. The upslope maxima are very sharp, lasting less than 4 hours, while
the maxima downslope are broad. The peaks dissipate more rapidly upslope than downslope, as has also been described
elsewhere e.g. Alaska (Sidle, 1984, 1986). The groundwater level starts to decline within hours after reaching peak levels,
165 while the valley bottom peaks last for half a day or more (Fig. 8).

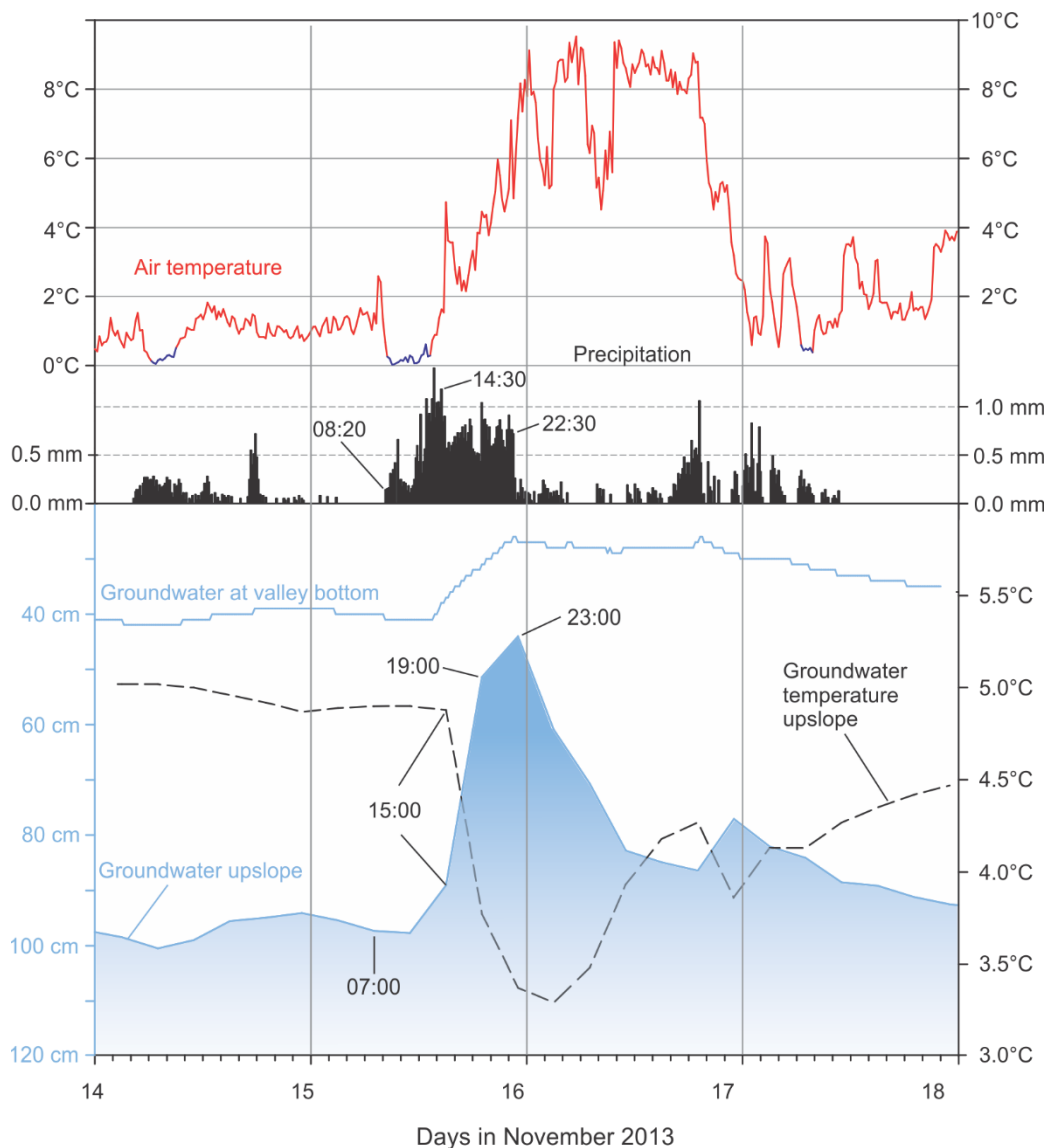
210 **Figure 8: Air temperatures, precipitation and groundwater between 14 and 18 November 2013. The upper diagram**
shows air temperature (red curve) and precipitation in mm per 10 min. The lower diagram shows the groundwater
level and groundwater temperature. Blue segments of the air temperature-curve show periods when the temperature
is close to 0°C. Groundwater probably reached its highest level between 19:00 and 23:00.

One of the largest oscillations in both groundwater level and temperature occurred during storm Hilde on 15–16
November 2013, and triggered the slide event. In only 8 hours, the groundwater level rose by 46 cm and the temperature
180 dropped by 1.5°C (Fig. 8). The precipitation at Anestølen began at 08:20 on 15 November and fell as snow until about 14:30,
in all 22 mm (3.3 mm/h), because the air temperature was between 0° and 0.6°C (blue line in Fig. 8). From about 15:00 the
air temperature rose quickly and reached 9.5°C at midnight (Fig. 8), and precipitation was 4.2 mm/h until 22:30 p.m. The
response in groundwater level was a rapid rise, 9.5 cm/h (Fig. 9), and a drop in temperature, from 4.9°C to 3.4°C between
15:00 and 19:00.

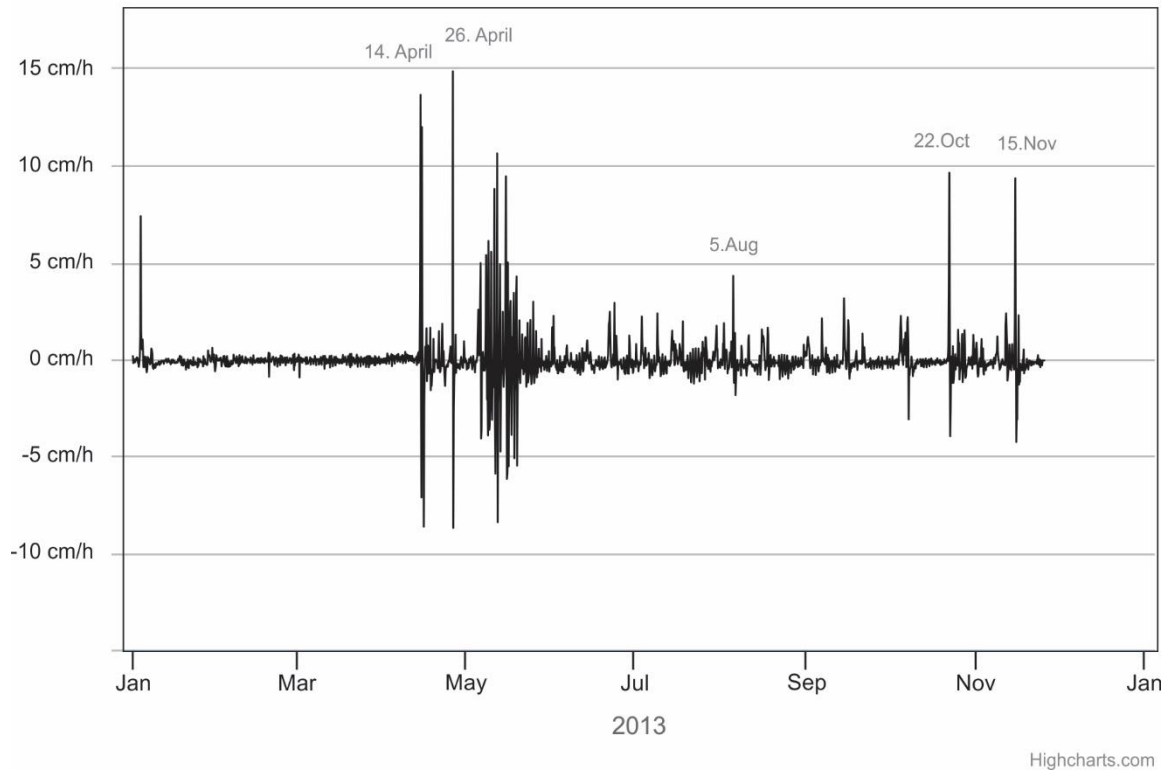
Figure 9: Rates of change of groundwater level in 2013. The highest rates are in April and May and are caused by melting of the snow cover and thawing of the ground.

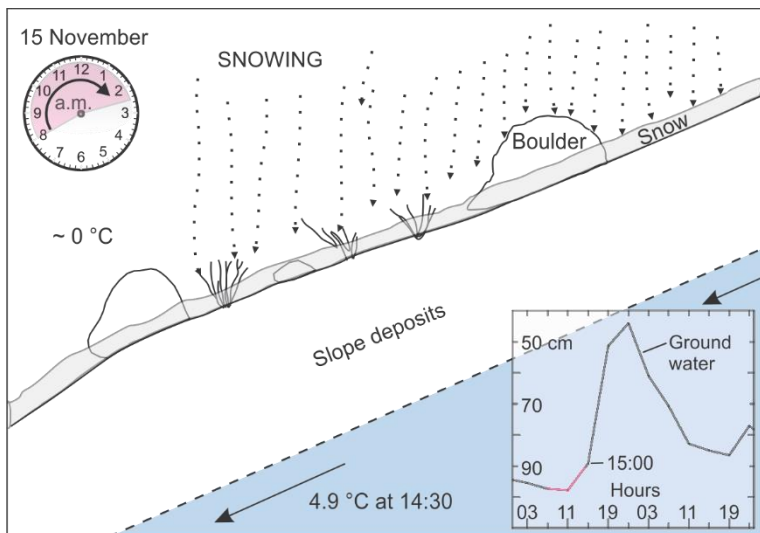
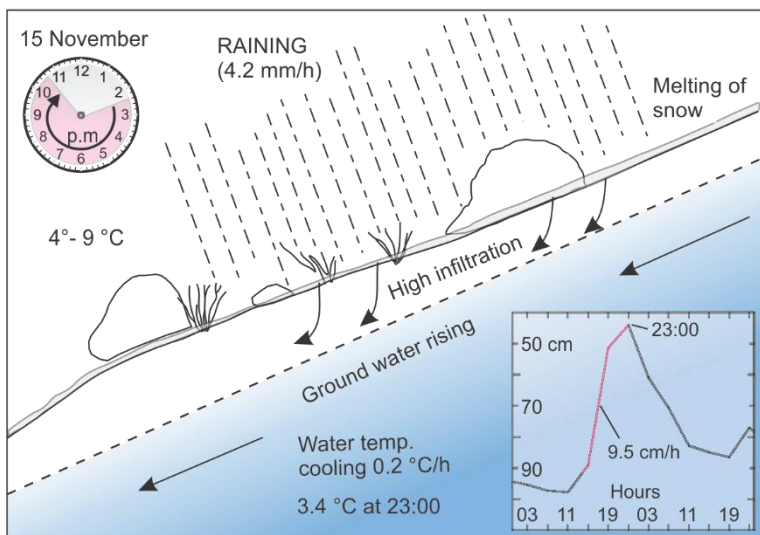
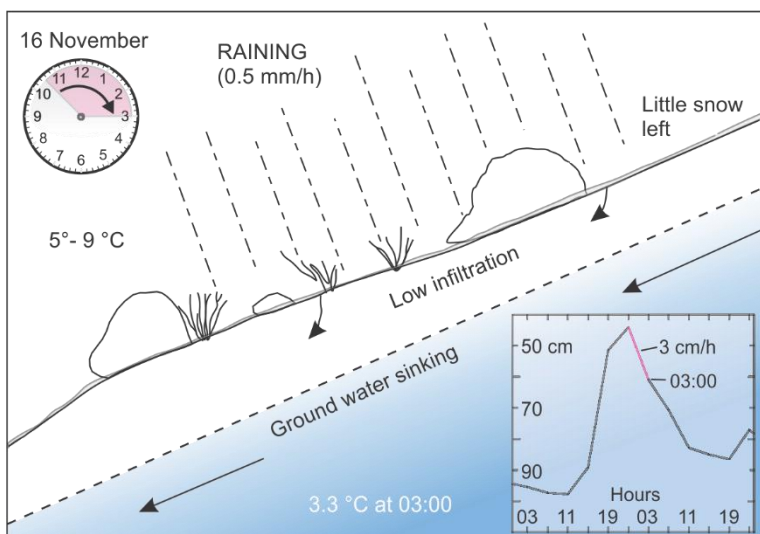
Figure 10: Diagrams to explain the situation on the hillslope during storm Hilde on 15–16 November 2013. The purple
305 **section of the clock and purple segment of the groundwater curve in the graph in the lower right corner show the time.**
Upper panel: Between 08:00 and 14:30, air temperatures were close to 0° C and the precipitation fell as snow.
Groundwater level was stable (graph in lower right corner). Middle panel: Between 14:30 and 22:30, the air
temperature rose to 9 ° C, it rained 4.2 mm/h, groundwater level rose by 9.5 cm/h and groundwater temperatures
dropped by 1.6 ° C. Lower panel: After 22:30, the heavy rain ceased and the groundwater dropped by 3 cm/h.

250 The groundwater level in the hillslope continued to rise as long as the infiltration rate was higher than the downslope discharge of groundwater (Fig. 10, middle panel). The heavy rain ceased at 22:30, and after 23:00 the groundwater level fell by 3 cm/h (Fig. 10, lower panel). The groundwater level was still rising just after 19:00, so the peak itself must have been
