Sources and pathways of biocides and their transformation products in urban stormwater infrastructure of a 2_{ha} urban district

Felicia Linke^{1, 3}, Oliver Olsson², Frank Preusser³, Klaus Kümmerer², Lena Schnarr², Marcus Bork¹, Jens Lange¹

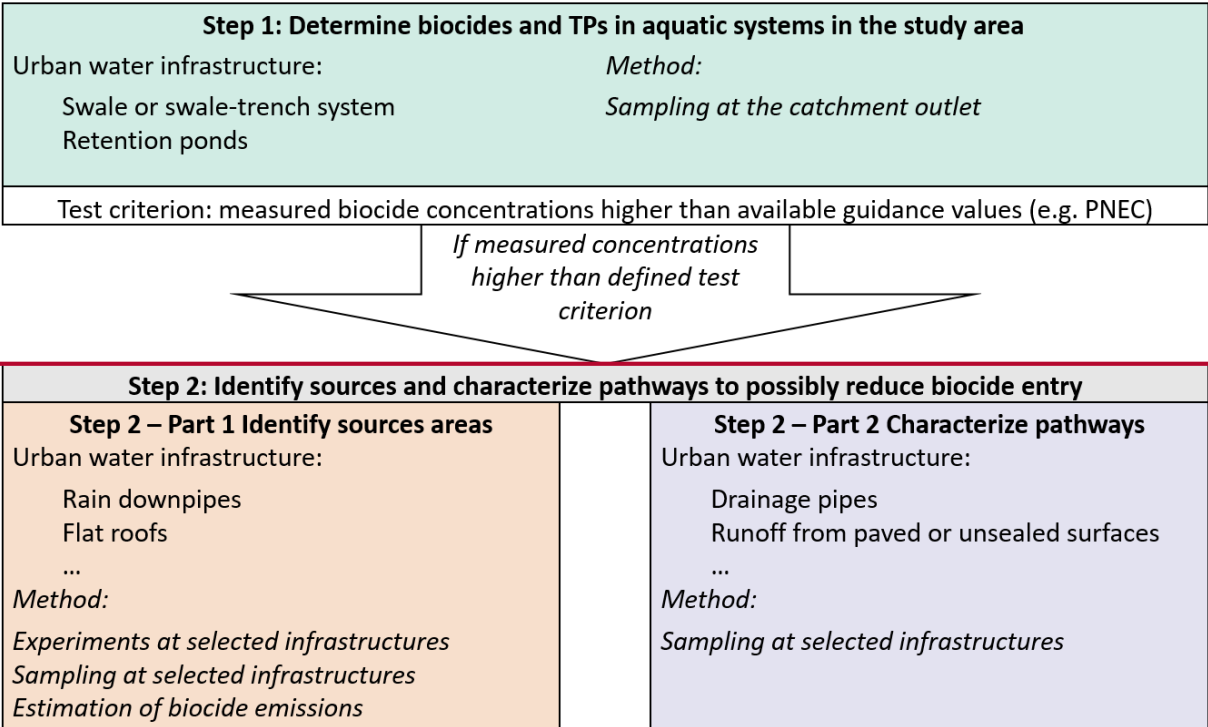
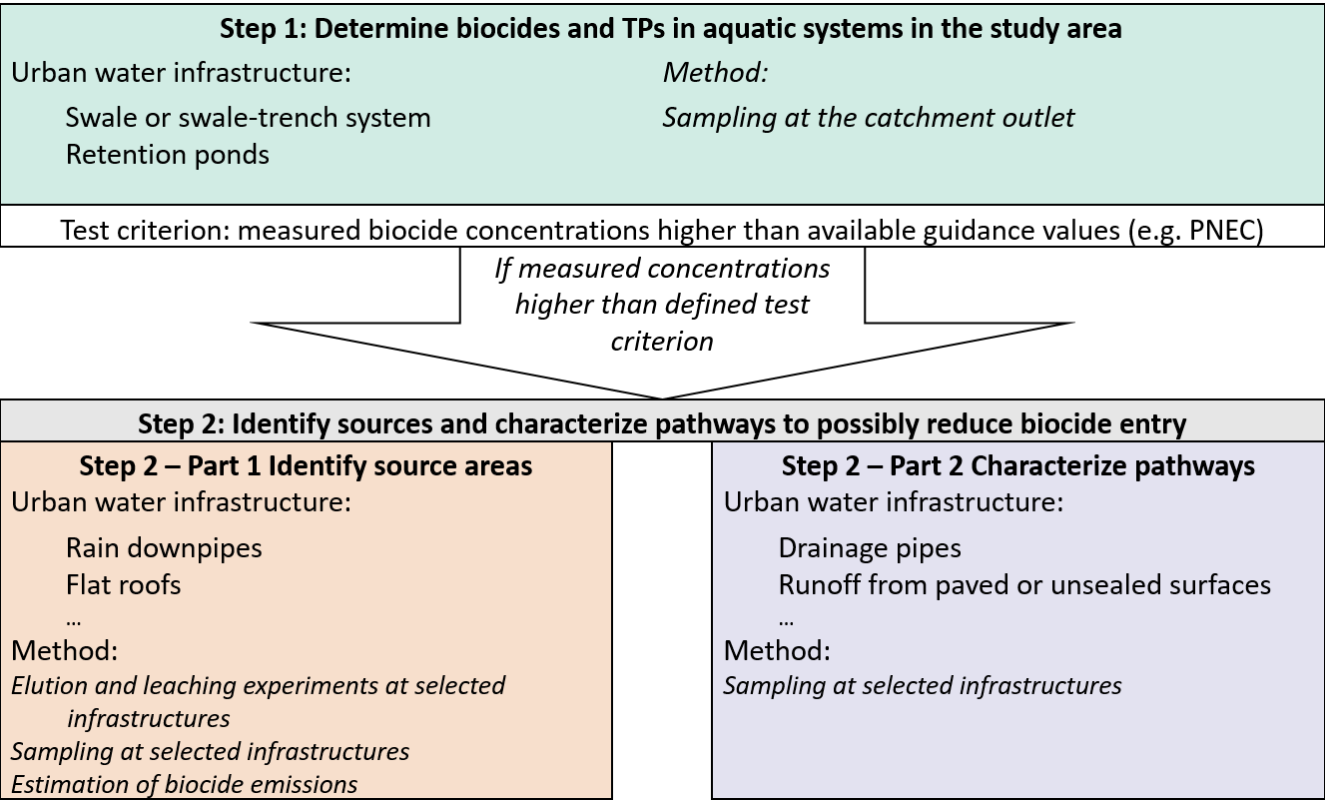
Figure 1: Two-step approach focusing on urban water infrastructure.

We developed a two-step approach utilizing existing urban water infrastructure (Fig. 1). This was done to first check the relevance of biocide emission in the study area and then investigate sources and entry pathways. In a first step, we verified the occurrence of terbutryn, diuron and OIT and their TPs (diuron-desmethyl, terbuthylazin-2-hydroxy, terbutryn-desethyl and terbumeton) in urban aquatic systems and therefore the potential of biocide leaching from building materials by sampling in a selected urban water infrastructure at the outlet of the study area. If the determined concentrations were higher than the available guidance values (e.g. Measured Environmental Concentrations/ Predicted no Effect Concentrations (MEC/PNEC) >1) there is a risk and thus a relevance to take further measures for risk mitigation. In this study, MEC/PNEC was chosen. If this criterion is fulfilled, Step 2 is carried out to identify sources and pathways of selected biocides and their TPs. Finally, this knowledge may guide measures to mitigate biocide pollution.

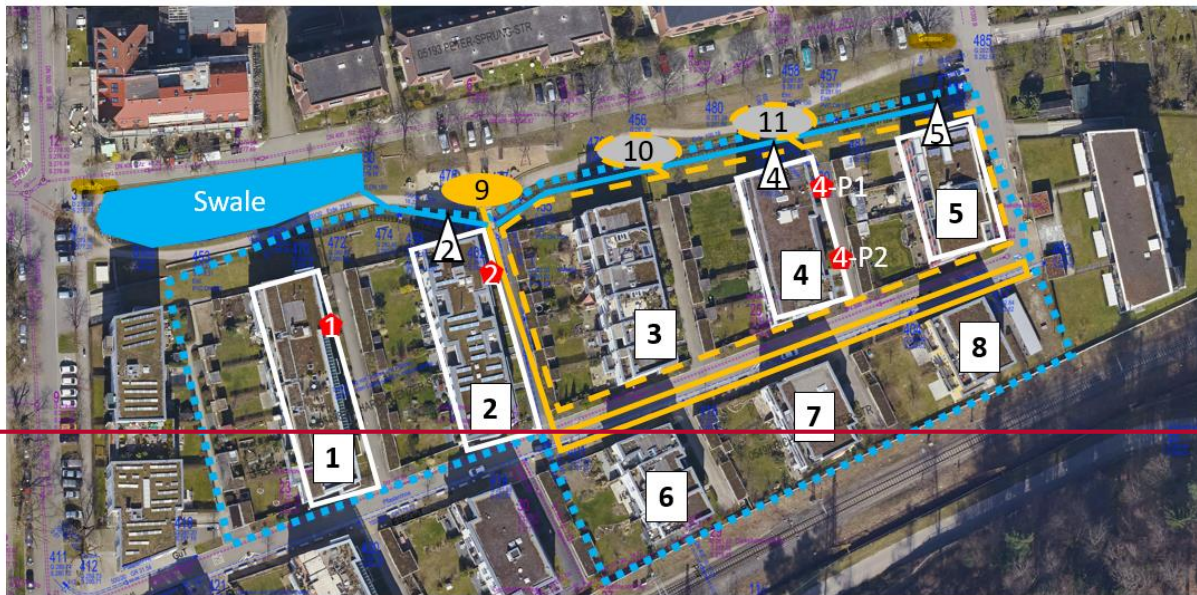
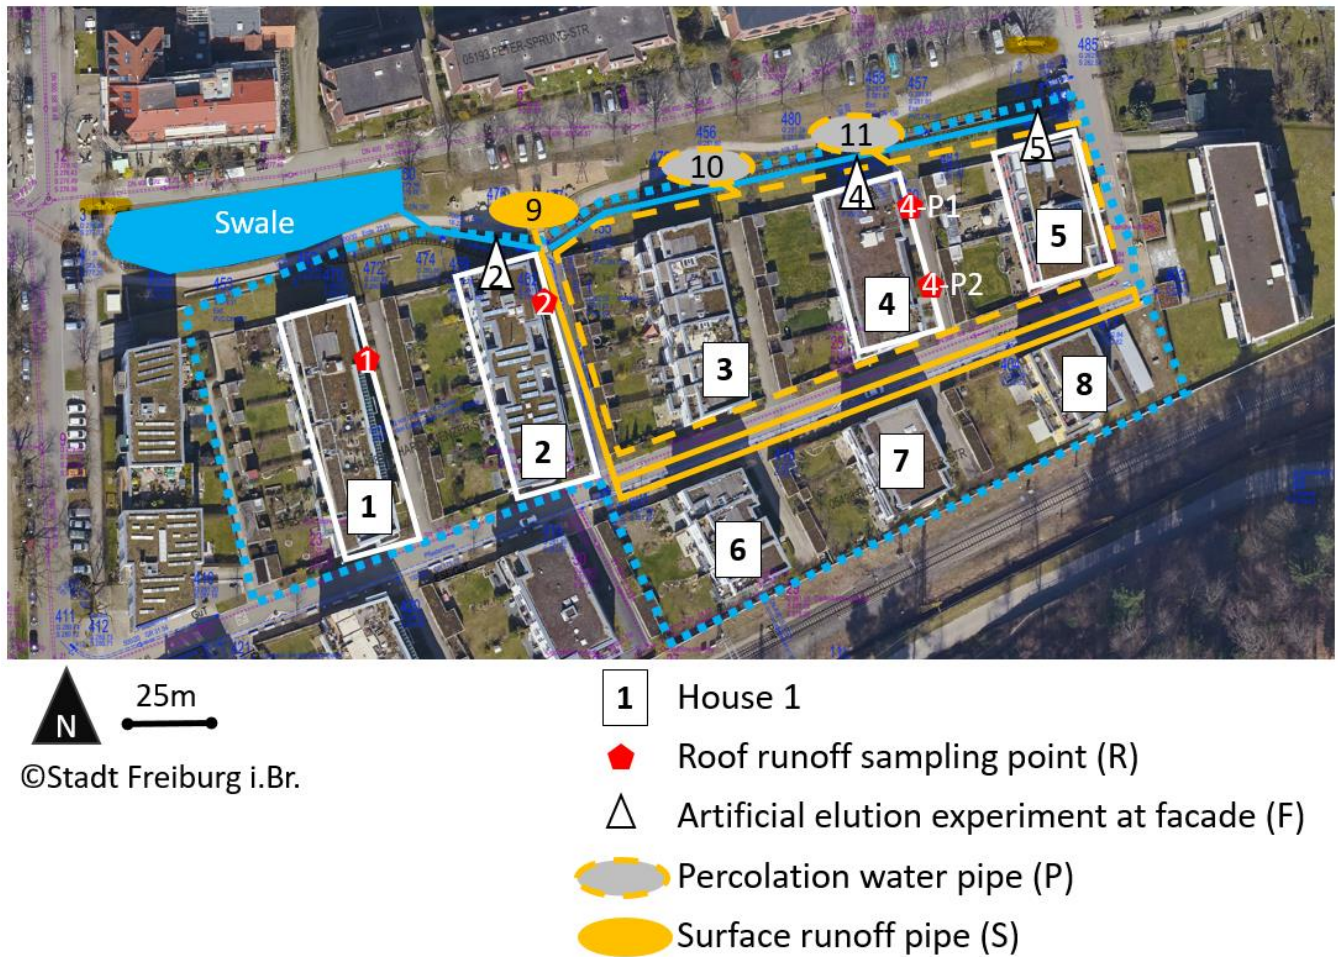
Figure 2: Study area with sampling points and houses, aerial view. White lines indicate investigated houses. The blue dotted line encloses the drainage area connected to the swale. Yellow and dashed yellow lines enclose approximate areas connected to percolation water pipes and surface water-runoff pipe. Source: Stadt Freiburg i.Br.

The study area consists of eight houses connected to a separated sewer system that ends up in a swale that is dry during dry weather (Fig. 2). The focus of the sampling campaign was on four houses (1, 2, 4 and 5) and on surface runoff from a
140 neighboring street that accepts water from three additional houses (6, 7 and 8). Footprints of buildings vary from 624 to 214 m² (houses 1 to 8) with an approximate height of 13 m. Estimated facade areas covered by paints and renders are 634 m² to 296 m² for houses 1 to 8 (see Table A1). All houses were constructed at the same time and thus exposed to identical weather

We placed our sampling sites along assumed biocide source areas and pathways (Fig. 3). Names of sampling points correspond to house numbers. Assumed sources were **facades** of buildings (**F**) and roof areas. Storm water from roof areas drains into rain
150 downpipes. These rain downpipes were sampled at three individual houses (**roof runoff sampling points, R**). Water from rainwater downpipes flows via paved gutters into a small grass-covered trench along the houses. This trench leads into the swale system. Surface runoff of a neighboring street is diverted by an underground pipe and drains into the same trench. Water samples were taken at this pipe (**surface ~~water~~-runoff pipe, S**).

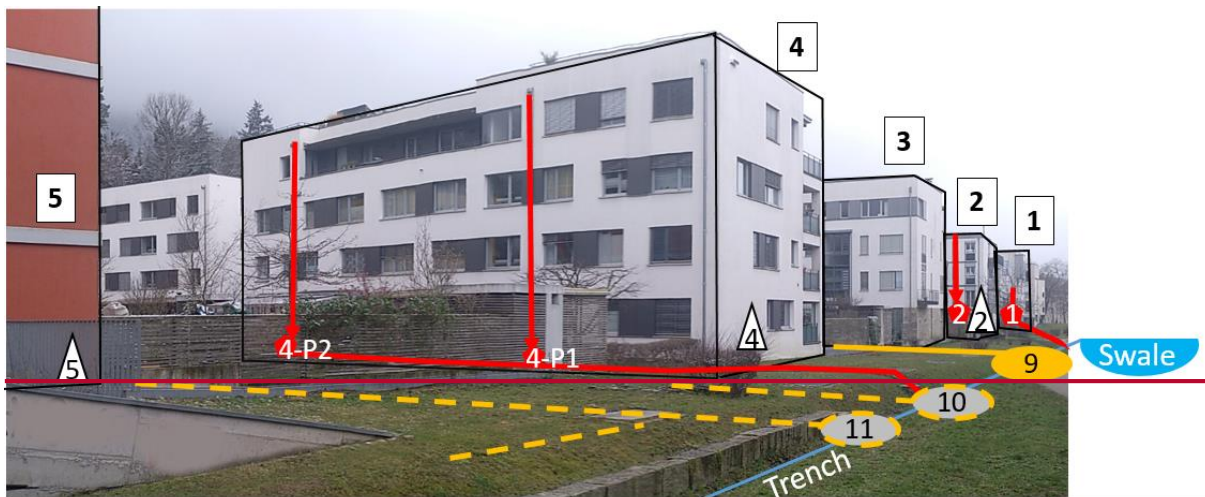
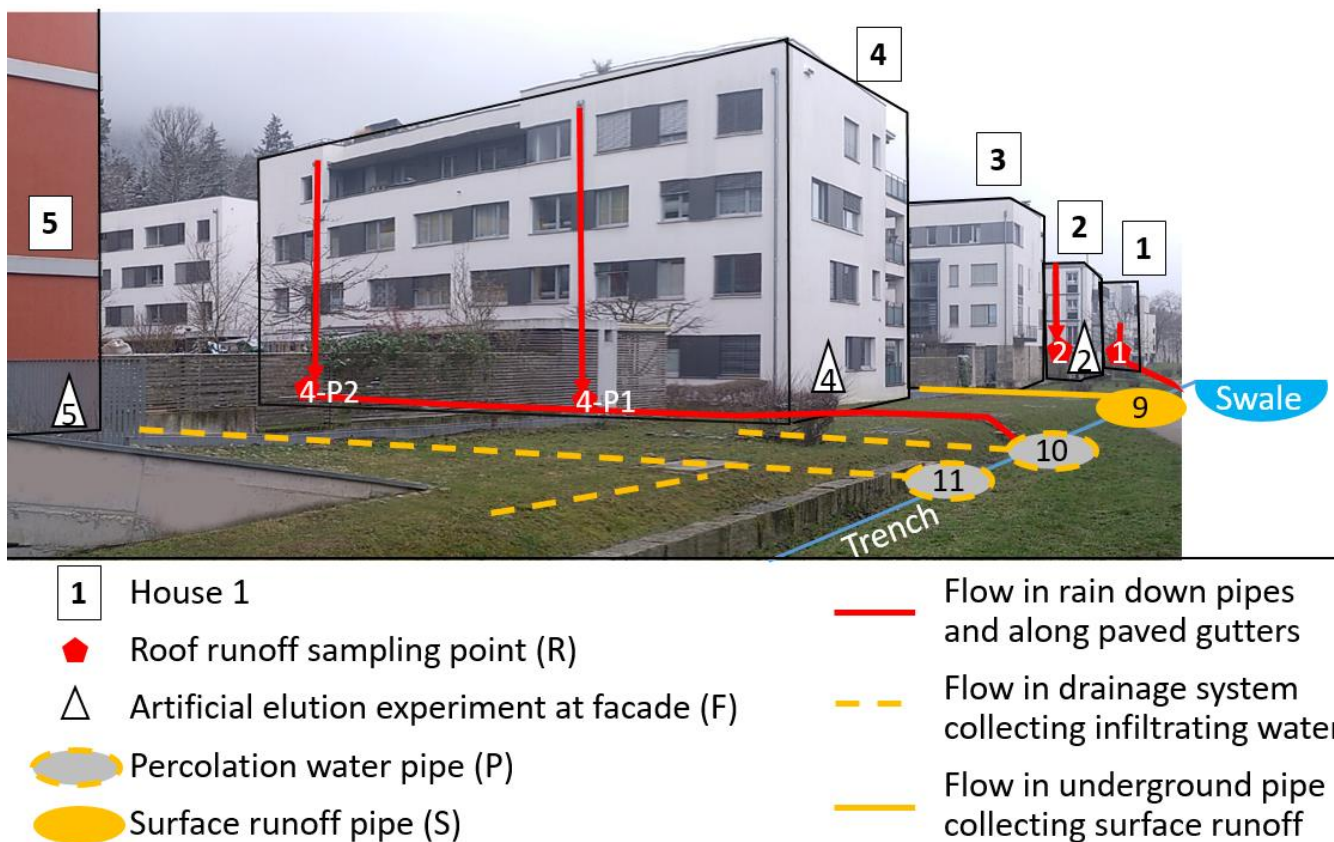
170 **Figure 3: Side view of storm water management infrastructure and sampling points.**

A special feature of the study area is the possibility to collect water samples after soil passage. A drainage system above an underground parking garage located beneath houses 3 to 5 collects all water infiltrating from gardens and green areas surrounding the houses including facade runoff. The soil consists of a 10 - 20 cm topsoil layer covered with grass. Beneath, the soil is composed of expanded clay aggregates to reduce the weight on the underground parking garage. At regular distances, there are pipe outlets of this drainage system directing water to the small trench at the northern site of the study area. The material of these pipes is polyvinyl chloride. Two of these pipes, hereafter referred to as **percolation water pipes (P)**, were selected for sampling, P10 and P11. Both pipes represent the surrounding area of a house with all the infiltrating water.

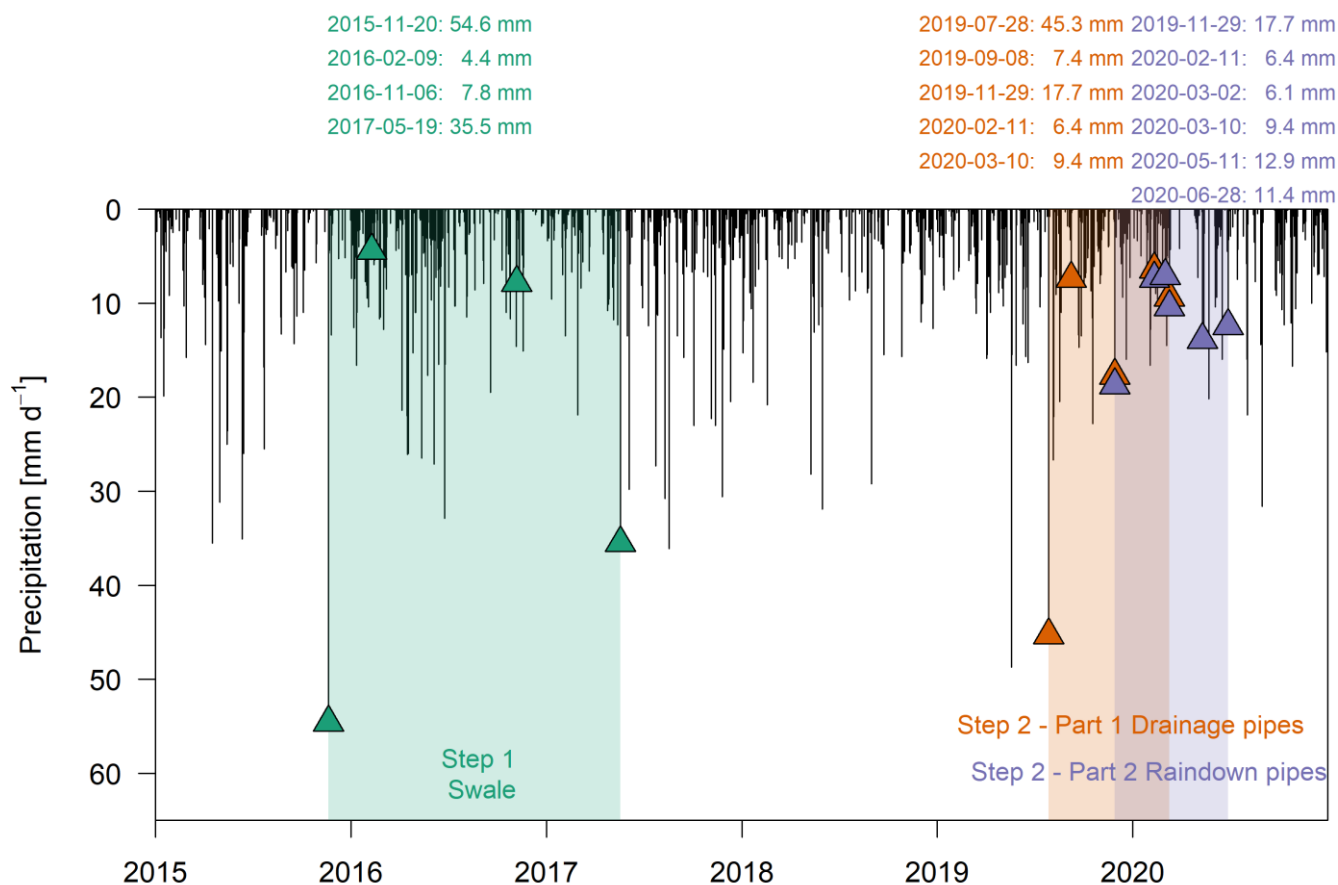
Figure 4: Daily precipitation about 5 km away from study site between 2015 and 2020. Sampled events are marked according to the two-step approach. Colors correspond to the steps of the experimental procedure and sampling sites. Precipitation data taken from Deutscher Wetterdienst, Station Freiburg.

Fig. 4 shows daily precipitation at a climate station about 5 km away from the study area and the time of sampling in swale, at drainage pipes and at rain downpipes. Daily rainfall ranged between 0 mm and 54.6 mm. The first swale sample was collected shortly after the highest rainfall in the six-year monitoring period. We determined the representativeness of the sampled rain events by comparisons to a 30-year period of rainfall data.

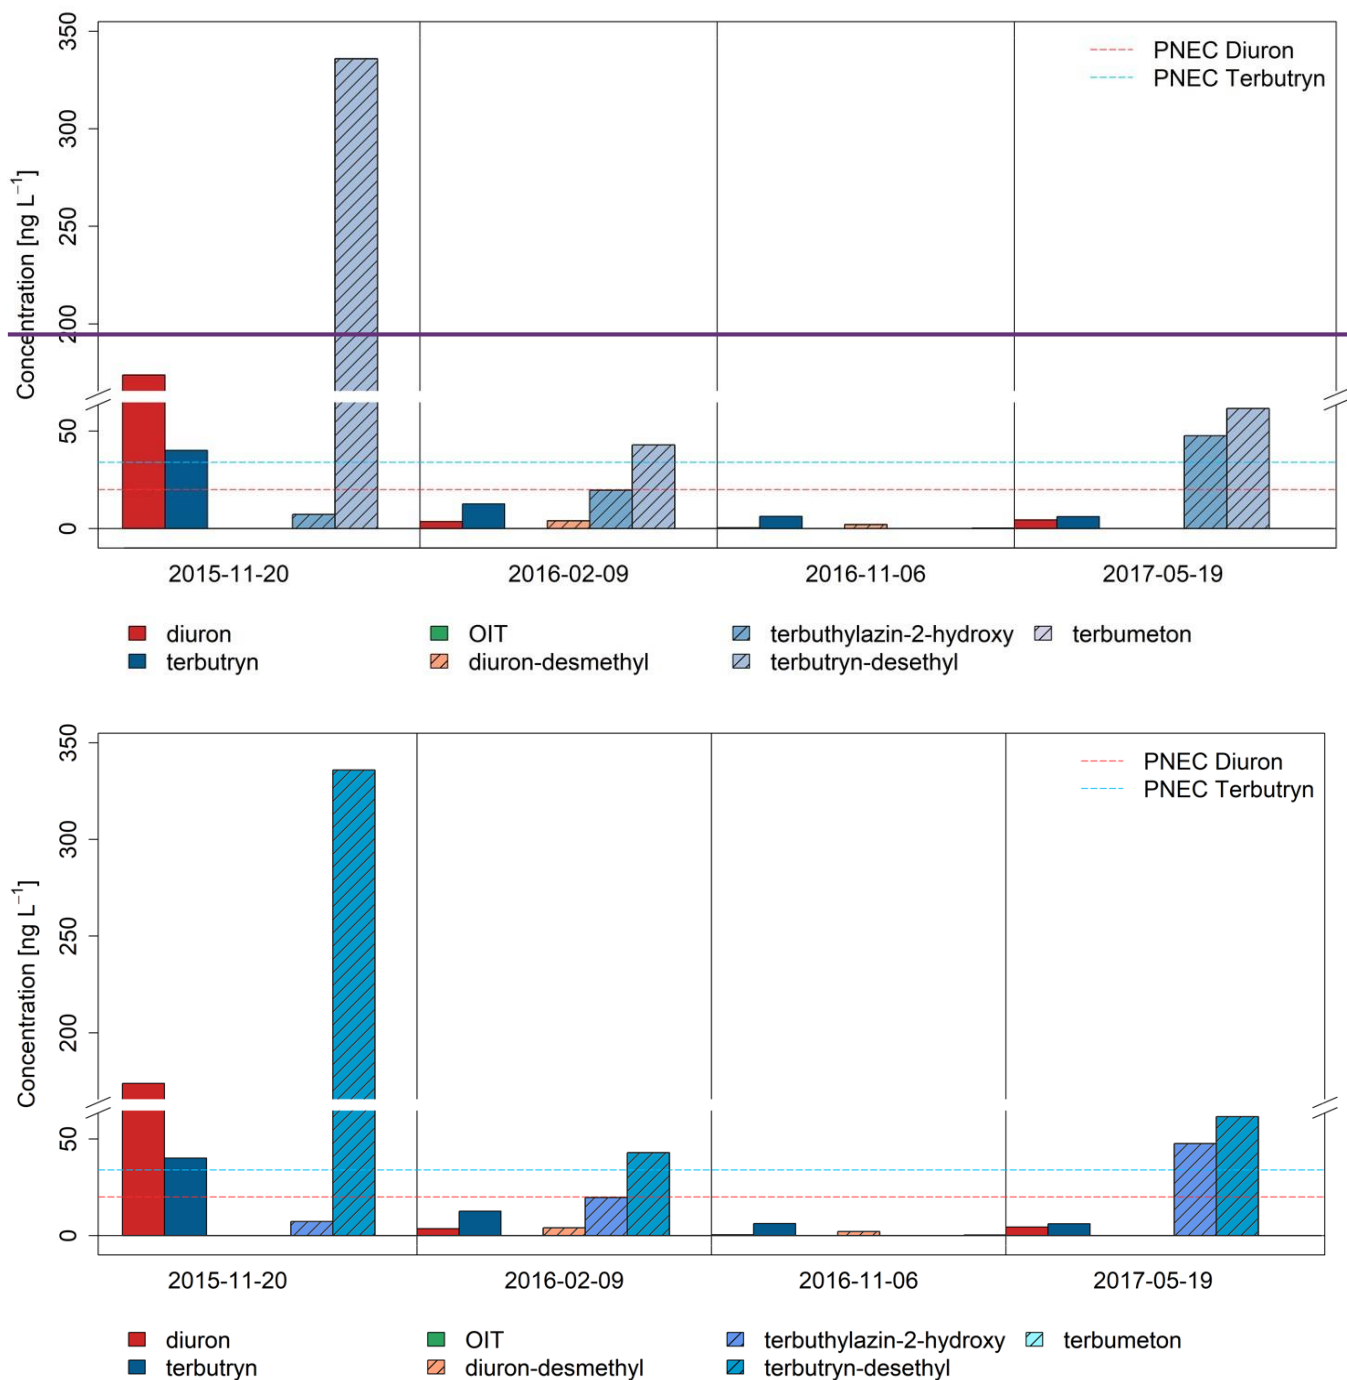
325 **Figure 5: Concentrations of monitored biocides of standing water in the swale during four events.**

~~Our Data~~ data suggested ~~suggests~~ that biocides emission ~~was~~ are relevant in the investigated district, since measured concentrations of terbutryn and diuron exceeded PNEC values (Fig. 5). Terbutryn and diuron were detected during all four events when standing water in the swale was sampled. Maximum concentrations in the first event (0.04 µg L⁻¹ terbutryn, 0.17 µg L⁻¹ diuron) exceeded PNEC values of surface water (0.034 µg L⁻¹ for terbutryn and 0.02 µg L⁻¹ for diuron). OIT was not detected in the swale. These concentrations were within the range found in other studies of urban storm water. Reported concentrations of terbutryn ranged between <10 and 360 ng L⁻¹ in storm water channels of a separated sewer system in the city of Berlin, Germany (Wicke et al., 2015). In the same study, diuron showed maximum concentrations of up to 0.6 µg L⁻¹ and OIT up to 60 ng L⁻¹. Gasperi et al., 2013 analyzed storm water at the outlet of three catchments in Paris, Nantes and near Lyon. Mean concentrations were 2 µg L⁻¹ for diuron and OIT concentrations remained below 4 ng L⁻¹. There, diuron showed maxima up to 0.6 µg L⁻¹ and OIT up to 60 ng L⁻¹, while 2 µg L⁻¹ was found for diuron and OIT concentrations remained below 4 ng L⁻¹

The TPs terbuthylazin-2-hydroxy and terbutryn-desethyl were detected in samples of the first two and the fourth event, diuron-desmethyl in samples of the second and third event. Terbumeton was detected only during the third event at very low concentrations of 0.25 ng L⁻¹. Diuron-desmethyl concentrations ranged between 0.2 and 4 ng L⁻¹, terbuthylazin-2-hydroxy between 8 and 48 ng L⁻¹, and terbutryn-desethyl between 43 and 335 ng L⁻¹. Hensen et al. (2018) found concentrations of up to 23 ng L⁻¹ for terbuthylazin-2-hydroxy, 73 ng L⁻¹ for terbutryn-desethyl and 2 ng L⁻¹ for ~~detect~~ diuron-desmethyl in a swale-trench system located 2.8 km southwest.

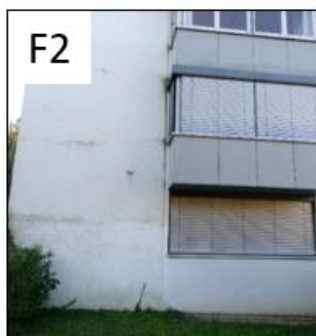
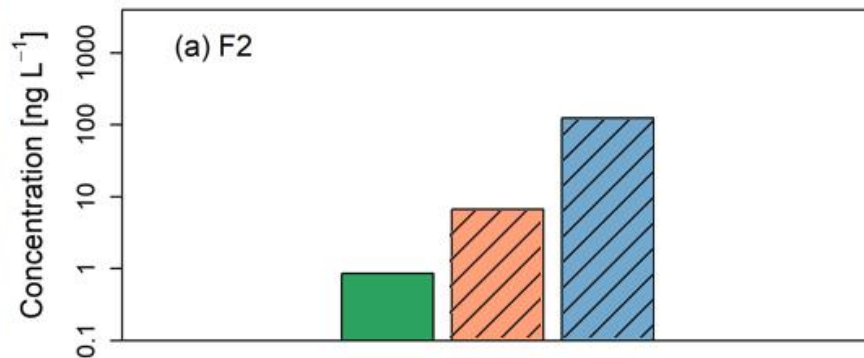
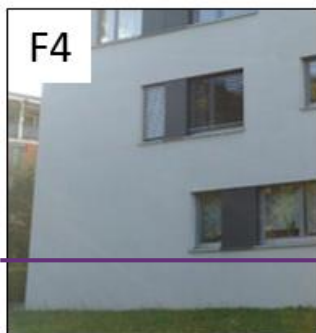
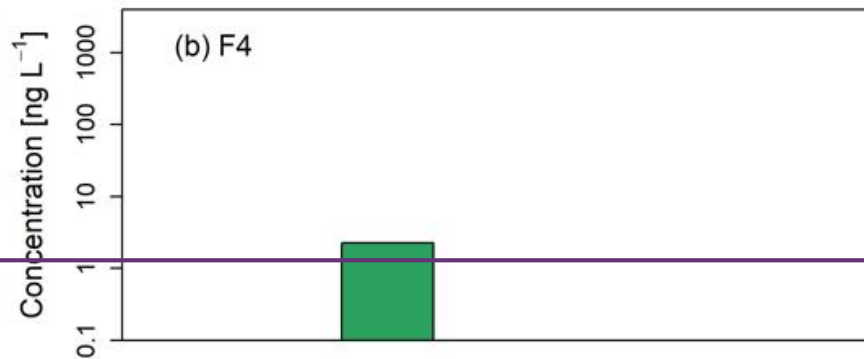
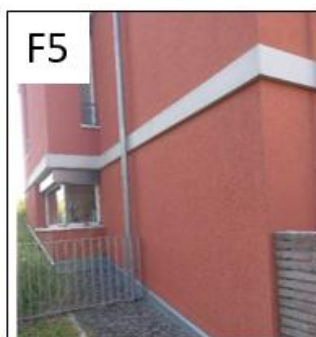
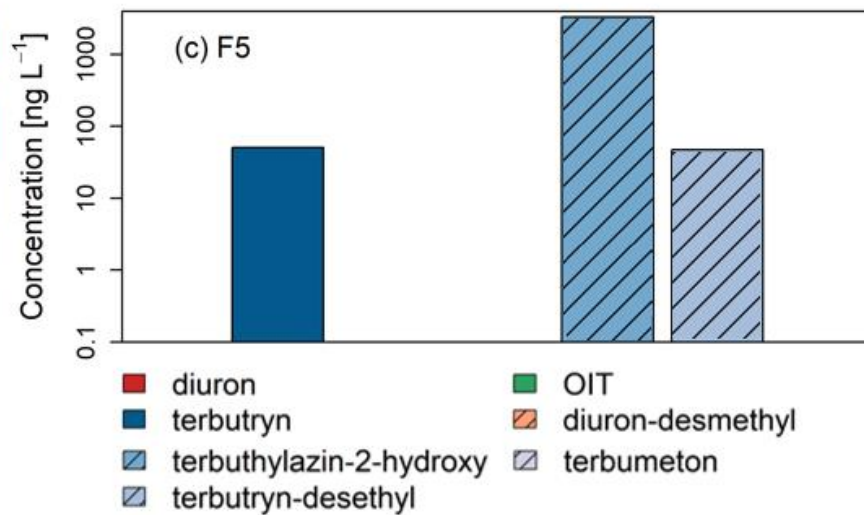
Figure 6: Photos of sampled facade sides and results of facade elution experiments at houses 2, 4 and 5.

Elution experiments at northwestern facades of houses 2, 4 and 5 showed different biocide composition of the wash off (Fig 6). We conducted the elution experiment twice at different parts of the facades and found similar concentrations in the obtained duplicates. Due to our simple experimental approach and missing information about initial biocide loads, we will focus on a qualitative evaluation of the results. Terbutryn was detected at one facade (F5), OIT at two (F2, F4), diuron not at all. Instead, diuron-desmethyl was detected at one facade (F2), which suggests *in-situ* photo transformation of the parent compound (Burkhardt et al., 2012). Terbuthylazin-2-hydroxy was found at two (F2, F4) facades, terbutryn-desethyl at one (F5), terbumeton at none. Both detected TP of terbutryn can be formed by photo transformation (Hensen et al., 2018). Detected TP and biocides imply the application of terbutryn at all facades, diuron only at facade F2 and OIT at facades F2 and F4. Substances below LOD might have been part of used renders or paints and may have been washed out or were not detected due to low concentrations. ~~and thus easier detection of TP~~ Additionally, biocides might still be present in deeper layers of the facade while degraded on the surface (Uhlig et al., 2019).

Although all houses were built at the same time, buildings show different color shades and sizes of protruding parts. Differences in detected TP at the individual facades might be due to different color shades although its influence is reported to be rather low (Bollmann et al., 2018). Urbanczyk et al.; (2019) found differences in pigments contained in paints and renders influencing formation of TP. Other factors influencing the differences in found TP can include local wind conditions, UV exposure (Paijens et al., 2019) and, most probably, differences in application of paint and renders. Terbutryn was only found at F5 which pointed to a different product used during construction also evident by different color and by very high concentrations of the TP terbuthylazin-2-hydroxy.

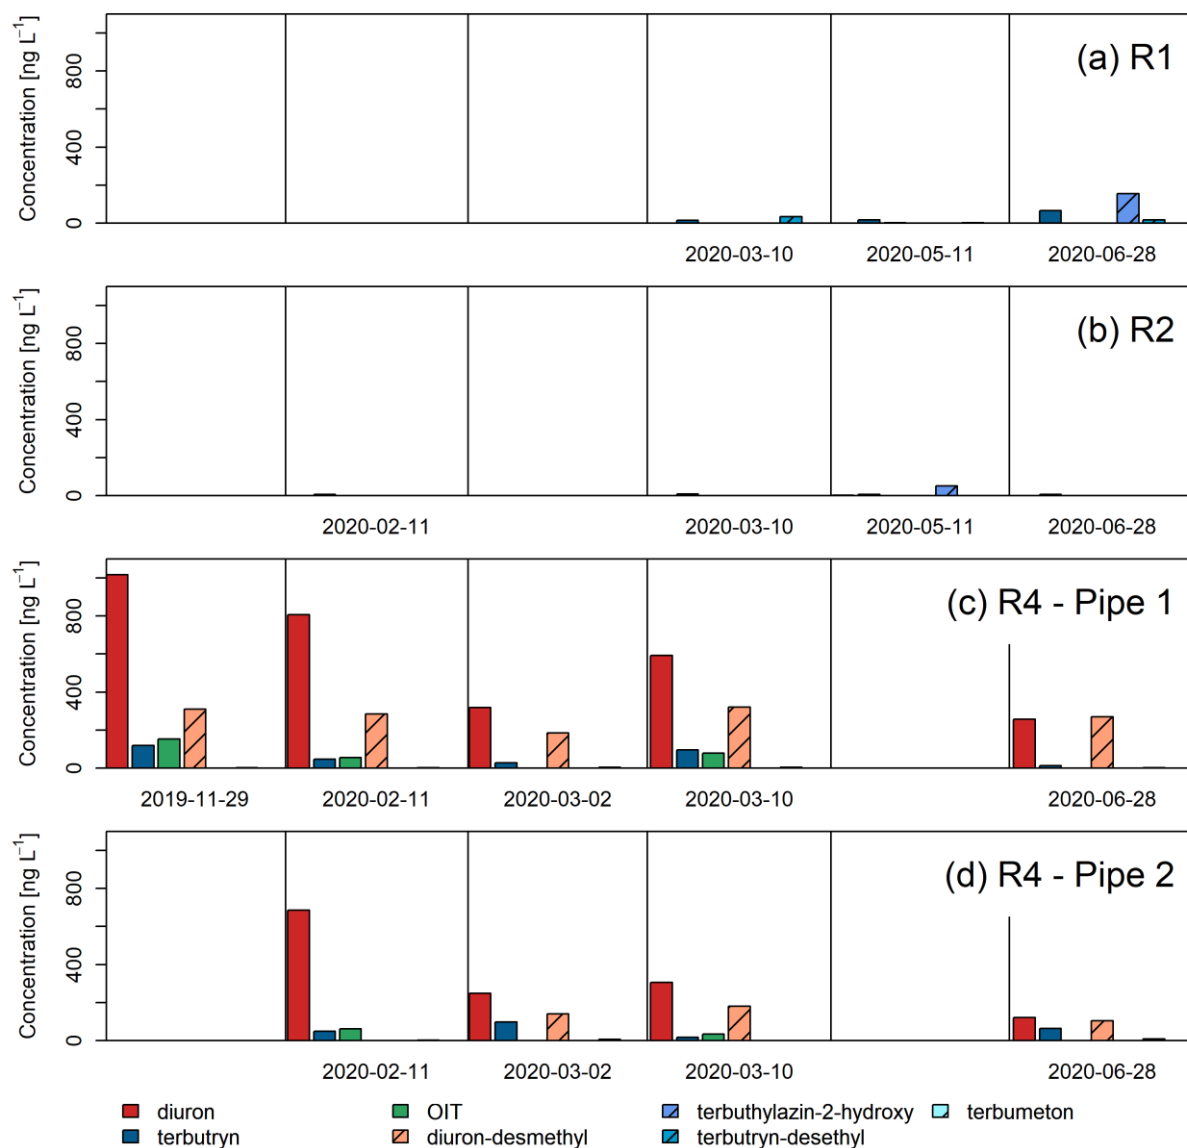
Figure 7: Sampled events in rain-water downpipes at three houses. Number after “R” refers to the number of the house. Non-sampled events shown without date.

In all rain downpipes, biocides were detected indicating the application of biocides on the flat roofs. However, concentrations of biocides and TPs largely differed between pipes and houses (Fig.7). Concentrations in pipe R4-P1 were high, as we did not expect roof areas as a biocide source. Concentrations at house 4 (R4-Pipe 1) exceeded those at houses 1 and 2 by an order of magnitude. We sampled an additional pipe at the same building (R4-P2) to exclude potential contamination in the first pipe. Both R4 pipes showed concentrations of a similar magnitude. For comparison, we decided to sample one pipe at another house (R2). To confirm the low concentrations, we sampled at a third building (R1). We then sampled multiple events at all pipes. Due to these high concentrations, we sampled an additional pipe (R4-Pipe 2) during following events. Both R4 pipes showed concentrations of a similar magnitude.

Concentration differences between houses can be attributed to different products used on different roofs, as previously discussed for the investigated facades (3.2.1). Additionally, houses differ in layout of their roofs (2.2) which might also lead to differences in biocide use and emission. Due to the limited number of investigated houses, general conclusions, if certain roof structures pose a higher risk for biocide emission than others cannot be drawn. Generally, biocides are used in roof sealants, treated tiles, roof paints and bitumen roofing membranes (Paijens et al., 2019). Terbutryn and OIT may be included

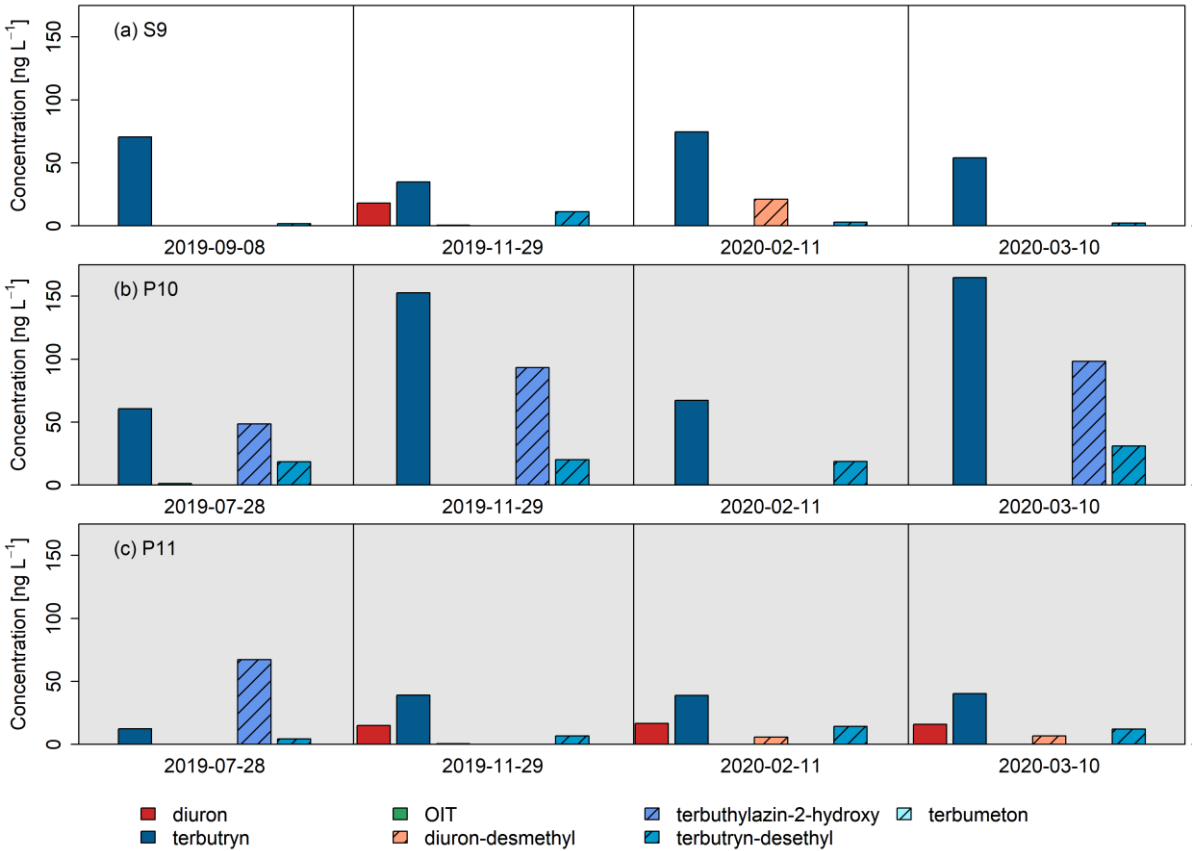
Figure 9: Samples in drainage pipes during four events. (a) Pipe S9 collects street runoff. (b) Pipes P10 and (c) P11 collect infiltrated water around the houses (percolation water).

The three investigated drainage pipes S9 (surface ~~water~~runoff), P10 and P11 (percolation water) are entry pathways for emitted biocides into the swale. Terbutryn was detected in all pipes during all four sampled events, while diuron was found in

percolation water pipe P11 during three and in surface ~~water-runoff~~ pipe S9 during one event (Fig. 9). As in the swale (Fig. 5), OIT was not detected at all, probably due to fast degradation in the soil passage (Bollmann et al., 2017b). OIT concentrations at the facades were very low (-Fig. 6), thus we did not expect to find OIT in the surface runoff pipe S9.

Detected biocides in percolation water pipes P10 and P11 were different probably due to different paints and renders used in the corresponding connected areas. The biocide concentrations of individual products may also vary (Sauer, 2017). Another reason might be a different dilution before reaching the outlet of the drainage pipe due to possible differences in the pipe system leading to the individual drainage pipe outlets. Additional sources may also affect the system, since infiltrated water from gardens and terraces around the building accumulates on top of the underground parking garage and reaches the drainage pipes. This could include biocides used on terraces or garden furniture, although inhabitants denied having used biocides. Diuron and terbutryn are authorized for use in coatings, which includes terraces or furniture coating (European Parliament and Council, 2013).

Diuron-desmethyl was detected only during one event in surface ~~runoff-water~~ pipe S9 and during two events in percolation water pipe P11. Concentrations of diuron-desmethyl were lower in P11 than in S9. This might be explained by higher dilution effects in the percolation water pipe P11 or by enhanced degradation during soil passage. Diuron-desmethyl is reported to be a photo TP that possibly can be formed by microorganisms in soil additionally (Hensen et al., 2018.).

TPs of terbutryn were detected in all pipes, although there was a difference between surface ~~water-runoff~~ and percolation water pipes regarding the number of detected terbutryn TPs. We detected terbutryn-desethyl in all three drainages during all events. The different appearance of the other two TPs of terbutryn implied different degradation processes in pipes S and P. Terbuthylazin-2-hydroxy was only found in percolation water pipes P10 and P11 (with soil passage) and not in S9 (without soil passage). This suggests preferred formation of terbuthylazin-2-hydroxy by biodegradation, although photo transformation could not be excluded, since both terbutryn TPs were already found at the sources (Fig. 5, 6). Concentrations in the swale were in a similar range, which suggests similar input concentrations and degradation processes. Terbumeton was not found in samples in the drainage pipes, though detected in the swale.

For terbutryn, concentrations of both the parent compound and its TPs were highest in percolation water pipe P10. Biochemical transformation in soil is important and TPs are obviously formed, our findings suggest that also the parent compound poses a risk to groundwater by diffuse infiltration of contaminated runoff from urban settings. Much less transformation of terbutryn takes place along surface pathways, represented by surface ~~water-runoff~~ pipe S9 where overall concentrations of TPs were smaller and terbuthylazin-2-hydroxy was not found.

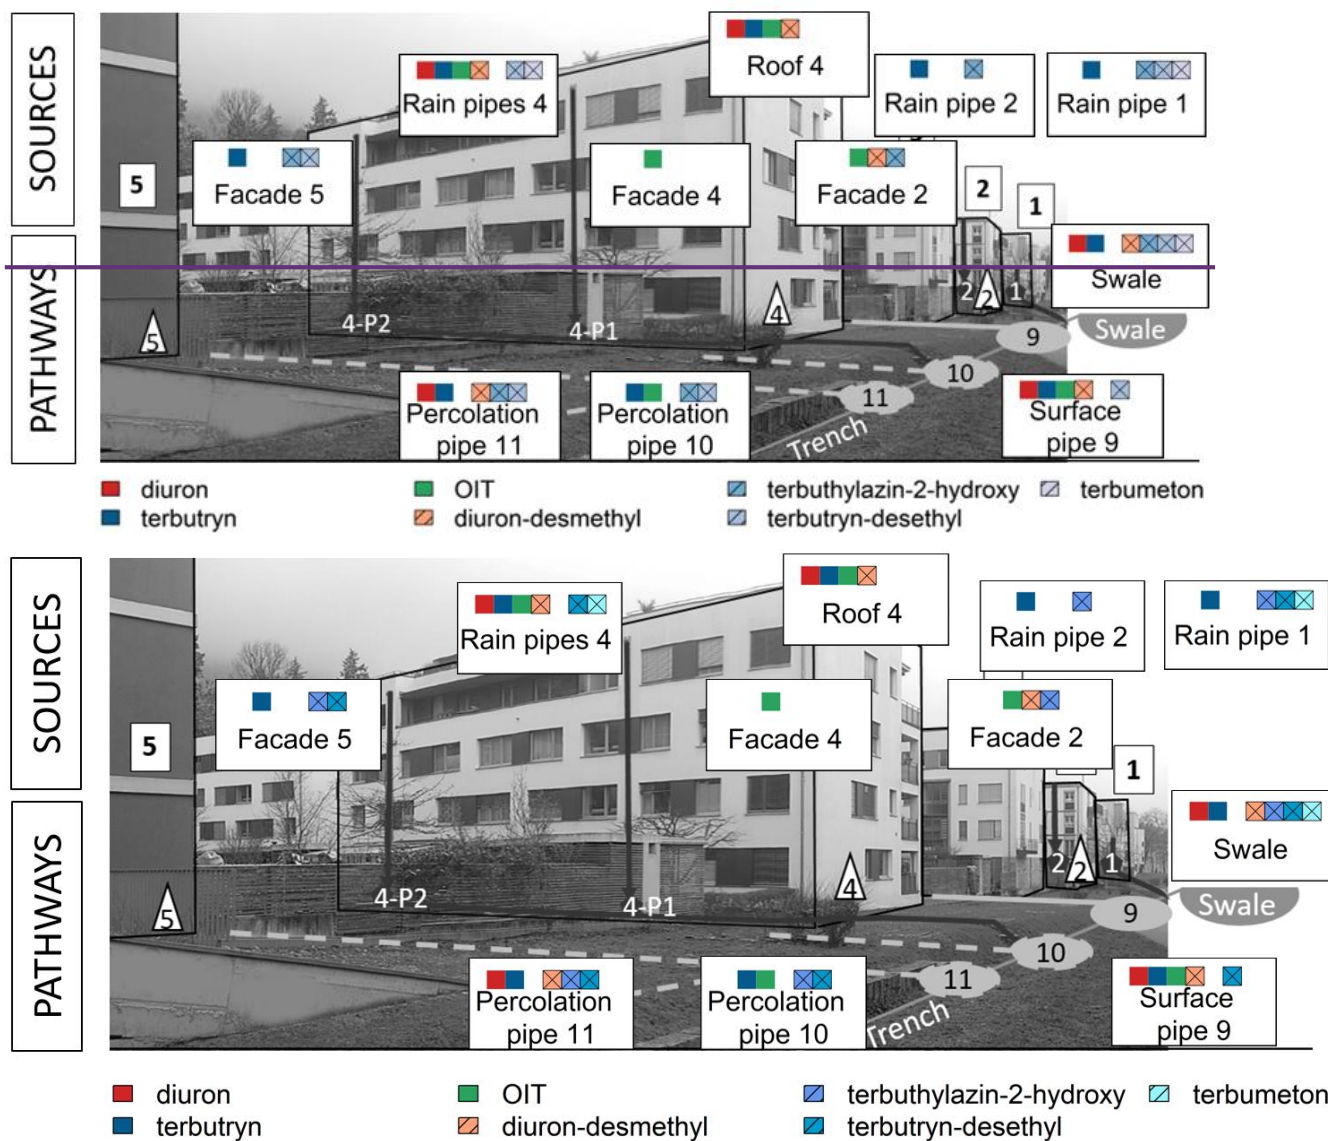
485 **Figure 10: Qualitative overview of biocides and their TPs in the investigated water infrastructures. Shown colors at sampling points represent detected substances. For legend of background picture, refer to Fig. 3.**

We also showed which infrastructure or area is important and should be considered for reducing the risk of biocide pollution. We identified sources both by sampling rainwater downpipes and by conducting artificial elution experiments. This might be an advantage when considering the transfer of our approach to other catchments due to an easy adaptation to existing buildings.
