Exposure of tourism development to salt karst hazards along the Jordanian Dead Sea shore

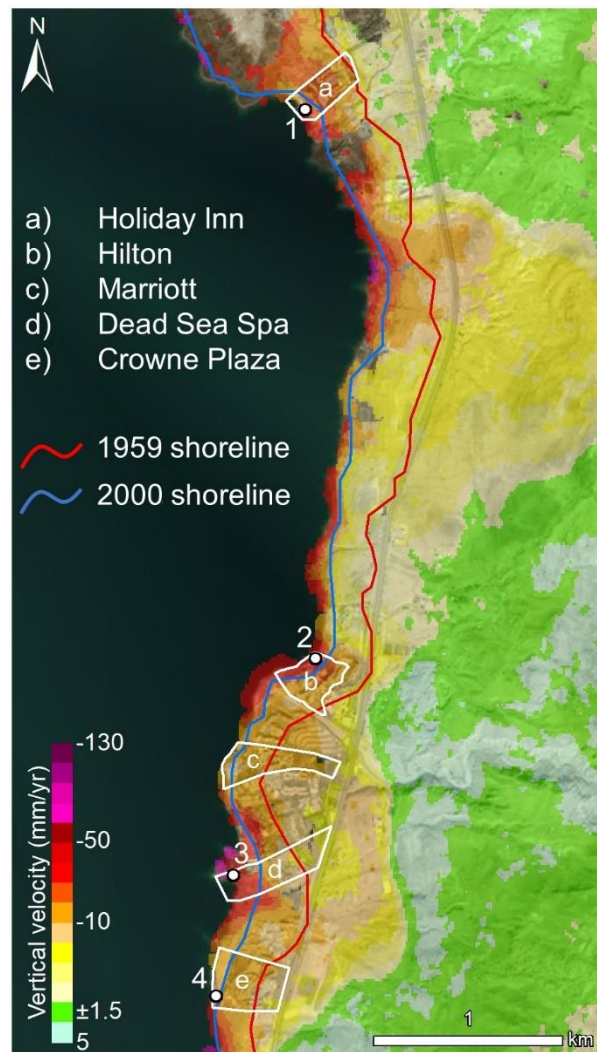
30   subsidence (red and purple areas). Highest subsidence velocities up to -130 mm/yr are found in seepage areas along the coastline and in the exposed muddy plains. The front beaches of the parcels A, B and D are the most affected, with velocities reaching -25 mm/yr, -36 mm/yr and -68 mm/yr. Examples of the displacement time-series extracted at the hotels' location

Figure 4. Vertical velocity map of the study area obtained from the SBAS processing of Sentinel-1A/B images. The white dots labelled with numbers are the points select to extract the displacement time-series presented in Fig. 5.

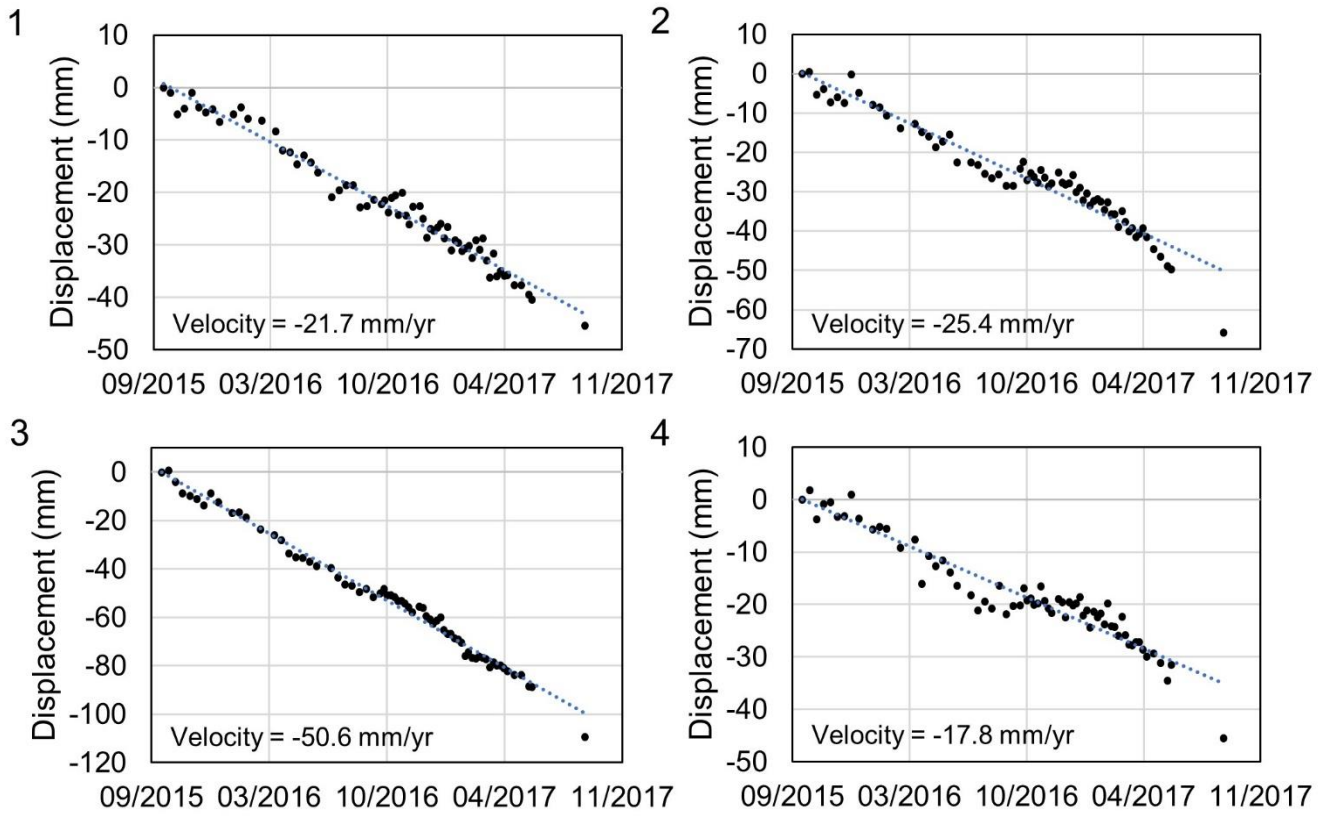
Figure 5. Displacement time-series of four points selected in the hotels' cadastral parcels.

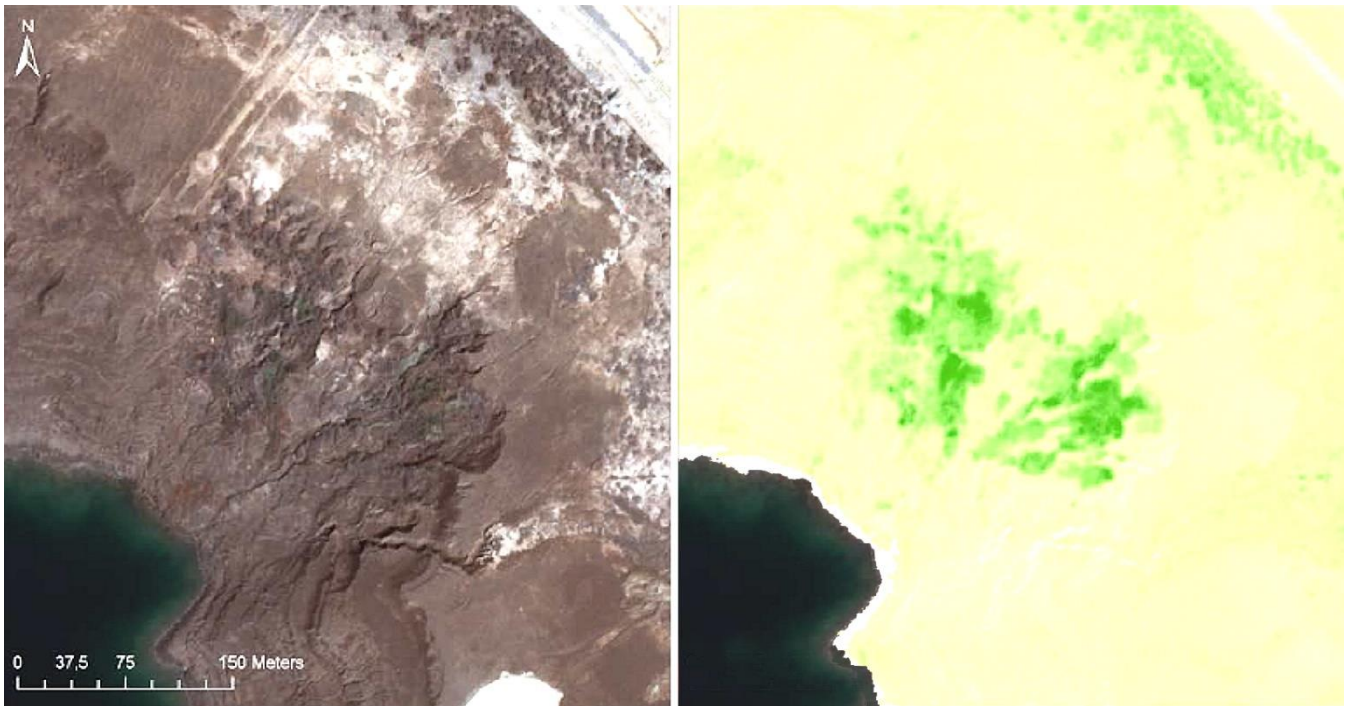
Figures 6 and 7 illustrate the contribution of the vegetation mapping to the identification of areas prone to landslides and sinkholes. Figure 6 displays side by side a major landslide observed with optical imagery and its equivalent using the NDVI index. The vegetation appears in green while the salty-mud is in yellow. The DS is in the lower left corner (dark in colour). The growth of Tamarix bushes at the landslide crown underlines the presence of seepage zones. Areas covered by reeds are
15   also found in the downstream sections of the landslide.

Figure 6. Comparison between optical and NDVI images over a landslide area. Left: optical image (RGB) showing a seepage area. The muddy sediments impregnated with water and salt (white patches) flowed towards the lake and created an amphitheatre. Right: in evidence the vegetation (green) that develops only near the springs.

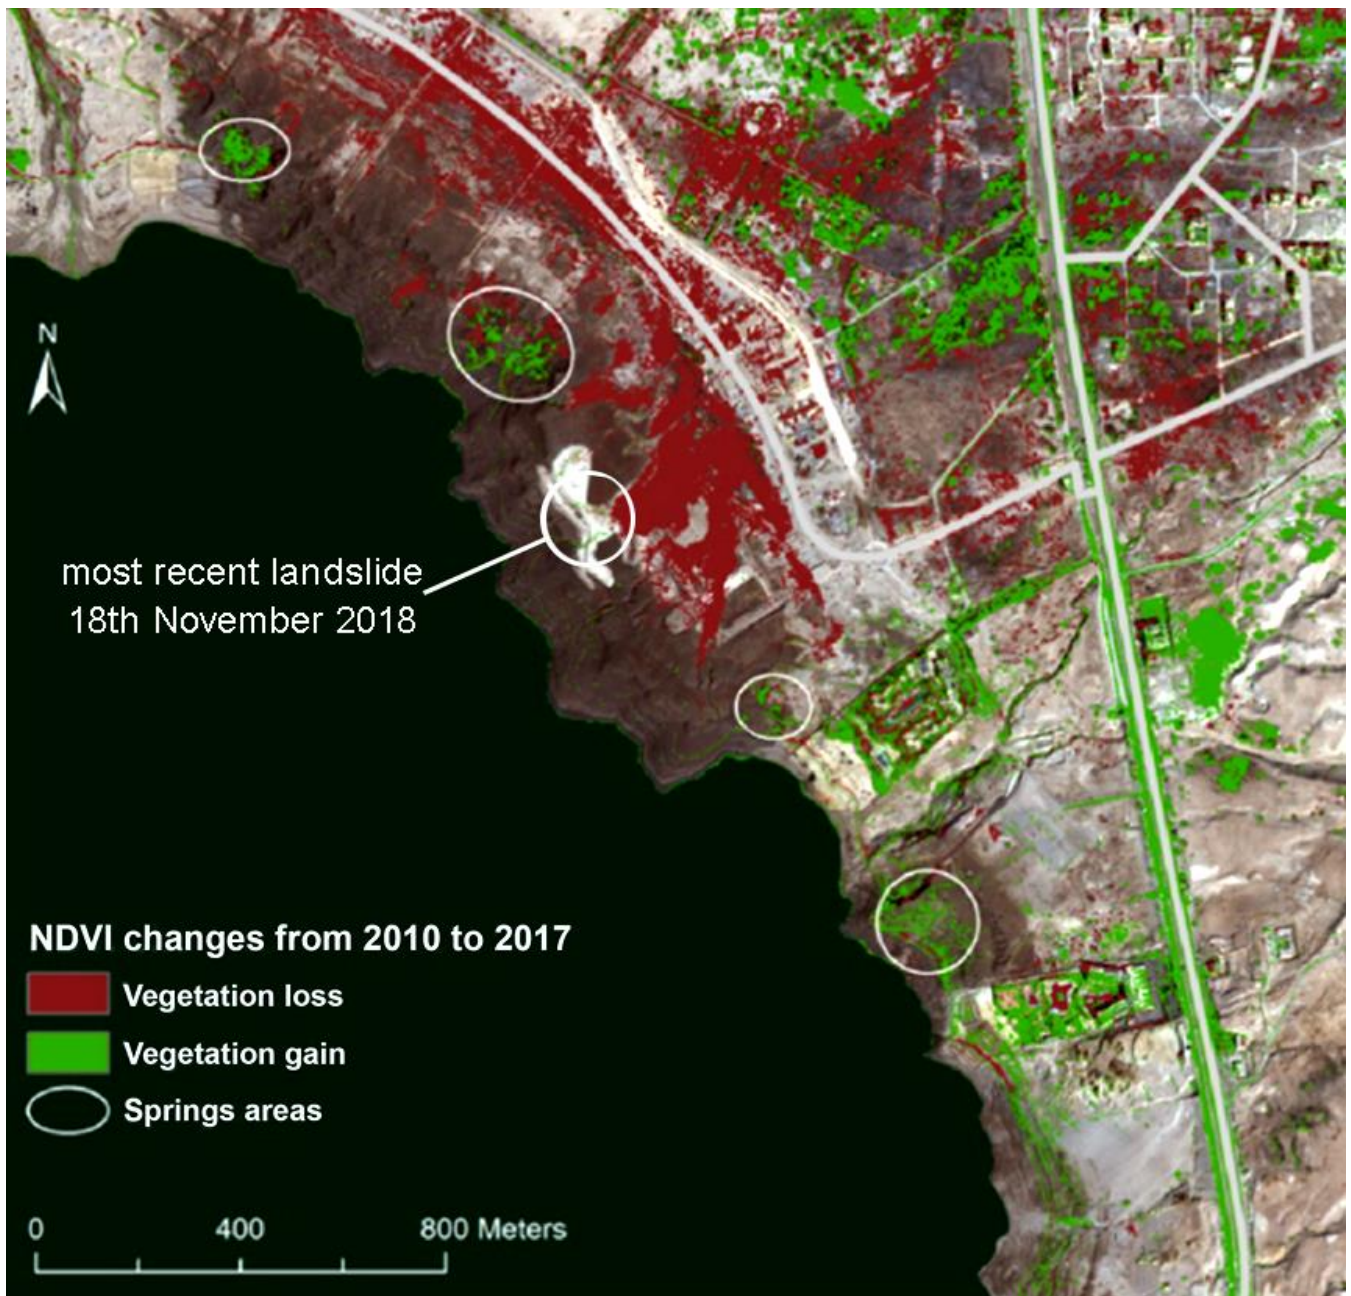
The largest part of the vegetation loss can be attributed to the development of tourism infrastructure while the vegetation gains to the presence of fresh/brackish water at or close to the surface. Four main zones with major vegetation development
30   where mudslides occurred have been observed in the study area (Fig. 7, white circles). The emergence of springs in the beachfront of the hotels could represent a substantial hazard for the stability of the ground and the infrastructure (Fig. 8c). Since early 2016, we observed two distinct places where reeds have developed in the Holiday Inn beachfront (Fig. 8d). These areas have been fenced off by the security engineers, as sinkholes developed some meters upstream.

Figure 7. Vegetation change detection map obtained from NDVI difference between 2010 and 2017 in the north-eastern part of the study area. The white circles highlight the areas along the coastline where new springs appeared in correspondence of vegetation gain.

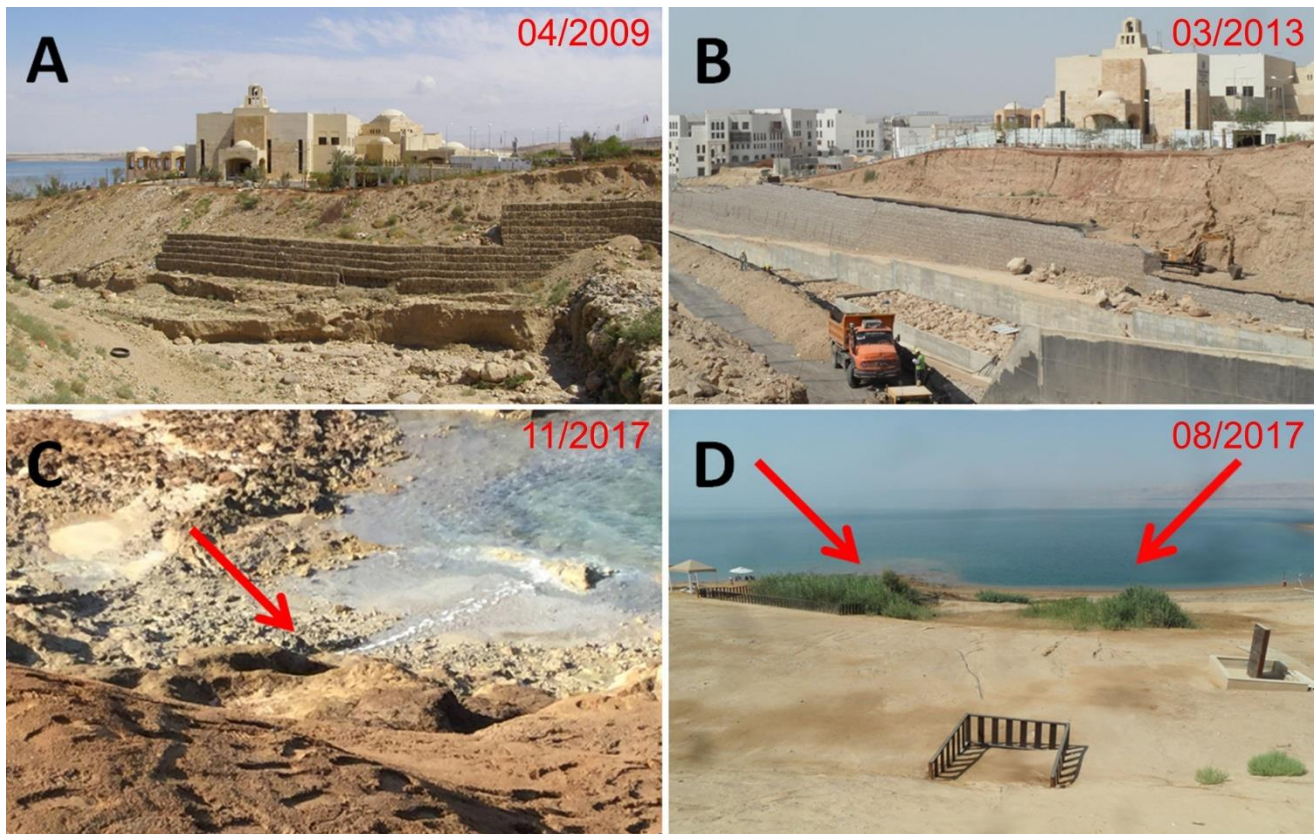
The King Hussein bin Talal convention centre, located between plots B and C (Fig. 4) is a 3-story building featuring 27 conference halls often used for winter World Economic and Scientific Forums, major exhibitions, conferences and meetings. The convention centre is capable of hosting up to several thousand participants at a time. The recent state of the centre and the repair works done in order to protect it are shown in Figs. 9a and b. Efforts seem to be focused on large scale engineering measures designed to attenuate the erosion effects of flash floods on the slopes. However, field evidence on the shorefront highlights the presence of water seepage, possibly coming from beneath the centre. In the medium term (years) and long term (decades), this water flow may increase the geological hazard of the area, which could be exposed to subsidence, sinkholes and landslides, as already occurred in the near coastal zones. As mentioned above, the presence of springs is one factor that may indicate the possible occurrence of ground instability. Figure 9d illustrates the growth of vegetation around such springs in the beachfront of the Holiday Inn. This area has been hit at least three times by hectometre-size landslides, in September 1999, May 2009, and August 2012.

Figure 9. The King Hussein bin Talal convention centre and surrounding areas. a and b: the river next to the conference centre is entrenching at the same pace as the DS level lowering. Frequent works are needed to stabilize the slopes in the area. c: groundwater flowing under the convention centre. d: when the flow path remains stable and the water is unsaturated with respect to salt, then vegetation can grow.

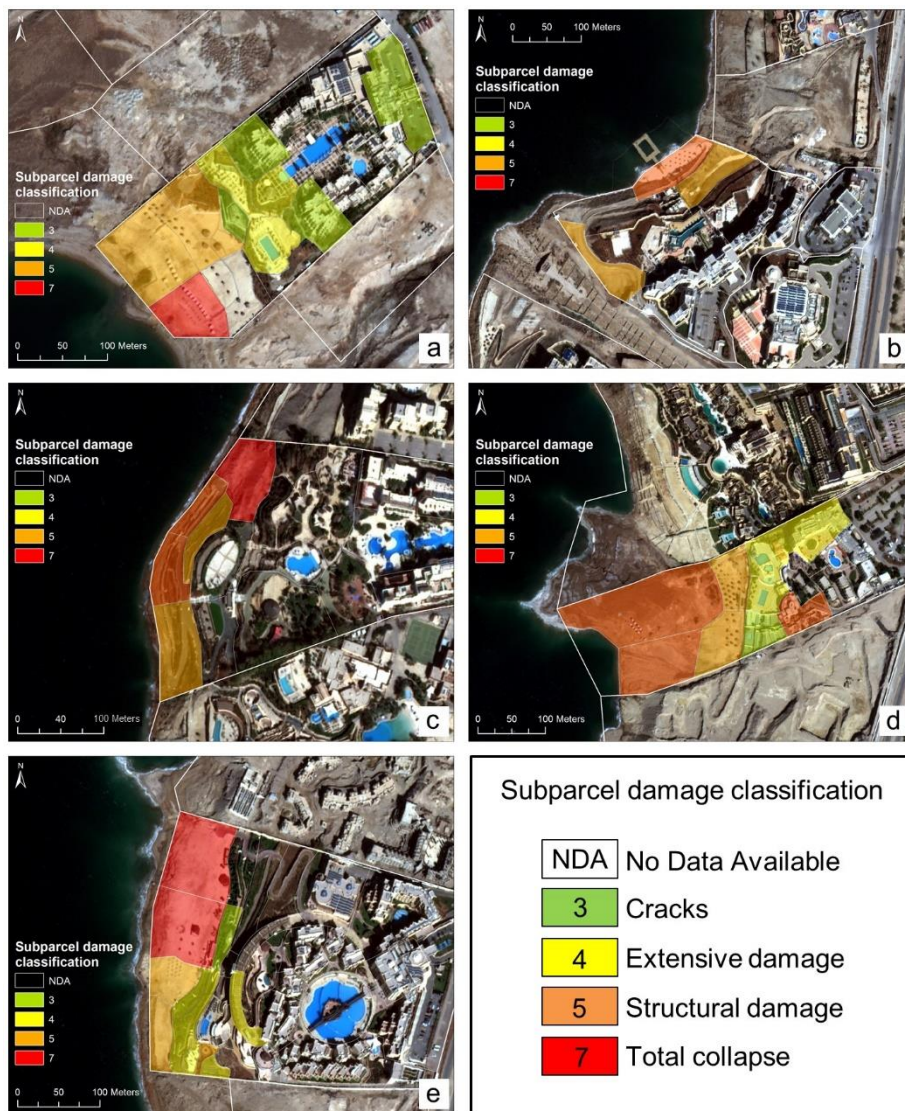
10   indicating increasing structural damage observed in each plot. In the Holiday Inn plot, during the 1960s, the shoreline was in the area now occupied by the main swimming pools. Therefore, most of the infrastructures developed over areas exposed in the last years, which are susceptible to geohazard exposure. The beach area (Fig. 4a) has been affected by landslides and sinkholes since 1999. Because the beach is constantly worked and repaired to offer tourists a pristine sandy beach, cracks are not clearly visible there. The red polygon corresponds to a landslide, while the orange one has fewer observable features.

15   Northwest of the orange zone, the beach is not affected by cosmetic work and fissures are apparent. Close to the shoreline, several springs of brackish water and areas covered by reeds are found. In the upstream part of the orange zone, the presence of sinkholes suggests groundwater circulation towards the springs. The part of the hotel next to the beach is marked by a large number of cracks in the pavements (yellow and orange polygons). Here the size of the cracks is smaller and their number lower in respect to the beach area. The main section of the hotel has no visible cracks, but the main entrance of the

20   building is subsiding with significant damage to the walls (in green).

The Hilton plot (Fig. 11b) is affected by geohazards on two sides. The beach area, in red, is directly exposed to a landslide which has its crown upstream, in orange. Similar to the Holiday Inn, the beach area is entirely covered with sand and regularly worked. During field surveys, cracks related to strong subsidence were evident. North of the plot, cracks were much more visible and extended hundreds of meters northwards, parallel to the shore. In this area, it appears that the whole

25   coastal zone is sliding. The obtained InSAR results confirmed these observations. The access road to the beach is located next to the landscaped Wadi Mukheris. This road shows important fissures that indirectly delineate the lack of stability of Wadi Mukheris' northern slope.

South of Wadi Mukheris, the Marriott plot (Fig. 11c) is strongly affected by recurrent landslides. The entire beach area is in red and/or orange, depending on the density and size of the damage. The red colour corresponds to active landslides, and the

30   orange colour indicates areas where engineers managed to stabilize hazardous ground. The exposed zone corresponds to the steepest part of Wadi Mukheris delta that has emerged with the decline of the DS water level.

The area of the Dead Sea Spa in its entirety (Fig. 11d) presents a high number of fissures. The beach area shows numerous cracks and is affected by sinkholes. Different parts of the plot are sliding towards the DS at different rates. The presence of

The beach of the Crowne Plaza Hotel (Fig. 11e) presents many cracks and springs of brackish water. Walls separating terraced gardens outside the hotel are either fissured or partially collapsed. The southeast part of the plot is also affected by underground water circulation related to the Wadi ad Dardur delta. Repeated field investigations suggest that although the river bed has been diverted southwards, groundwater circulation follows the direction prior to its diversion.

Figure 11. Damage exposure map of five main hotels in the study area. a: Holiday Inn; b: Hilton; c: Marriott; d: Dead Sea Spa; e: Crowne plaza.
