*Supplement of*

## **Enhanced flood hazard assessment beyond decadal climate cycles based on centennial historical data (Duero basin, Spain)**

**Gerardo Benito et al.**

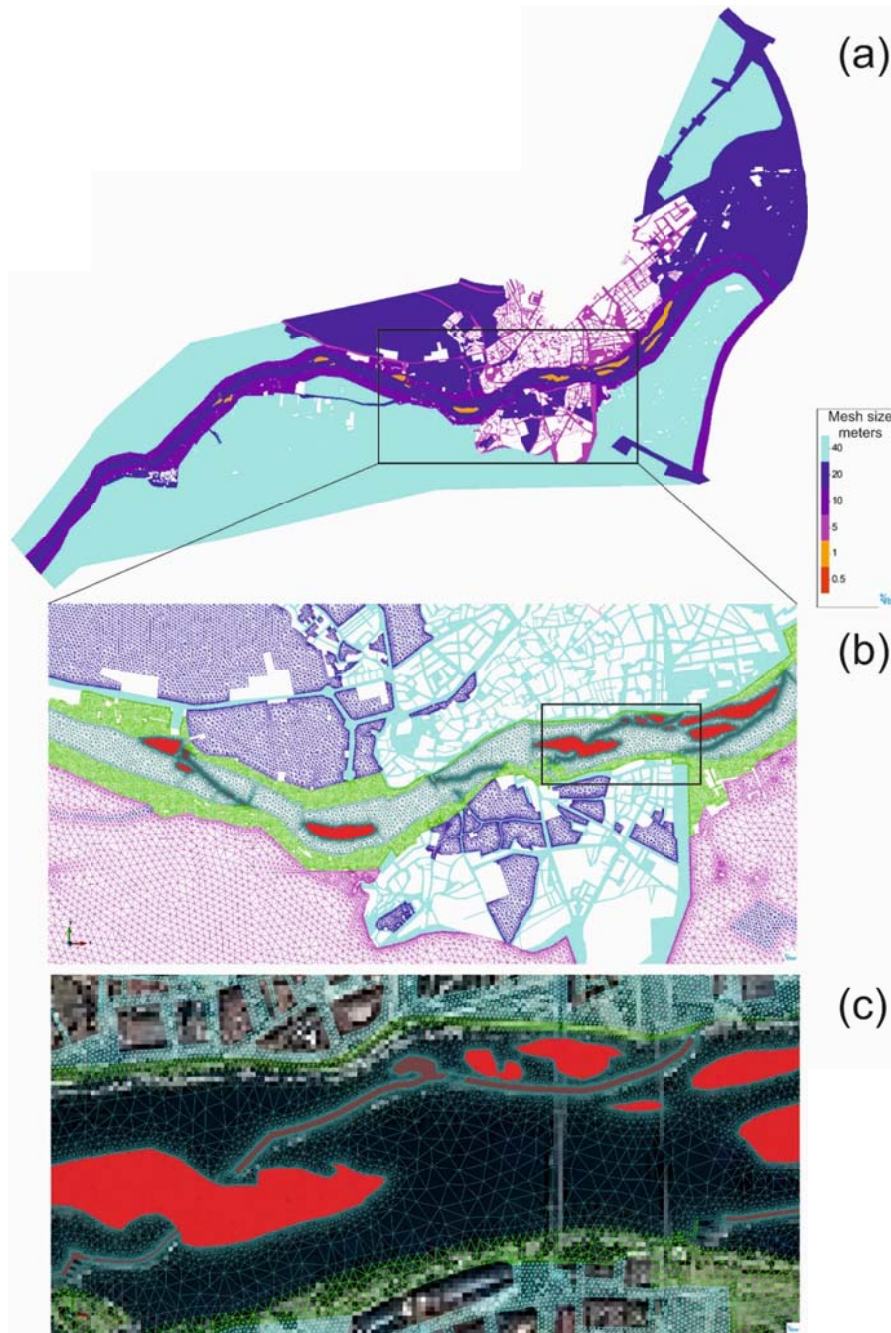
Figure S1: Numerical domain used on the two-dimensional hydraulic model (Iber) along the 13 km studied reach of the Duero River between the Carrascal gauge station and the confluence with the Valderaduey River. The elements of the mesh range from a size of 40-10 m on the floodplains, 5-1 m in the channel and 5 to 0.5 m in urban areas. a) General view of the studied reach and characteristic mesh sizes. b) Detail of the mesh size at the Zamora city area. c) Mesh size used between the Cabañas mills and the railroad bridge. Location of this area is marked by a rectangle in b. Aerial Orthophoto and LiDAR data from the Spanish National Geographic Institute, IGN; <https://www.ign.es>.

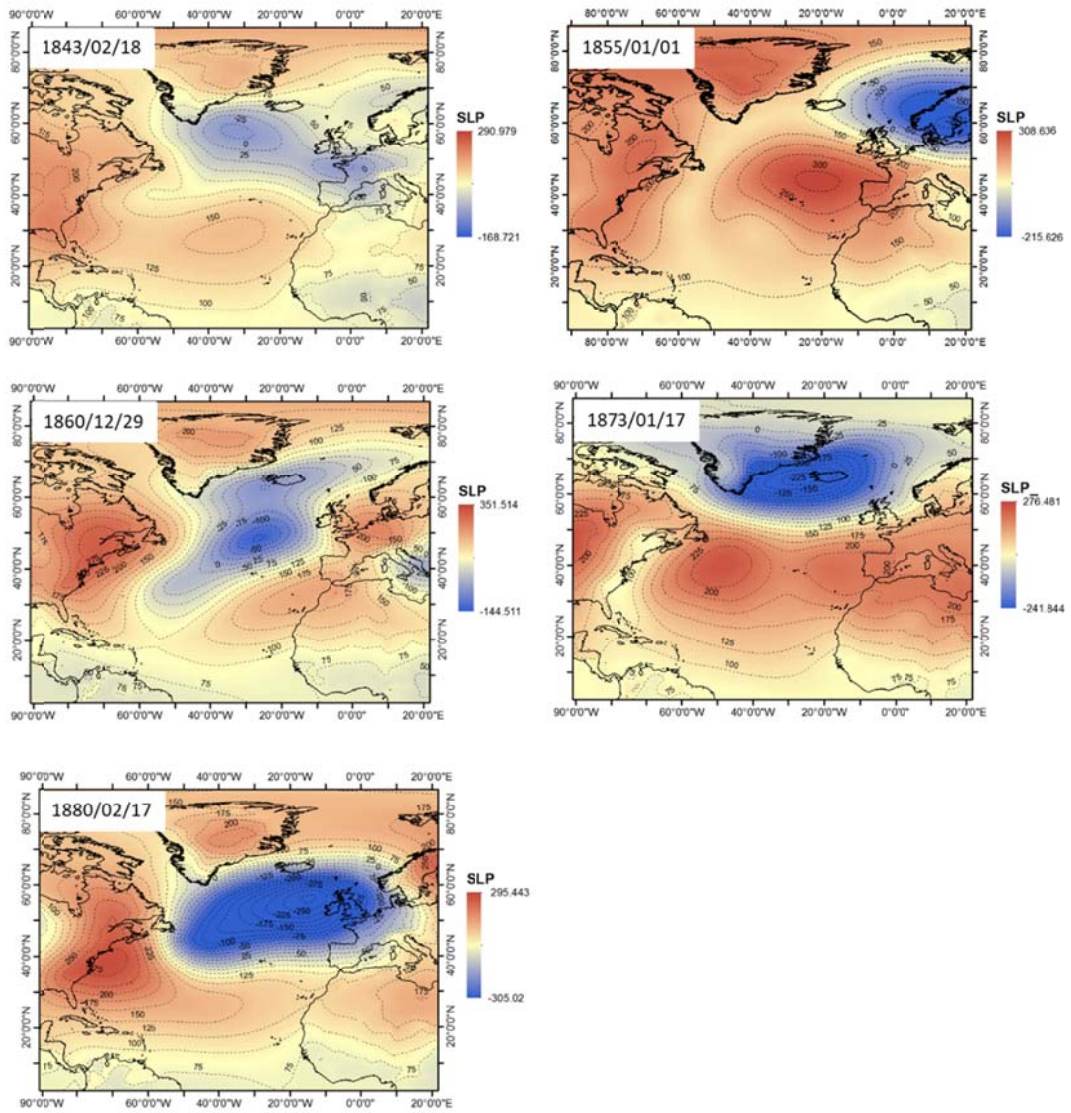
Figure S2: Chart displaying the composite (-5 days) SLP related to each flood previous 1881.

Table S2. Temperature and precipitation anomalies (wrt: 1980-2010) derived from 20CRV3, monthly NAO index (NAO index refereeing to Gibraltar – Stykkisholmur; Jones et al., 1997; source: Climate Explorer); and the predominant circulation type during the 5 days previous to the flood records according to Katalog Der Grosswetterlagen Europas (1881-2004) (source: <https://www.pik-potsdam.de/en/output/publications/pikreports/.files/pr100.pdf>). WZ (facing west over Central Europe, predominantly cyclonic); SWZ (south-west over Central Europe, predominantly cyclonic); WS (South-west facing); HNFZ (high North Sea Fennoscandia over Central Europe predominantly cyclonic); TM (Depression over Central Europe); TRM (trough over Central Europe); BM (high pressure bridge Central Europe); and SZ (facing south over Central Europe, predominantly cyclonic). The circulation types for flood events before 1881 are defined according to the composite Sea Level Pressure 5 days before the flood (Figure S3).

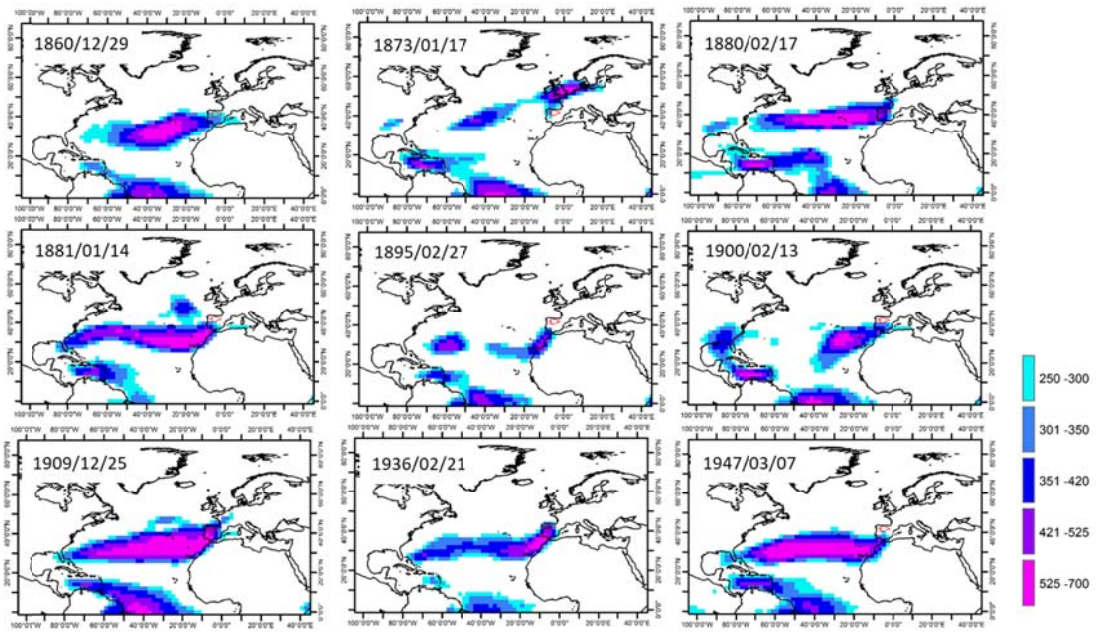
Integrated vapor transported ( $\text{kg m}^{-1} \text{s}^{-1}$ ) - composite flood day (-10:1)

Figure S3: Mean integrated vapor transported for the 10 days prior each flood exceeding the perception thresholds. Data: 20CRV2c

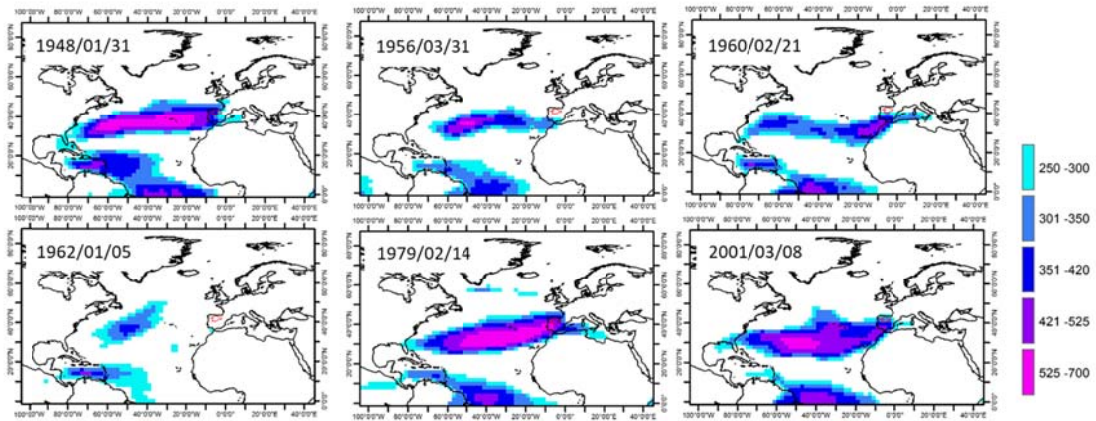
Integrated vapor transported ( $\text{kg m}^{-1} \text{s}^{-1}$ ) - composite flood day (-10:1)

Figure S3 (cont.): Mean integrated vapor transported for the 10 days prior each flood exceeding the perception thresholds. Data: 20CRV2c

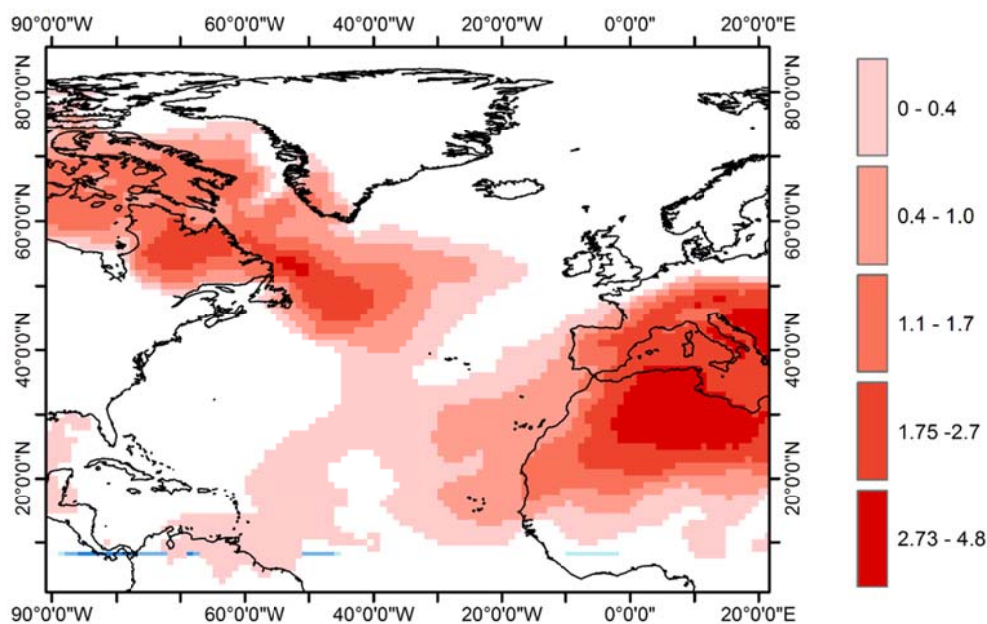
Figure S4: Temperature anomaly retrieved from 20CRV3.

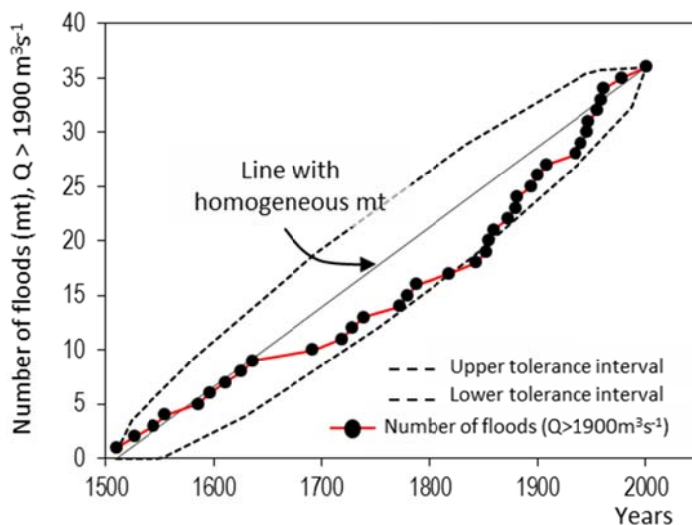
Figure S5. Stationary test on the time flood process of the Duero River over the period CE 1511–2018, for flood events equal or exceeding a discharge threshold of 1900 m<sup>3</sup>/s. The null hypothesis is to assume that the distribution of the number of exceedences can be described by a homogeneous Poisson process (i.e., independent and identically distributed random variables; Lang et al., 1999 and 2004). The test is passed when the accumulated flood line (red line with black dots) stays inside the 90% tolerance interval (95 and 5% quantiles; dashed lines), implying the compliance of the Poisson process hypothesis.
