Authors' Response to Reviewers' Comments

A New Remote Hazard and Risk Assessment Framework for Glacial Lakes in the Nepal Himalaya

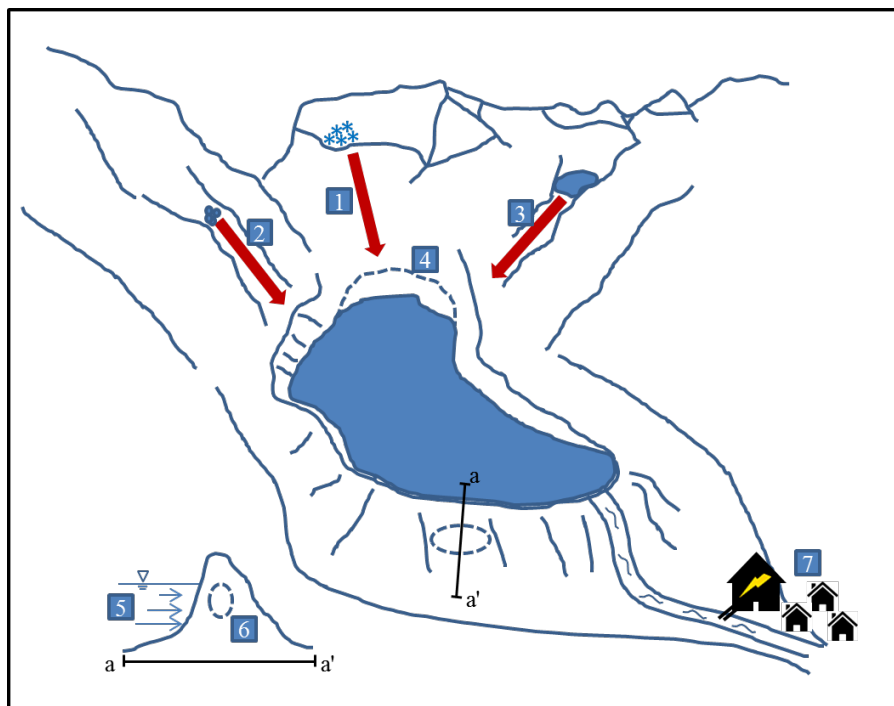
1
2 Figure 2. Schematic of GLOF hazard parameters used in new method: (1) snow/ice avalanche,
3 (2) rockfall, (3) flood from upstream lake, (4) lake expansion, (5) hydrostatic pressure, (6) ice-
4 cored moraine, and (7) downstream impact.

considers three types of dynamic failures: snow/ice avalanches, rockfalls/landslides, and upstream GLOFs (Figure 2). This section describes the mass movement trajectories for avalanches and rockfalls, while the upstream GLOFs are discussed later (Section 4.1.5). Landsat imagery was used to automatically detect glacierized and non-glacierized areas using a ratio of the NIR and SWIR 1 bands with a threshold of 2.2 (Huggel et al., 2004a). In this simplified model, there is no differentiation between snow and ice. Snow/ice avalanche prone areas were identified as any glacierized area with a slope greater than 45° (Alean, 1985), but less than 60° as mass is unlikely to accumulate beyond this threshold (Osti et al., 2011; Shea et al., 2015). Rockfall prone areas were identified as any non-glacierized areas with a slope greater than 30° (Bolch et al., 2011). In this case, the term rockfall is meant to refer to any mass movement from a non-glacierized area and hence is meant to include landslides as well. The lateral moraines were precluded from being rockfall prone areas as they tend to be fairly well developed and are unlikely to lose a large amount of material in a single event. A single flow model using the flow direction algorithm in ArcGIS 10.3 in conjunction with a sink-free GDEM was used to model the path of the mass movement.

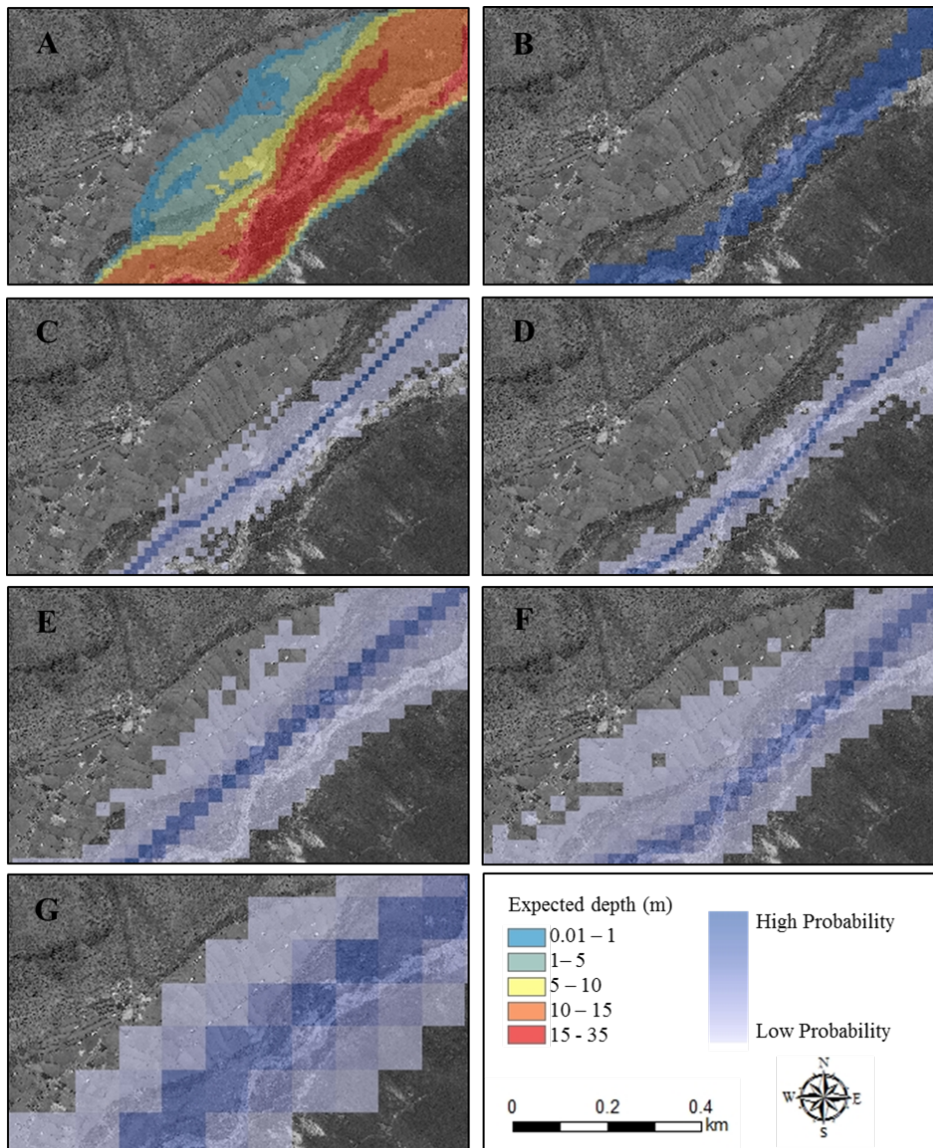
Figure 3. Inundated areas at Dingboche for a GLOF from Imja Tsho using (A) FLO2D (Somos-Valenzuela et al., 2015), (B) the MSF model using the GDEM, (C – G) the MC-LCP model with various DEMs and pixel sizes: (C) SRTM 90 m resampled 15 m, (D) GDEM 30 m resampled 15 m, (E) SRTM 90 m resampled 30 m, (F) GDEM 30 m, and (G) SRTM 90 m.

1 performance of the MSF and MC-LCP models to the actual flood extents. These models used
2 the GDEM resampled to 15 m and were found to perform reasonably well, although the MC-
3 LCP model had a larger inundation area and fewer artefacts. Watson et al. (2015) also observed
4 that in high relief Himalayan catchments, the requirements for an artificially filled DEM by the
5 MSF model created large linear inundation artefacts, whereas the MC-LCP model displayed
6 improved flow routing and hence is more appropriate for assessing first-order socio-economic
7 impacts of a potential GLOF. It is important to note that the GDEM reflects the post-GLOF
8 terrain, which was severely altered by the GLOF (Vuichard and Zimmermann, 1987). Ideally, a
9 pre-GLOF DEM would be used for model validation so modeled flood extents would not be
10 affected by scouring and deposition in the main channel. Furthermore, the comparison reveals

11 multiple areas where the MC-LCP model does not capture the actual flood extent, which would
12 be highly problematic for a hazard assessment if these areas were populated.

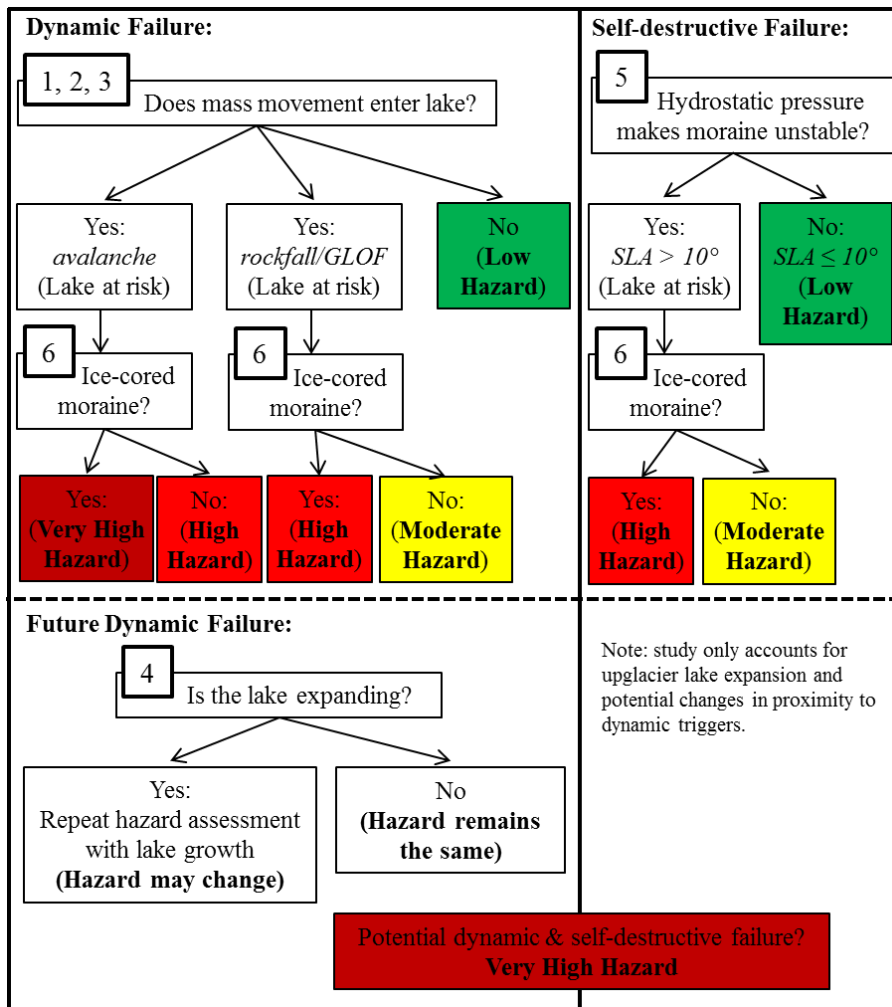
Figure 4. Hazard classification flow chart for determining the hazard associated with a glacial lake (numbers refer to hazard parameters in Figure 2).

The hazard elements described above are crucial for determining if a glacial lake is susceptible to a dynamic or a self-destructive failure. Figure 4 shows the workflow that is used to determine if the lake is susceptible to failure and how the cause of failure translates into the hazard associated with the lake. The most dangerous situation is a glacial lake that is susceptible to both dynamic and self-destructive failures, which would classify the lake as a very high hazard. Susceptibility is defined as a hazard greater than low, i.e., a lake that is considered a moderate hazard for dynamic failure and moderate hazard for self-destructive failure is still classified as very high

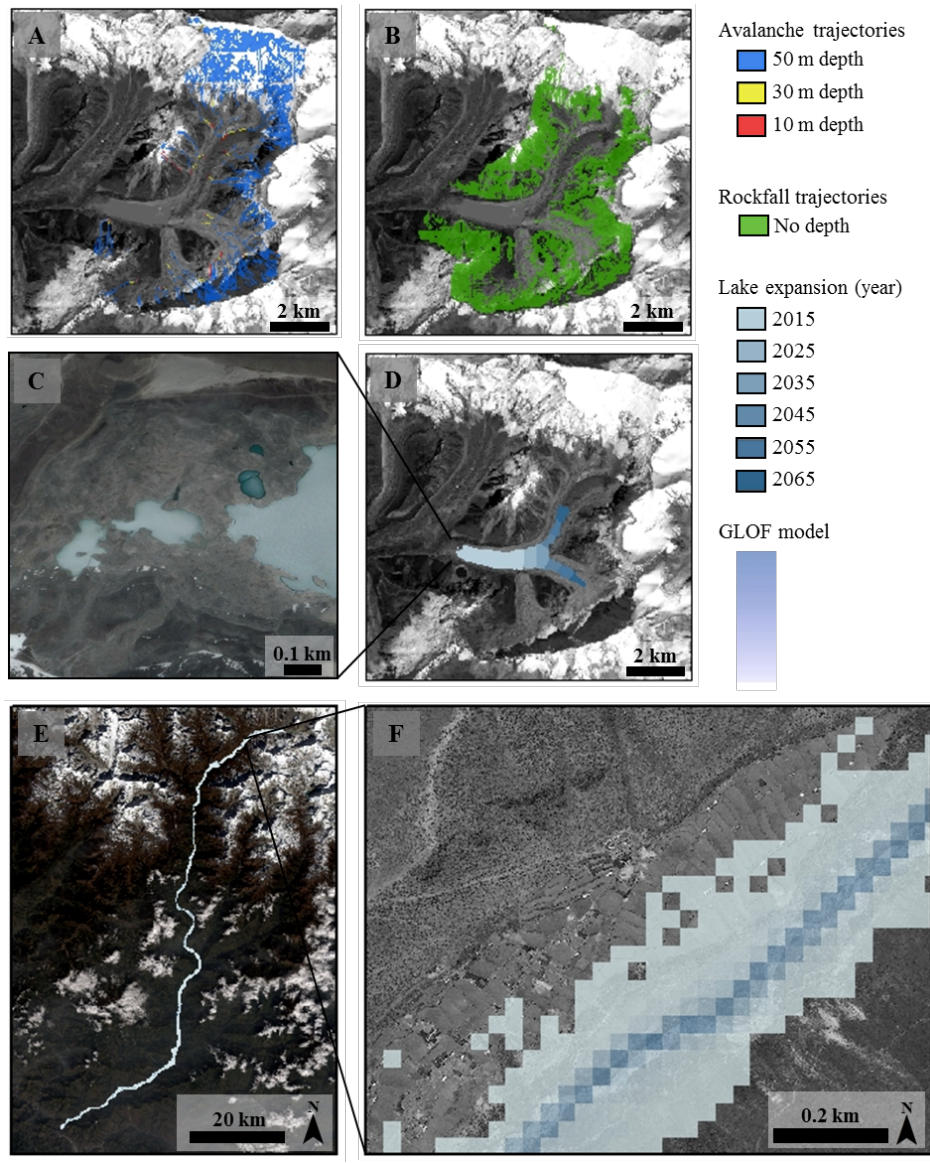
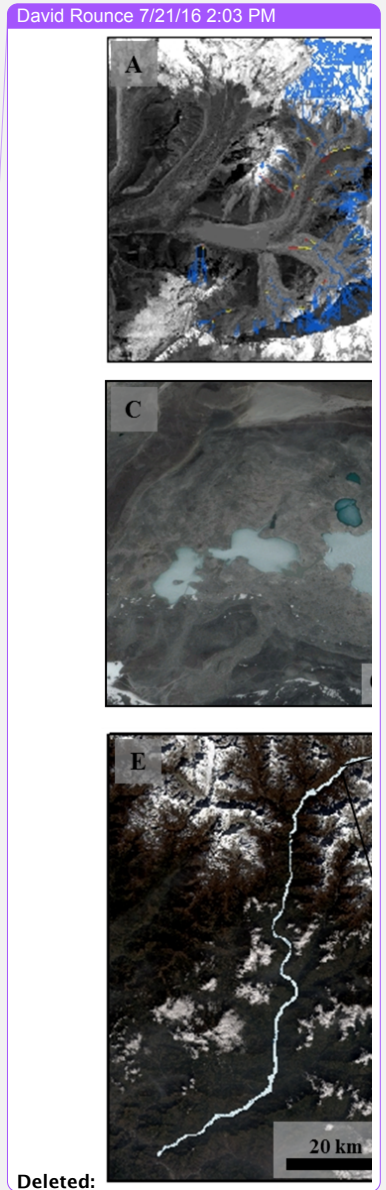
Figure 7. Hazards and downstream impact for Imja Tsho: (A) avalanche trajectories, (B) rockfall trajectories, (C) ponds on the moraine, (D) future lake expansion, and (E) the extent of MC-LCP

1 | GLOF model (F) highlighting the impacts at Dingboche. [Background image \(A-E\) is Landsat 8](#)
2 | [from 30 September 2015 and \(F\) WorldView 2 from 07 June 2015 \(DigitalGlobe, Inc.\).](#)

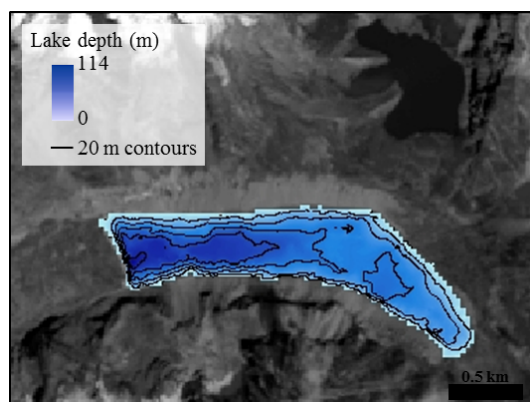
3 |
4 | Figure 8. Bathymetric survey conducted on Lumding Tsho on 22-23 October 2015
5 |

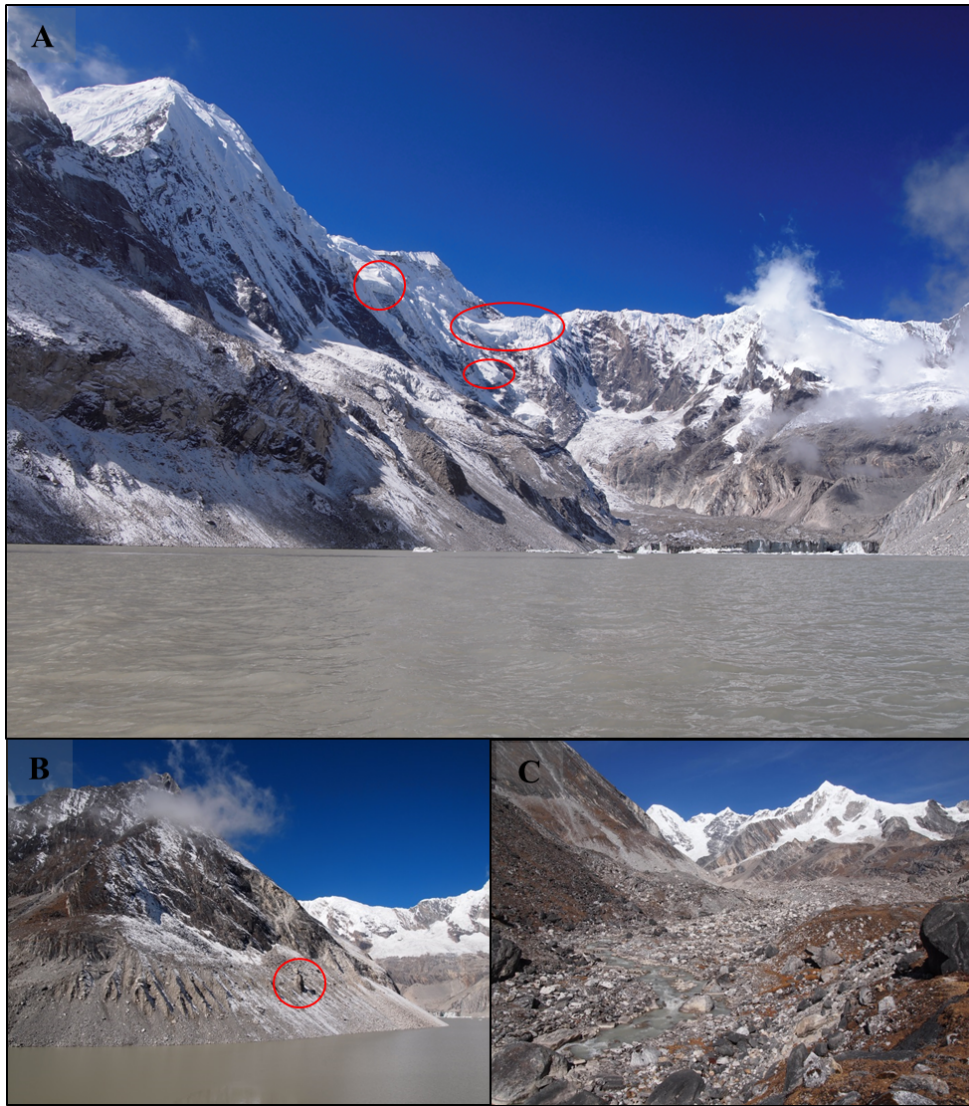
1
2 Figure 9. Lumding Tsho and its surrounding slopes with areas of concern highlighted in red
3 showing (A) the calving front and prone areas behind the glacier, (B) the southern side slope, and
4 (C) the terminal moraine and its gentle outlet.
5

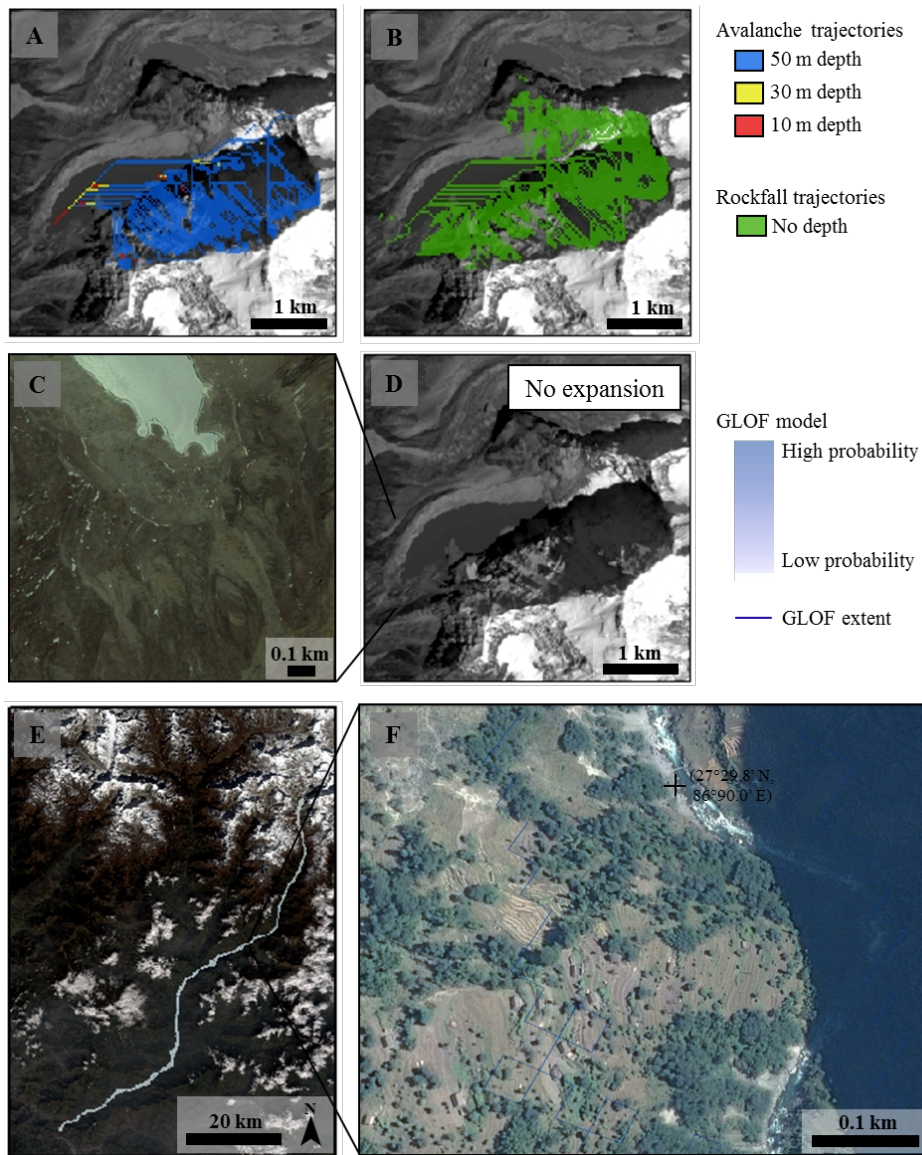
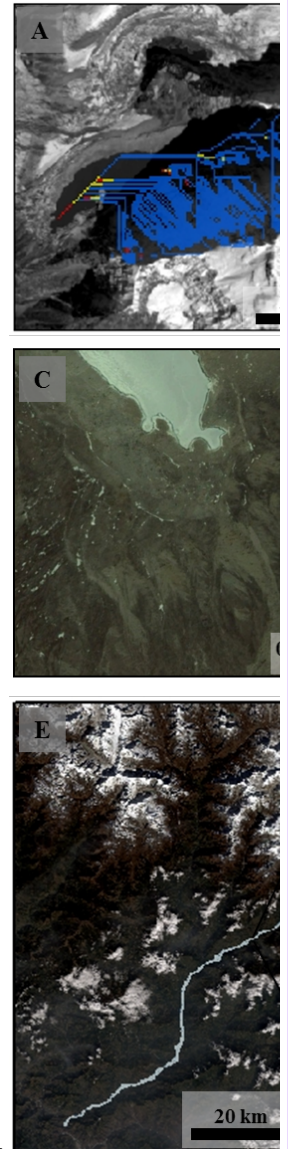
Figure S1. Hazards and downstream impact for Chamlang North Tsho: (A) avalanche trajectories, (B) rockfall trajectories (C) lack of ponds on the moraine, (D) future lake expansion, and (E) the extent of MC-LCP GLOF model (F) highlighting the impacts downstream. [Background image \(A-E\) is Landsat 8 from 30 September 2015 and \(F\) Google Earth.](#)

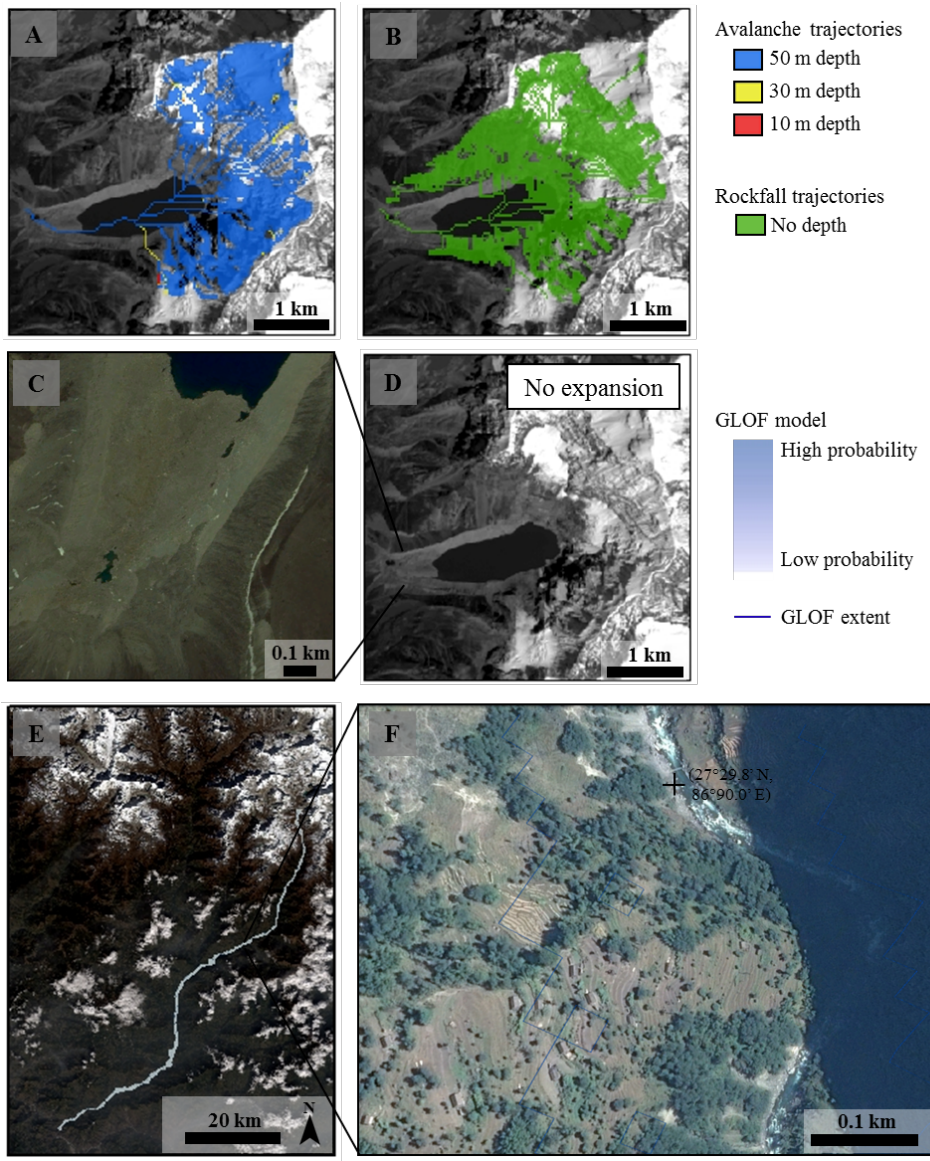
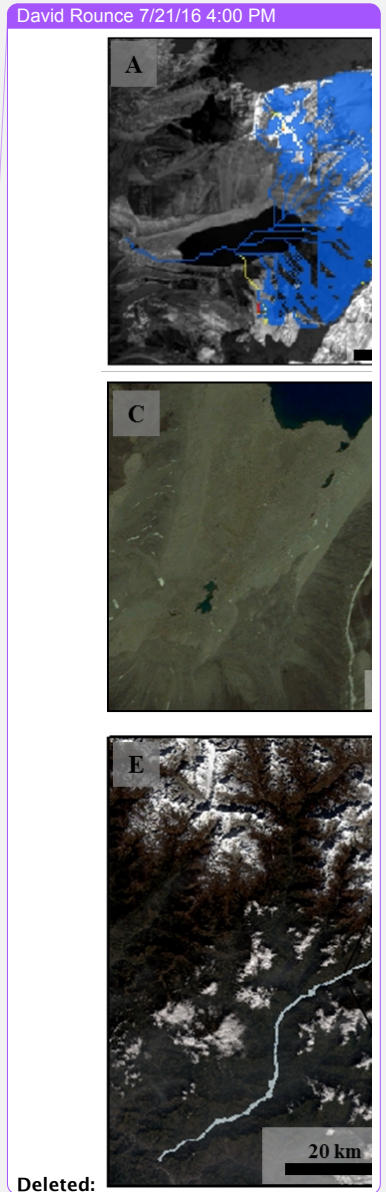
Figure S2. Hazards and downstream impact for Chamlang South Tsho: (A) avalanche trajectories, (B) rockfall trajectories (C) ponds on the moraine, (D) future lake expansion, and (E) the extent of MC-LCP GLOF model (F) highlighting the impacts downstream. [Background image \(A-E\) is Landsat 8 from 30 September 2015 and \(F\) Google Earth.](#)

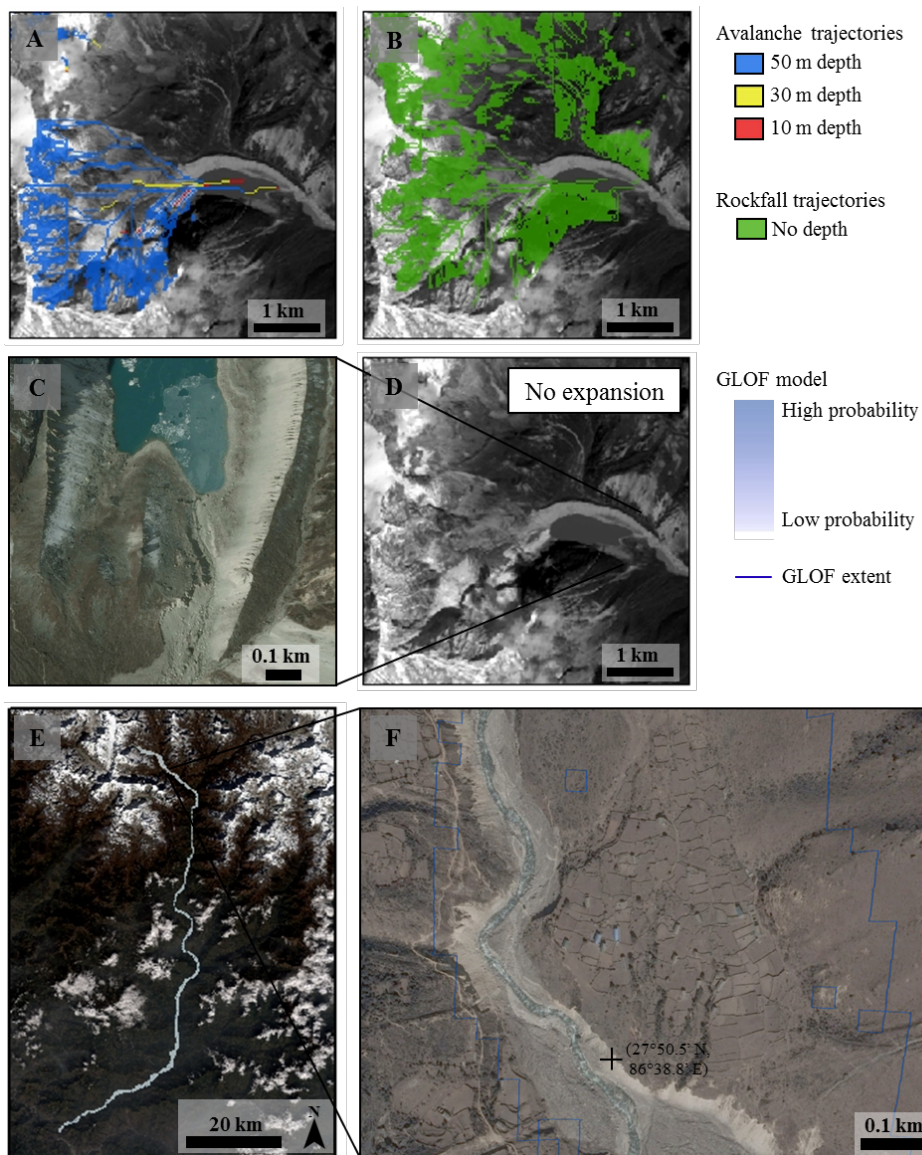
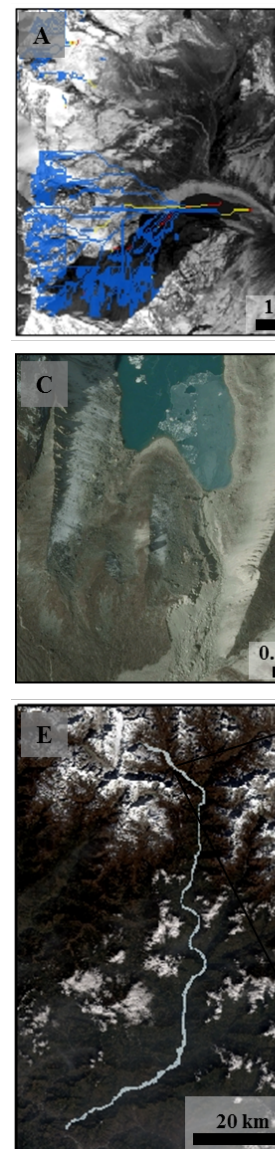
Figure S3. Hazards and downstream impact for Dig Tsho: (A) avalanche trajectories, (B) rockfall trajectories (C) ponds on the moraine, (D) future lake expansion, and (E) the extent of MC-LCP GLOF model (F) highlighting the impacts downstream. [Background image \(A-E\) is Landsat 8 from 30 September 2015 and \(F\) Google Earth.](#)

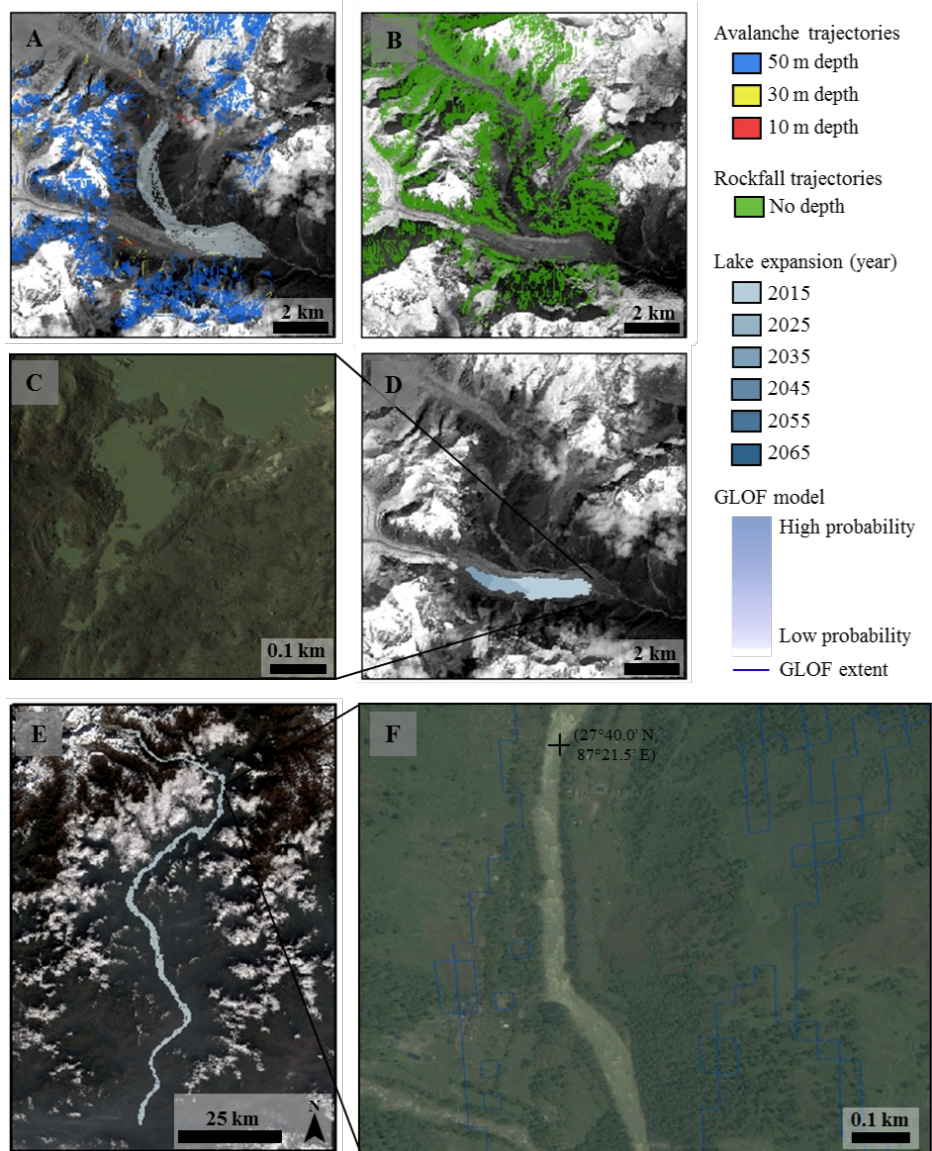
Figure S4. Hazards and downstream impact for Lower Barun Tsho: (A) avalanche trajectories and upstream GLOF, (B) rockfall trajectories (C) ponds on the moraine, (D) future lake

- 1 expansion, and (E) the extent of MC-LCP GLOF model (F) highlighting the impacts downstream.
- 2 [Background image \(A-E\) is Landsat 8 from 30 September 2015 and \(F\) Google Earth.](#)

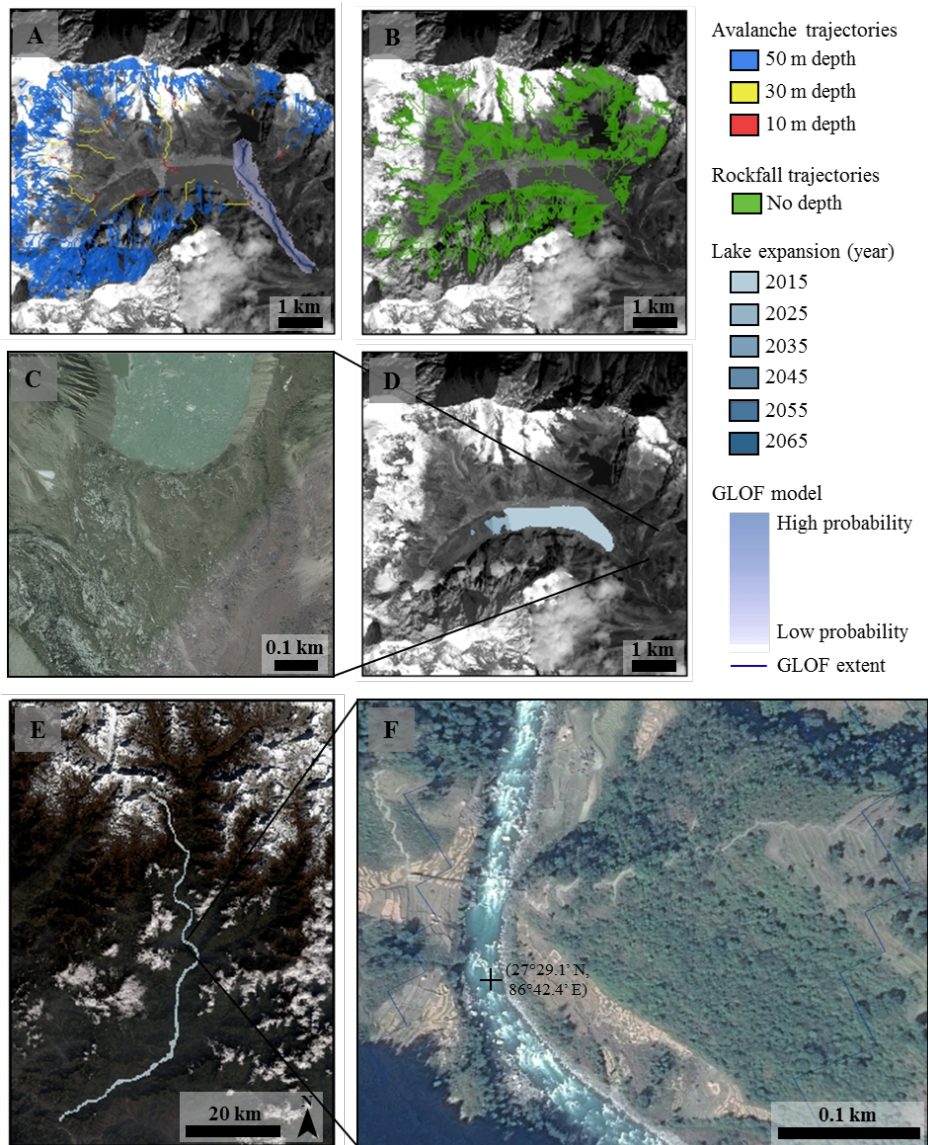
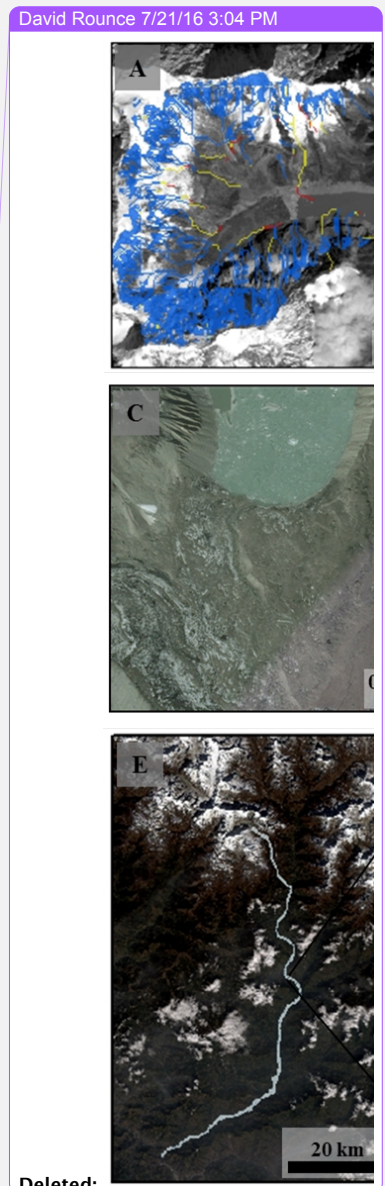
1 Figure S5. Hazards and downstream impact for Lumding Tsho: (A) avalanche trajectories and
2 upstream GLOF, (B) rockfall trajectories (C) ponds on the moraine, (D) future lake expansion,
3 and (E) the extent of MC-LCP GLOF model (F) highlighting the impacts downstream.
4 [Background image \(A-E\) is Landsat 8 from 30 September 2015 and \(F\) Google Earth.](#)

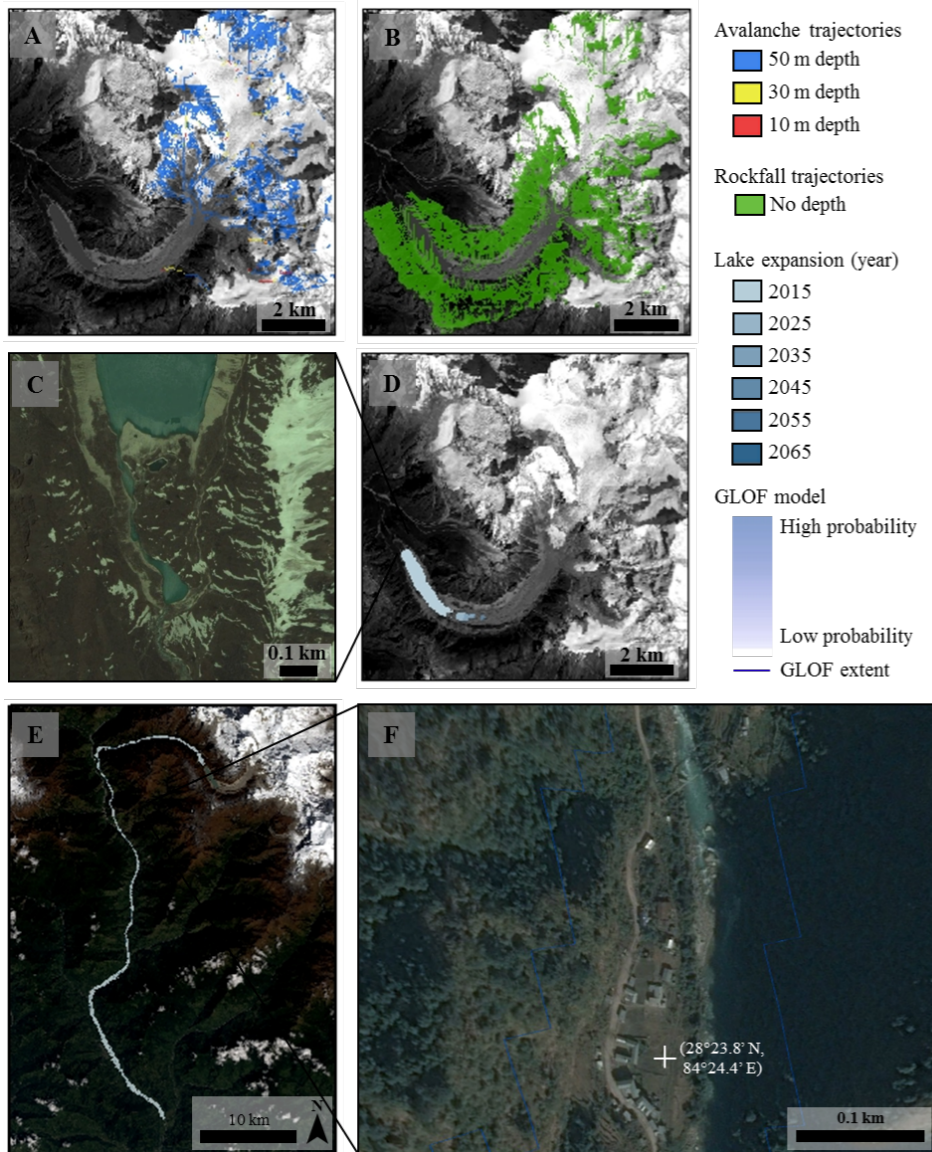
1
2 Figure S6. Hazards and downstream impact for Thulagi Tsho: (A) avalanche trajectories, (B)
3 rockfall trajectories (C) ponds on the moraine, (D) future lake expansion, and (E) the extent of
4 MC-LCP GLOF model (F) highlighting the impacts downstream. [Background image \(A-E\) is](#)
5 [Landsat 8 from 15 November 2015 and \(F\) Google Earth.](#)

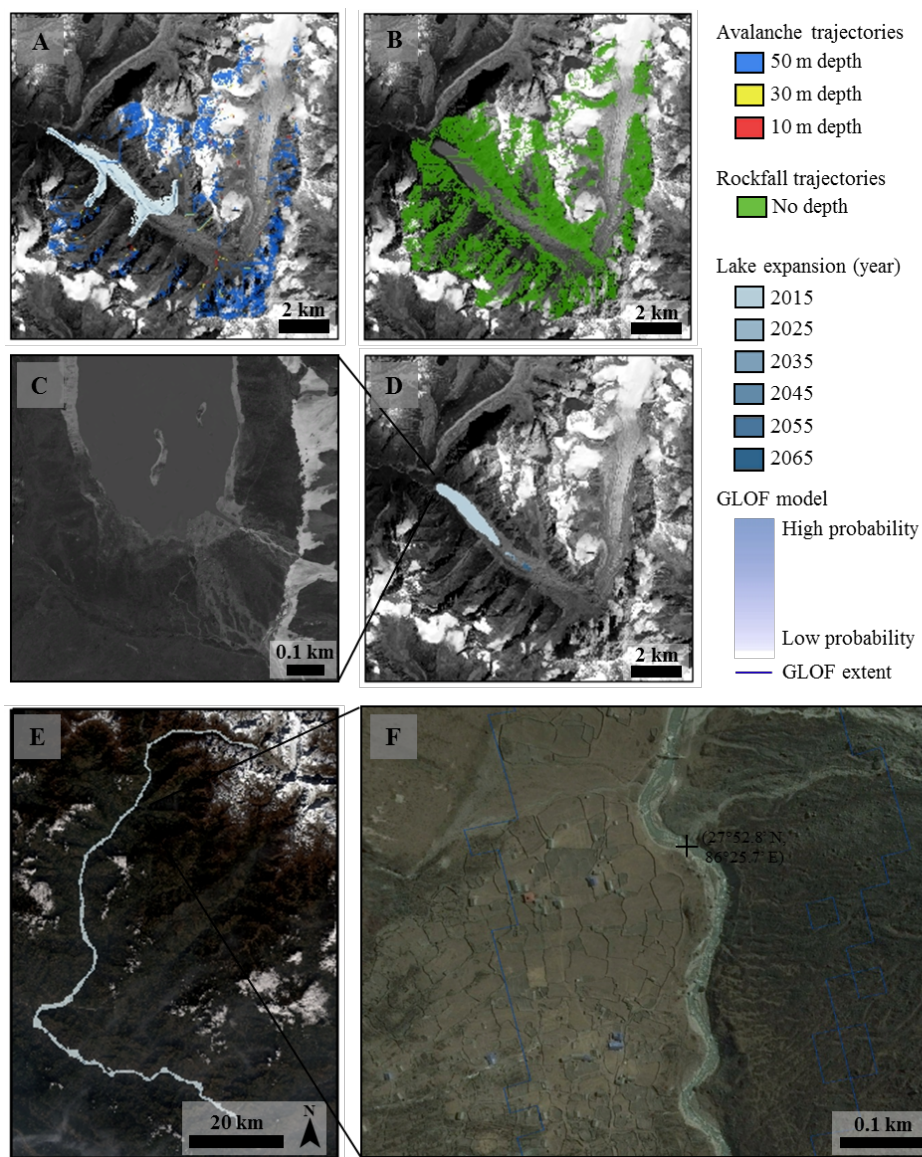
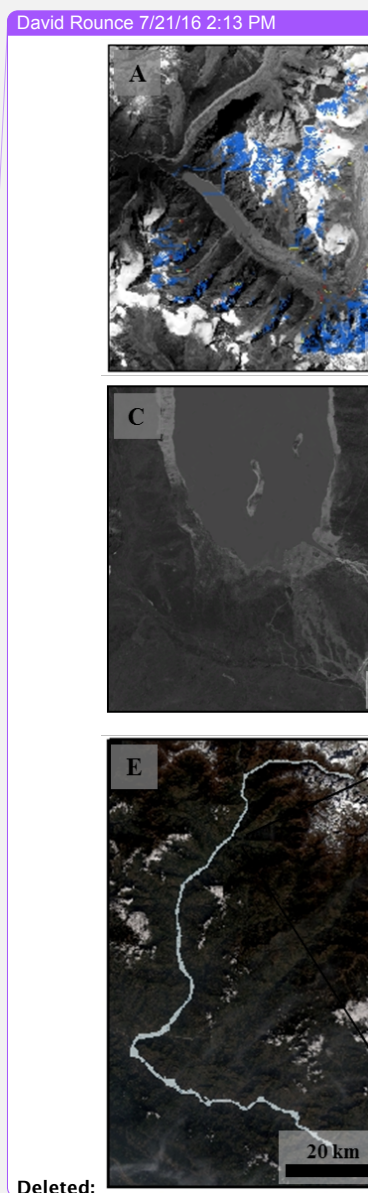
2 Figure S7. Hazards and downstream impact for Tsho Rolpa: (A) avalanche trajectories, (B)
3 rockfall trajectories (C) ponds on the moraine, (D) future lake expansion, and (E) the extent of

- 1 | MC-LCP GLOF model (F) highlighting the impacts downstream. [Background image \(A-E\) is](#)
- 2 | [Landsat 8 from 30 September 2015 and \(F\) Google Earth.](#)
