Sources and pathways of biocides and their transformation products in urban stormwater infrastructure of a 2_{ha} urban district

Felicia Linke^{1,3}, Oliver Olsson², Frank Preusser³, Klaus Kümmerer², Lena Schnarr², Marcus Bork¹, Jens Lange¹

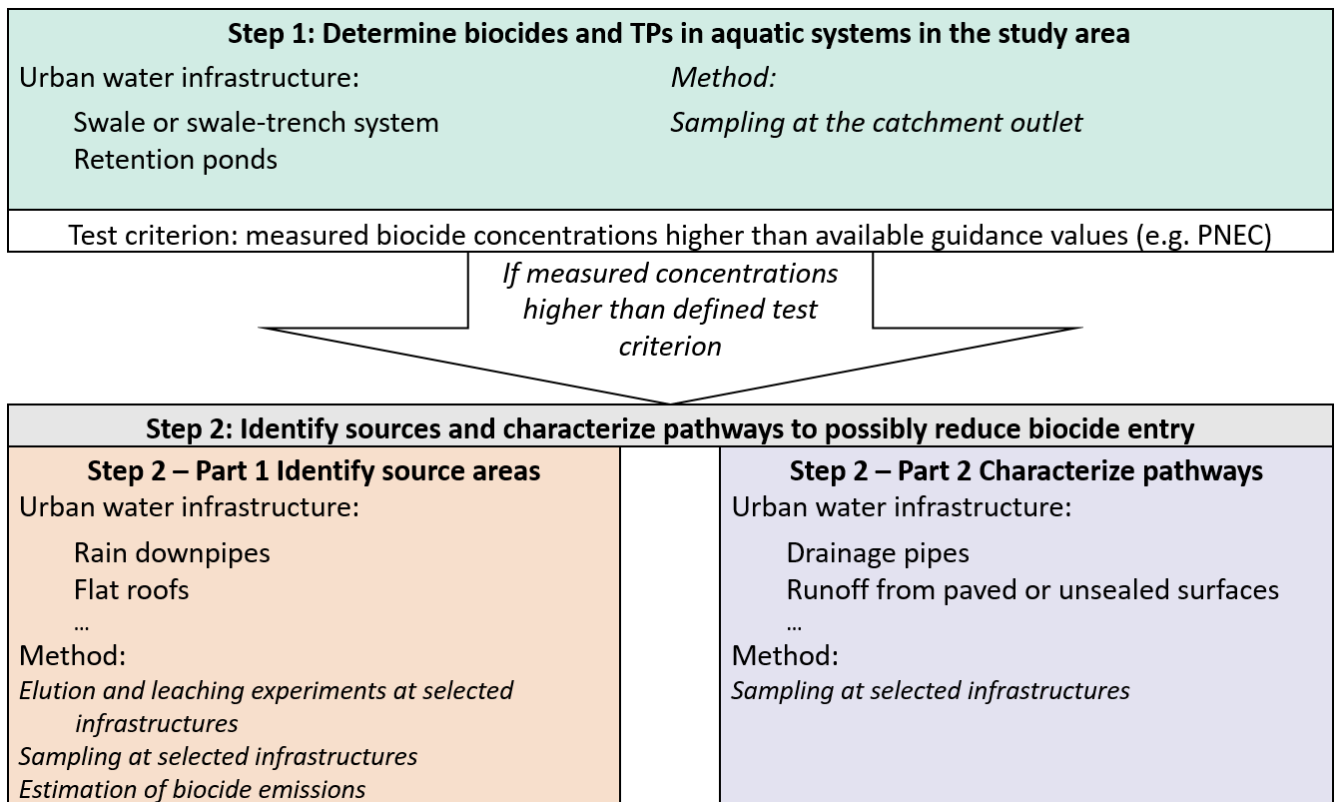
Figure 1: Two-step approach focusing on urban water infrastructure.

We developed a two-step approach utilizing existing urban water infrastructure (Fig. 1). This was done to first check the relevance of biocide emission in the study area and then investigate sources and entry pathways. In a first step, we verified the occurrence of terbutryn, diuron and OIT and their TPs (diuron-desmethyl, terbuthylazin-2-hydroxy, terbutryn-desethyl and
120 terbumeton) in urban aquatic systems and therefore the potential of biocide leaching from building materials by sampling in a selected urban water infrastructure at the outlet of the study area. If the determined concentrations were higher than the available guidance values (e.g. Measured Environmental Concentrations/ Predicted no Effect Concentrations (MEC/PNEC) >1) there is a risk and thus a relevance to take further measures for risk mitigation. In this study, MEC/PNEC was chosen. If this criterion is fulfilled, Step 2 is carried out to identify sources and pathways of selected biocides and their TPs. Finally, this

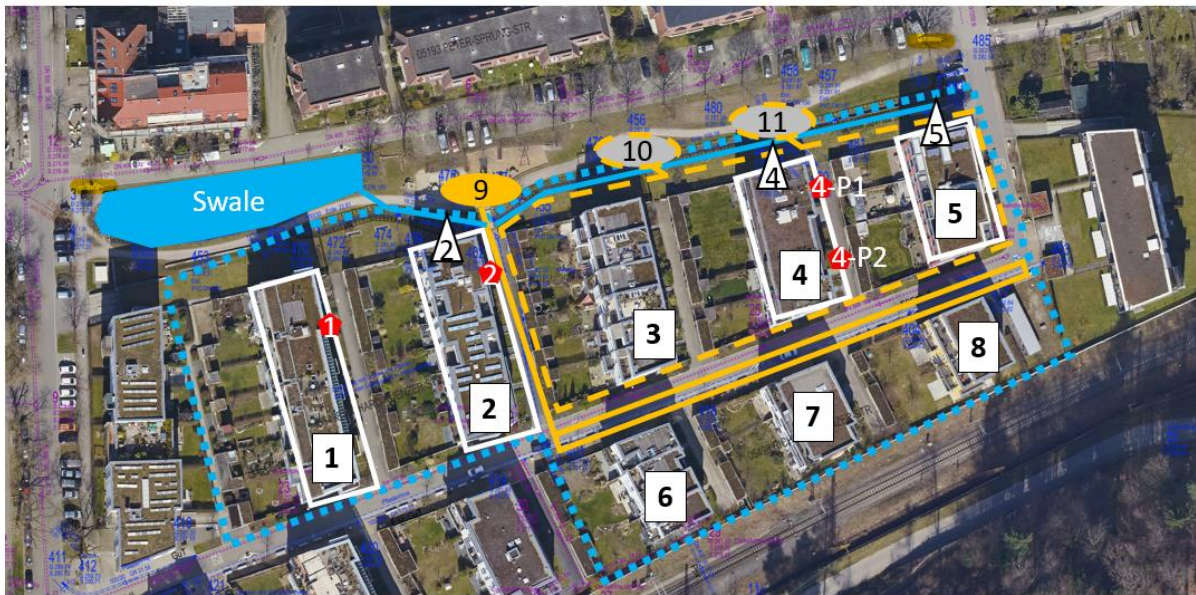
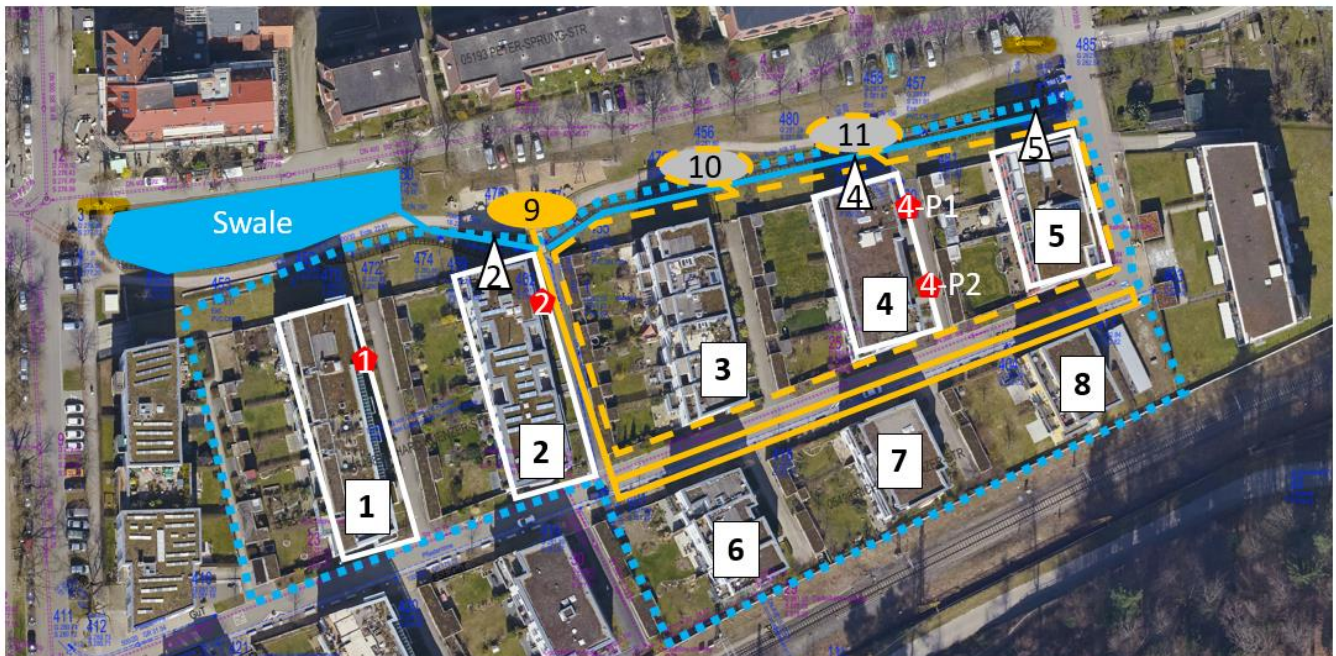
135 The study area consists of eight houses connected to a separated sewer system that ends up in a swale that is dry during dry weather (Fig. 2). The focus of the sampling campaign was on four houses (1, 2, 4 and 5) and on surface runoff from a neighboring street that accepts water from three additional houses (6, 7 and 8). Footprints of buildings vary from 624 to 214 m² (houses 1 to 8) with an approximate height of 13 m. Estimated facade areas covered by paints and renders are 634 m² to 296 m² for houses 1 to 8. All houses were constructed at the same time and thus exposed to identical weather conditions over

We placed our sampling sites along assumed biocide source areas and pathways (Fig. 3). Names of sampling points correspond to house numbers. Assumed sources were **facades** of buildings (**F**) and roof areas. Storm water from roof areas drains into rain downpipes. These rain downpipes were sampled at three individual houses (**roof runoff sampling points, R**). Water from rainwater downpipes flows via paved gutters into a small grass-covered trench along the houses. This trench leads into the swale system. Surface runoff of a neighboring street is diverted by an underground pipe and drains into the same trench. Water samples were taken at this pipe (**surface ~~water~~-runoff pipe, S**).

Figure 2: Study area with sampling points and houses, aerial view. White lines indicate investigated houses. The blue dotted line encloses the drainage area connected to the swale. Yellow and dashed yellow lines enclose approximate areas connected to percolation water pipes and surface water-runoff pipe. Source: Stadt Freiburg i.Br.

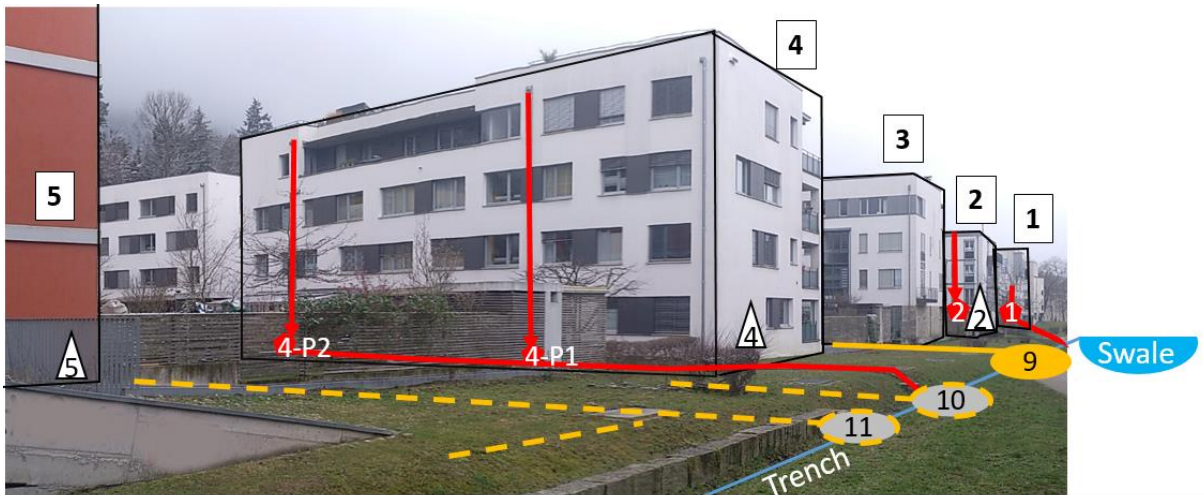
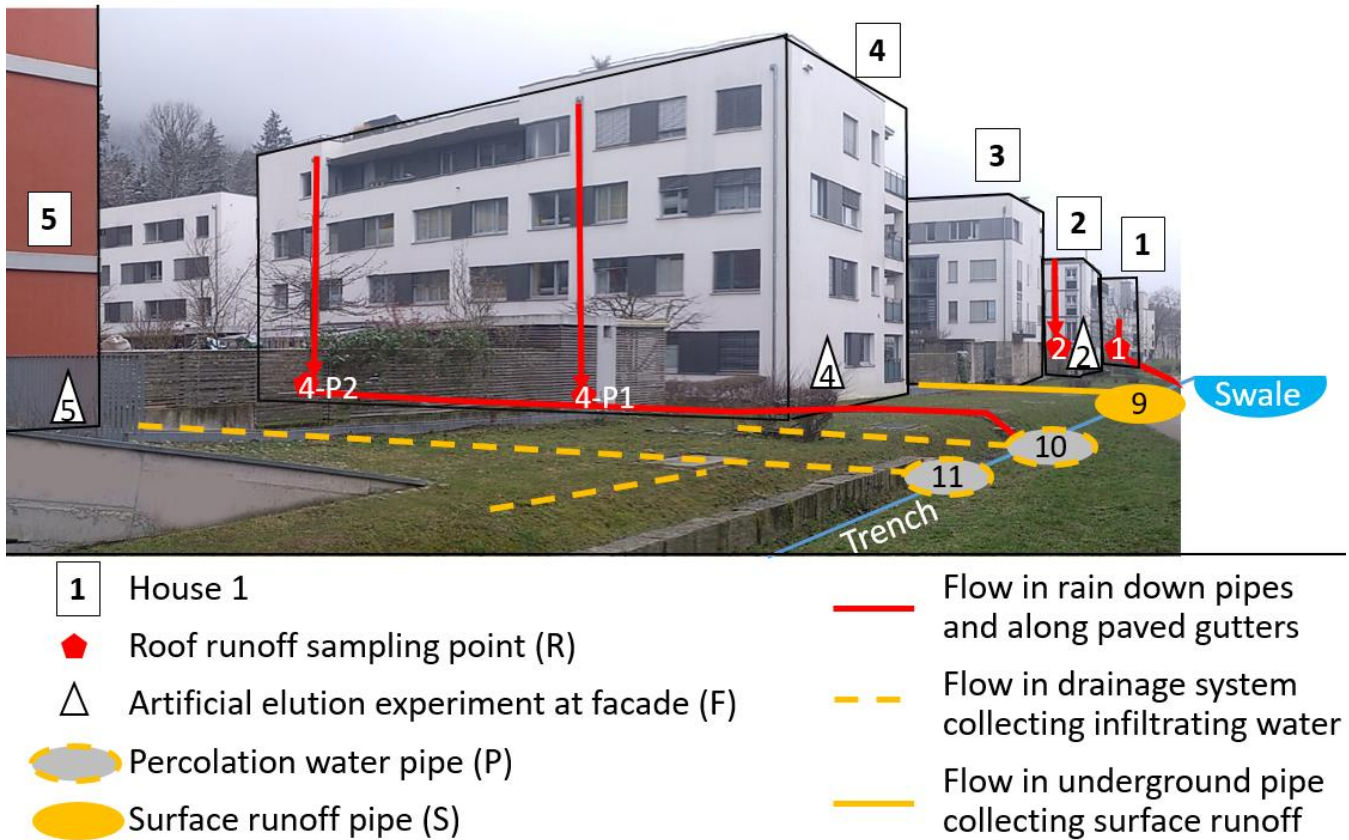
170 **Figure 3: Side view of storm water management infrastructure and sampling points.**

A special feature of the study area is the possibility to collect water samples after soil passage. A drainage system above an underground parking garage located beneath houses 3 to 5 collects all water infiltrating from gardens and green areas surrounding the houses including facade runoff. The soil consists of a 10 - 20 cm topsoil layer covered with grass. Beneath, the soil is composed of expanded clay aggregates to reduce the weight on the underground parking garage. At regular distances, there are pipe outlets of this drainage system directing water to the small trench at the northern site of the study area. The material of these pipes is polyvinyl chloride. Two of these pipes, hereafter referred to as **percolation water pipes (P)**, were selected for sampling, P10 and P11. Both pipes represent the surrounding area of a house with all the infiltrating water.

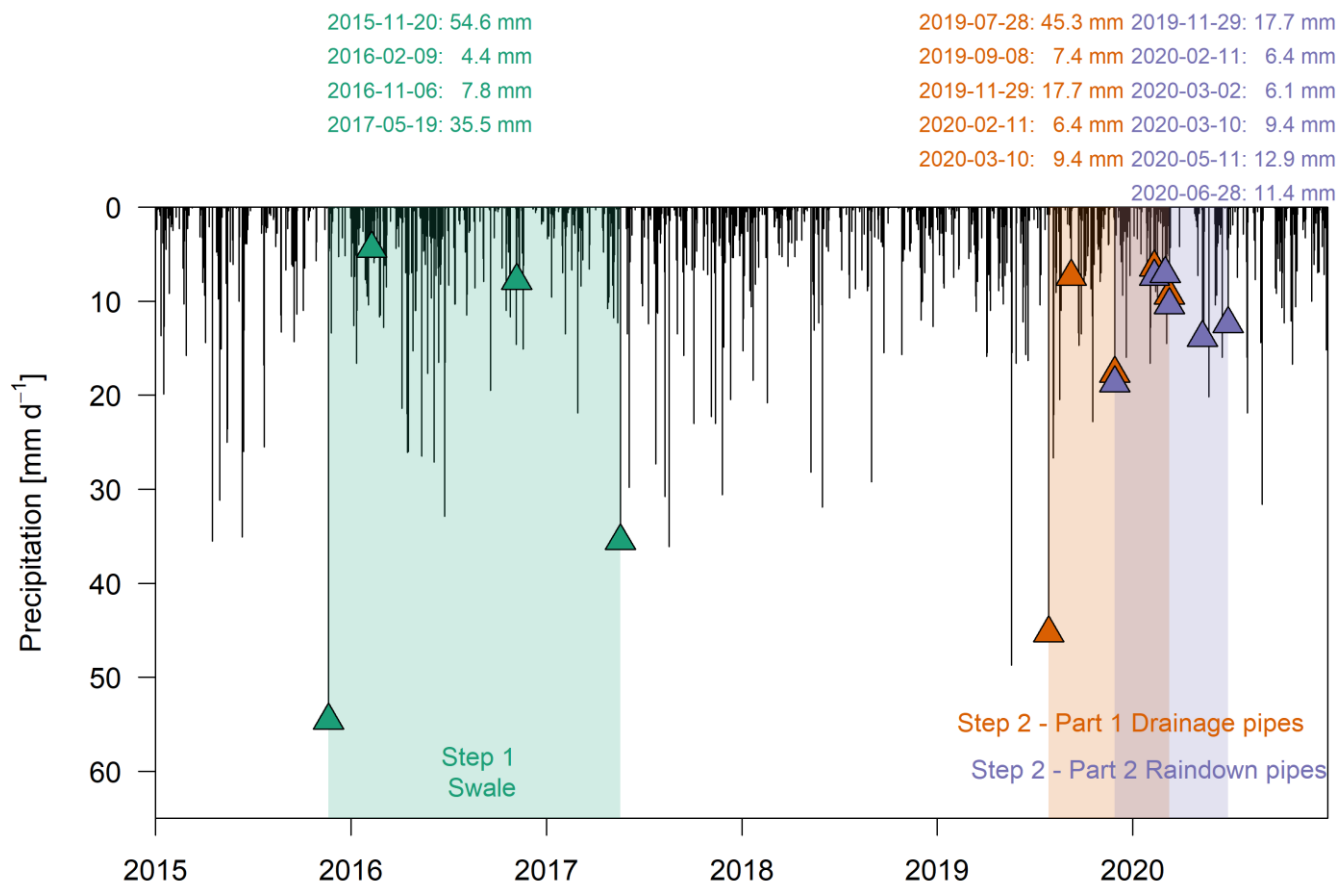
195 **Figure 4: Daily precipitation about 5 km away from study site between 2015 and 2020. Sampled events are marked according to the two-step approach. Colors correspond to steps. Precipitation data taken from Deutscher Wetterdienst, Station Freiburg.**

Fig. 4 shows daily precipitation at a climate station about 5 km away from the study area and the time of sampling in swale, at drainage pipes and at rain downpipes. Daily rainfall ranged between 0 mm and 54.6 mm. The first swale sample was collected shortly after the highest rainfall in the six-year monitoring period. We determined the representativeness of the sampled rain events by comparisons to a 30-year period of rainfall data.

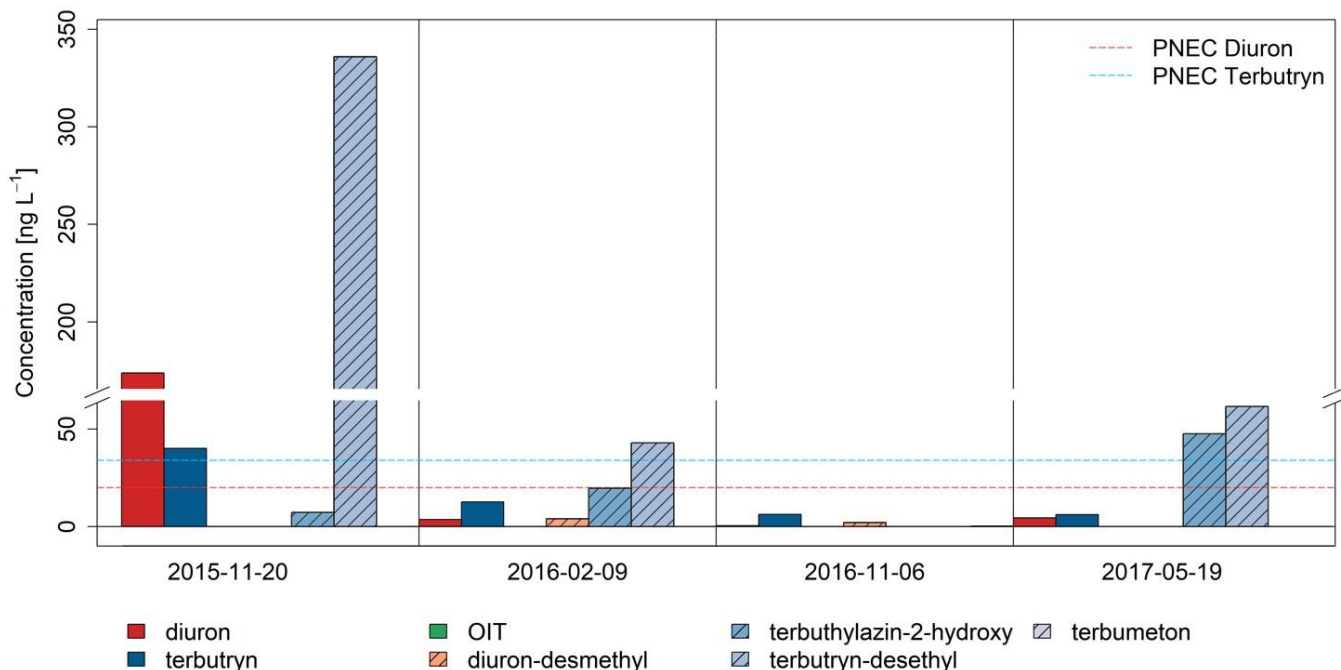
Figure 5: Concentrations of monitored biocides of standing water in the swale during four events.

280 Our Data data suggested suggests that biocides emission was are relevant in the investigated district, since measured
concentrations of terbutryn and diuron exceeded PNEC values (Fig. 5). Terbutryn and diuron were detected during all four
events when standing water in the swale was sampled. Maximum concentrations in the first event (0.04 µg L⁻¹ terbutryn, 0.17
µg L⁻¹ diuron) exceeded PNEC values of surface water (0.034 µg L⁻¹ for terbutryn and 0.02 µg L⁻¹ for diuron). OIT was not
detected in the swale. These concentrations were within the range found in other studies of urban storm water. Reported
285 concentrations of terbutryn ranged between <10 and 360 ng L⁻¹ in storm water channels of a separated sewer system in the city
of Berlin, Germany (Wicke et al., 2015). In the same study, diuron showed maximum concentrations of up to 0.6 µg L⁻¹ and
OIT up to 60 ng L⁻¹. Gasperi et al., 2013 analyzed storm water at the outlet of three catchments in Paris, Nantes and near Lyon.

The TPs terbuthylazin-2-hydroxy and terbutryn-desethyl were detected in samples of the first two and the fourth event, diuron-desmethyl in samples of the second and third event. Terbumeton was detected only during the third event at very low concentrations of 0.25 ng L⁻¹. Diuron-desmethyl concentrations ranged between 0.2 and 4 ng L⁻¹, terbuthylazin-2-hydroxy between 8 and 48 ng L⁻¹, and terbutryn-desethyl between 43 and 335 ng L⁻¹. Hensen et al. (2018) found concentrations of up to 23 ng L⁻¹ for terbuthylazin-2-hydroxy, 73 ng L⁻¹ for terbutryn-desethyl and 2 ng L⁻¹ for ~~detect~~ diuron-desmethyl in a swale-trench system located 2.8 km southwest. Two of the four detected TPs (diuron-desmethyl and terbuthylazin-2-hydroxy) are described as most probably toxic or probably toxic (Hensen et al., 2020). Differences in types and concentrations of detected substances between locations and events might be due to different sources (e.g. newly painted facades), different intensities of UV radiation and different precipitation amounts and intensities that affect biocide emissions (Paijens et al., 2019). This may explain the highest biocide concentrations during the first rain event, which was the largest of the monitoring period (Fig. 4). It was corresponded to the 5th largest event daily rainfall in the reference period of long term precipitation data from 1990-2020 period. All our sampled events were greater larger than 4 mm per day although this only applied to 39% of the events in the reference-1990-2020 period. Two of the four sampled events in the swale were greater exceeded than 30 mm per day whereas which was this was only the case for only 1% of the 1990-2020 events in the reference period. These findings suggest a bias towards larger events of in our sampling. However, this analysis is limited as since the weather station providing long term rainfall data is located 5 km away from the investigated site and there might be differences in local precipitation. the investigated site Due to dependencies on rain event magnitudes and thus high variability of detected concentrations in the swale, we did not expect new findings from a renewed sampling campaign in 2019-2020 and thus focused on sources of biocides in the next step.

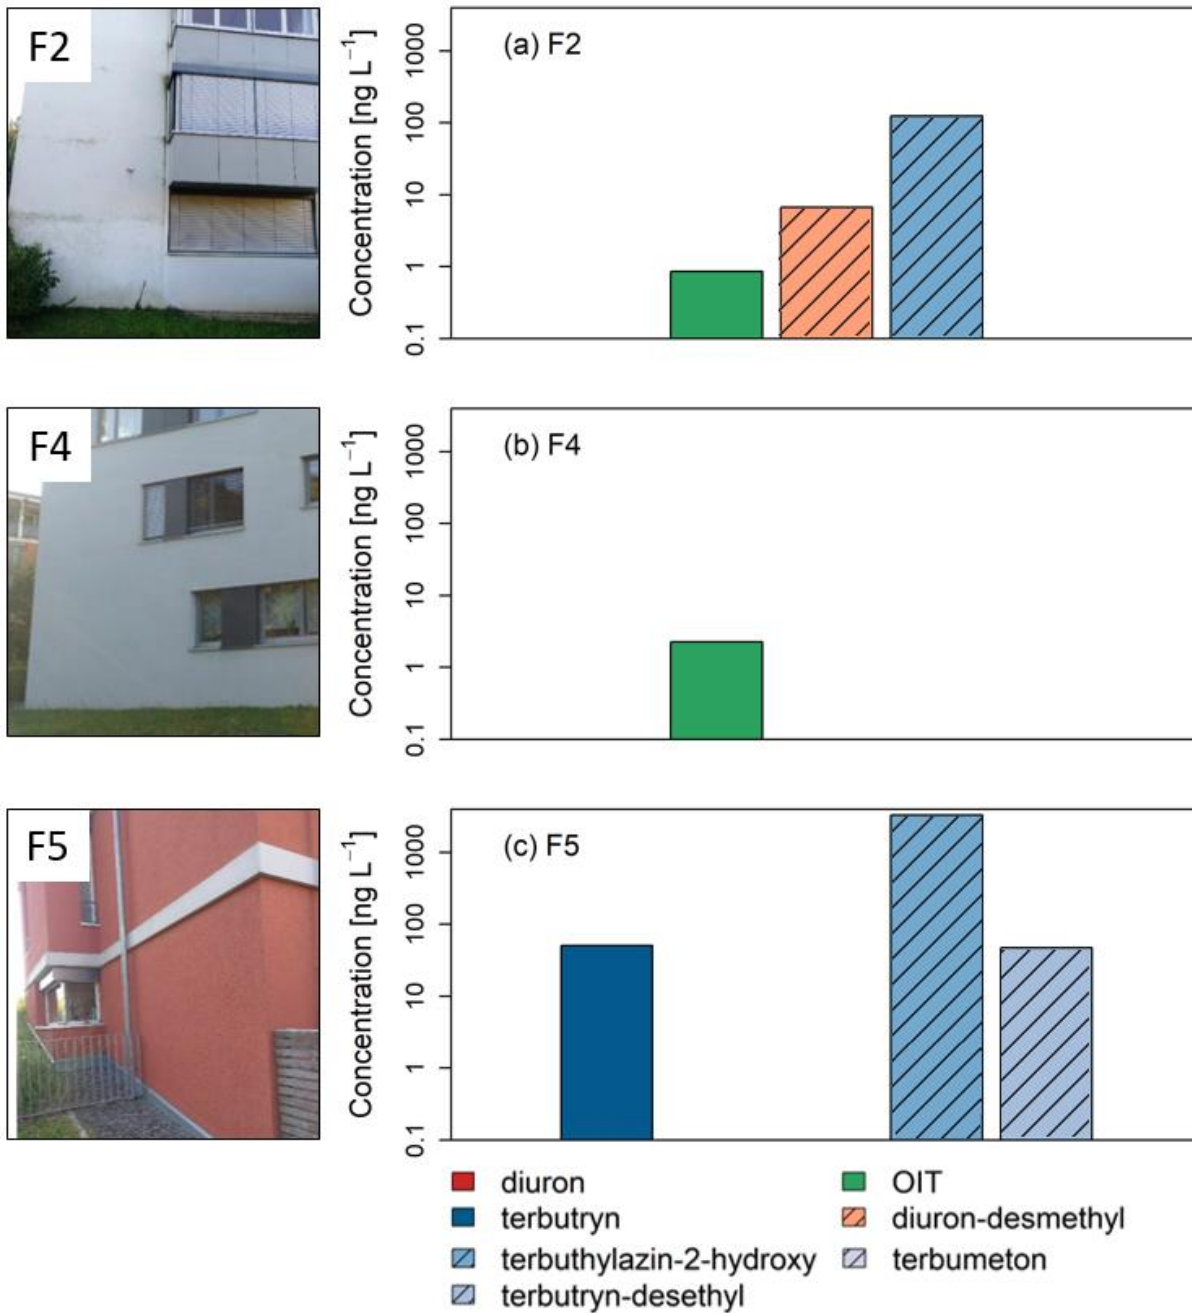
Figure 6: Photos of sampled facade sides and results of facade elution experiments at houses 2, 4 and 5.

Elution experiments at northwestern facades of houses 2, 4 and 5 showed different biocide composition of the wash off (Fig 6). We conducted the elution experiment twice at different parts of the facades and found similar concentrations in the obtained duplicates. Due to our simple experimental approach and missing information about initial biocide loads, we will focus on a qualitative evaluation of the results. Terbutryn was detected at one facade (F5), OIT at two (F2, F4), diuron not at all. Instead, diuron-desmethyl was detected at one facade (F2), which suggests *in-situ* photo transformation of the parent compound (Burkhardt et al., 2012). Terbuthylazin-2-hydroxy was found at two (F2, F4) facades, terbutryn-desethyl at one (F5),

Although all houses were built at the same time, buildings show different color shades and sizes of protruding parts. Differences in detected TPs at the individual facades might be due to different color shades although its influence is reported to be rather low (Bollmann et al., 2018). [Urbanczyk et al. \(2019\) found differences in pigments contained in paints and renders influencing formation of TPs.](#) Other factors influencing the differences in found TPs can include local wind conditions, UV exposure (Paijens et al., 2019) and, most probably, differences in application of paint and renders. Terbutryn was only found at F5 which pointed to a different product used during construction also evident by different color and by very high concentrations of the TP terbuthylazin-2-hydroxy.

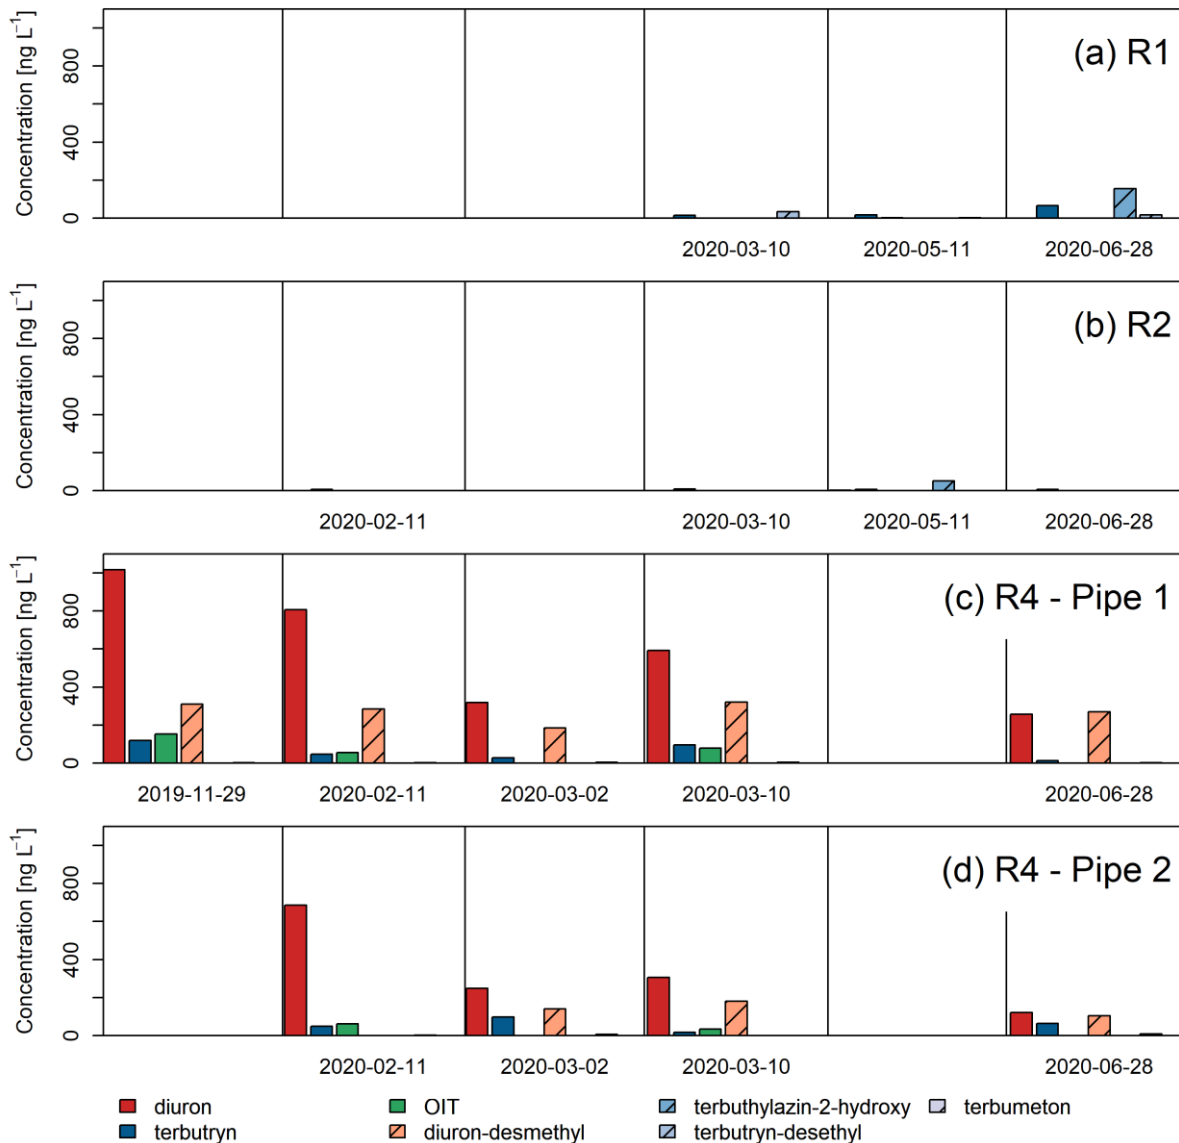
Figure 7: Sampled events in rain-water downpipes at three houses. Number after “R” refers to the number of the house. Non-sampled events shown without date.

In all rain downpipes, biocides were detected indicating the application of biocides on the flat roofs. However, concentrations of biocides and TPs largely differed between pipes and houses (Fig.7). Concentrations in pipe R4-P1 were high, as we did not

expect roof areas as a biocide source. Concentrations at house 4 (R4 - Pipe 1) exceeded those at houses 1 and 2 by an order of magnitude. We sampled an additional pipe at the same building (R4-P2) to exclude potential contamination in the first pipe. Both R4 pipes showed concentrations of a similar magnitude. For comparison, we decided to sample one pipe at another house (R2). To confirm the low concentrations, we sampled at a third building (R1). We then sampled multiple events at all pipes. Due to these high concentrations, we sampled an additional pipe (R4 - Pipe 2) during following events. Both R4 pipes showed concentrations of a similar magnitude.

370 Concentration differences between houses can be attributed to different products used on different roofs, as previously discussed for the investigated facades (3.2.1). Additionally, houses differ in layout of their roofs (2.2) which might also lead to differences in biocide use and emission. Due to the limited number of investigated houses, general conclusions, if certain roof structures pose a higher risk for biocide emission than others cannot be drawn. Generally, biocides are used in roof sealants, treated tiles, roof paints and bitumen roofing membranes (Paijens et al., 2019). Terbutryn and OIT may be included

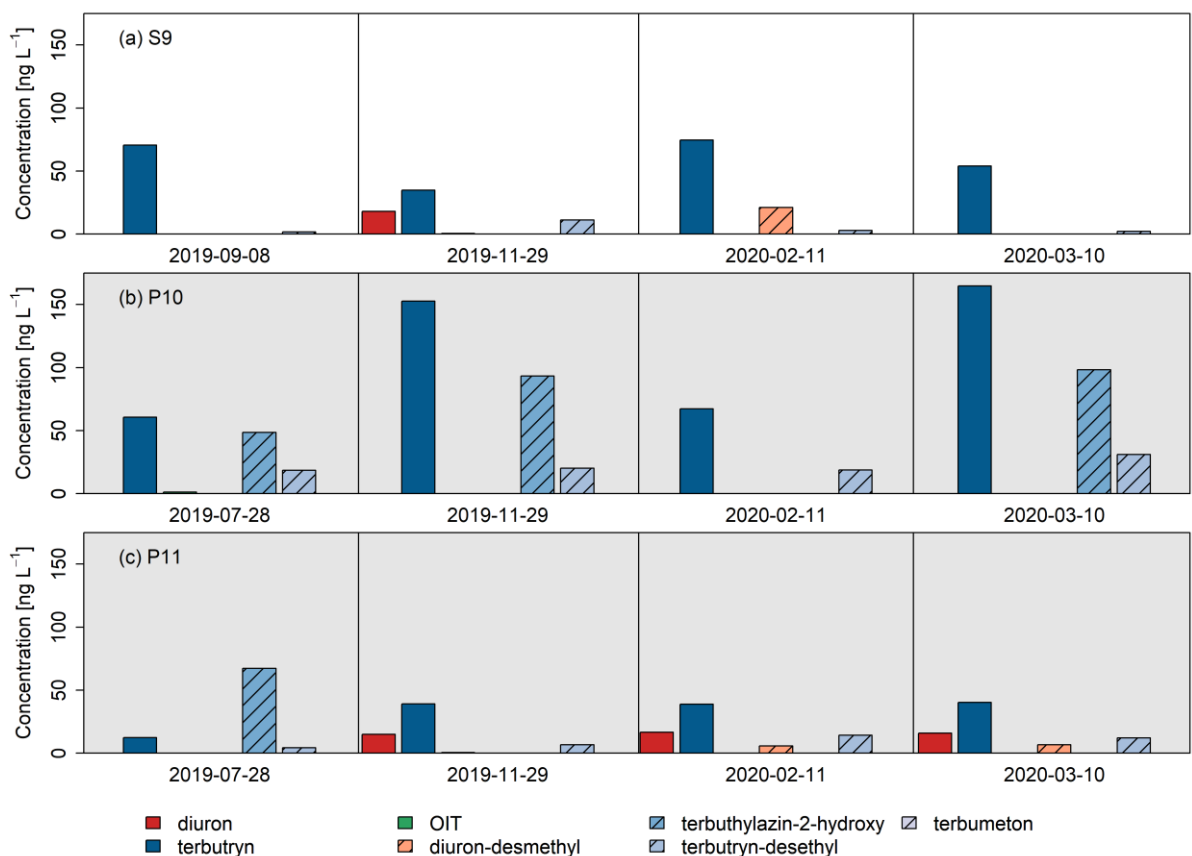
Figure 9: Samples in drainage pipes during four events. (a) Pipe S9 collects street runoff. (b) Pipes P10 and (c) P11 collect infiltrated water around the houses (percolation water).

The three investigated drainage pipes S9 (surface water-runoff), P10 and P11 (percolation water) are entry pathways for emitted biocides into the swale. Terbutryn was detected in all pipes during all four sampled events, while diuron was found in percolation water pipe P11 during three and in surface water-runoff pipe S9 during one event (Fig. 9). As in the swale (Fig. 5), OIT was not detected at all, probably due to fast degradation in the soil passage (Bollmann et al., 2017b). OIT concentrations at the facades were very low (-Fig. 6), thus we did not expect to find OIT in the surface runoff pipe S9.

445
 Detected biocides in percolation water pipes P10 and P11 were different probably due to different paints and renders used in the corresponding connected areas. The biocide concentrations of individual products may also vary (Sauer, 2017). Another reason might be a different dilution before reaching the outlet of the drainage pipe due to possible differences in the pipe system leading to the individual drainage pipe outlets. Additional sources may also affect the system, since infiltrated water from gardens and terraces around the building accumulates on top of the underground parking garage and reaches the drainage pipes. This could include biocides used on terraces or garden furniture, although inhabitants denied having used biocides. Diuron and terbutryn are authorized for use in coatings, which includes terraces or furniture coating (European Parliament and Council, 2013).

450
 Diuron-desmethyl was detected only during one event in surface runoff-water pipe S9 and during two events in percolation water pipe P11. Concentrations of diuron-desmethyl were lower in P11 than in S9. This might be explained by higher dilution effects in the percolation water pipe P11 or by enhanced degradation during soil passage. Diuron-desmethyl is reported to be a photo TP that possibly can be formed by microorganisms in soil additionally (Hensen et al., 2018.).

455 TPs of terbutryn were detected in all pipes, although there was a difference between surface [water-runoff](#) and percolation water pipes regarding the number of detected terbutryn TPs. We detected terbutryn-desethyl in all three drainages during all events. The different appearance of the other two TPs of terbutryn implied different degradation processes in pipes S and P. Terbutylazin-2-hydroxy was only found in percolation water pipes P10 and P11 (with soil passage) and not in S9 (without soil passage). This suggests preferred formation of terbutylazin-2-hydroxy by biodegradation, although photo transformation
460 could not be excluded, since both terbutryn TPs were already found at the sources (Fig. 5, 6). Concentrations in the swale were in a similar range, which suggests similar input concentrations and degradation processes. Terbumeton was not found in samples in the drainage pipes, though detected in the swale.

For terbutryn, concentrations of both the parent compound and its TPs were highest in percolation water pipe P10. Biochemical transformation in soil is important and TPs are obviously formed, our findings suggest that also the parent compound poses a
465 risk to groundwater by diffuse infiltration of contaminated runoff from urban settings. Much less transformation of terbutryn takes place along surface pathways, represented by surface [water-runoff](#) pipe S9 where overall concentrations of TPs were smaller and terbutylazin-2-hydroxy was not found.
